**An Assessment of Trails, Watercourses, Soils, and Redwood
Forest Health in Joaquin Miller Park, Oakland, California,
with Recommendations for Management**

City of Oakland
Office of Parks and Recreation
1520 Lakeside Drive
Oakland, California 94612

Richard D. Koehler and Janet M. Sowers
William Lettis & Associates, Inc.
1777 Botelho Dr., Suite 262
Walnut Creek, CA 94596

December 31, 2000

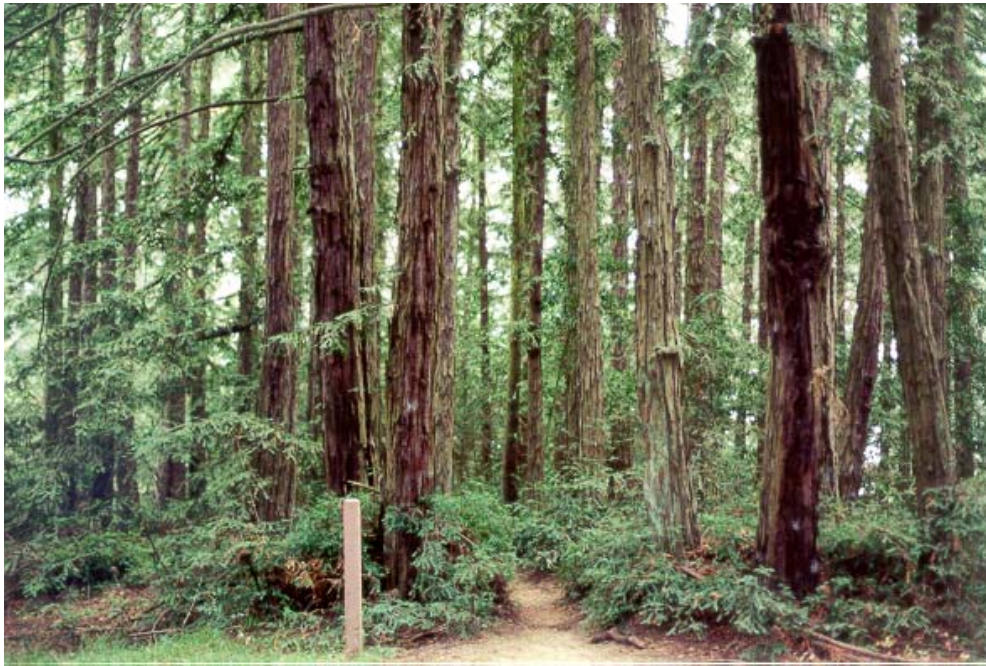
No extraordinary conditions were observed with regard to tree vigor, mechanical damage, and tree pathogens. No areas showed signs of declining vigor. One area was noted, however, that was observed to be a poorer growing site than other areas of the Park. This area is located on a ridge along the Big Trees Trail and is identified as Area “I” on Figure 1. The redwood trees in this area are of much smaller diameters than in other areas of the Park, and they exhibit a shaggy bark condition that is more pronounced than seen on other trees of the Park (see Figure 2).

Figure 2: Area “I” of the Big Trees Trail, Harsh Growing Site

Although these trees are smaller on average than other trees of the Park, they are the same age as the other larger redwood trees. This area shows a lower overall tree vigor because it is a harsher growing site, probably due in part to shallower soils, not due to any Park use.

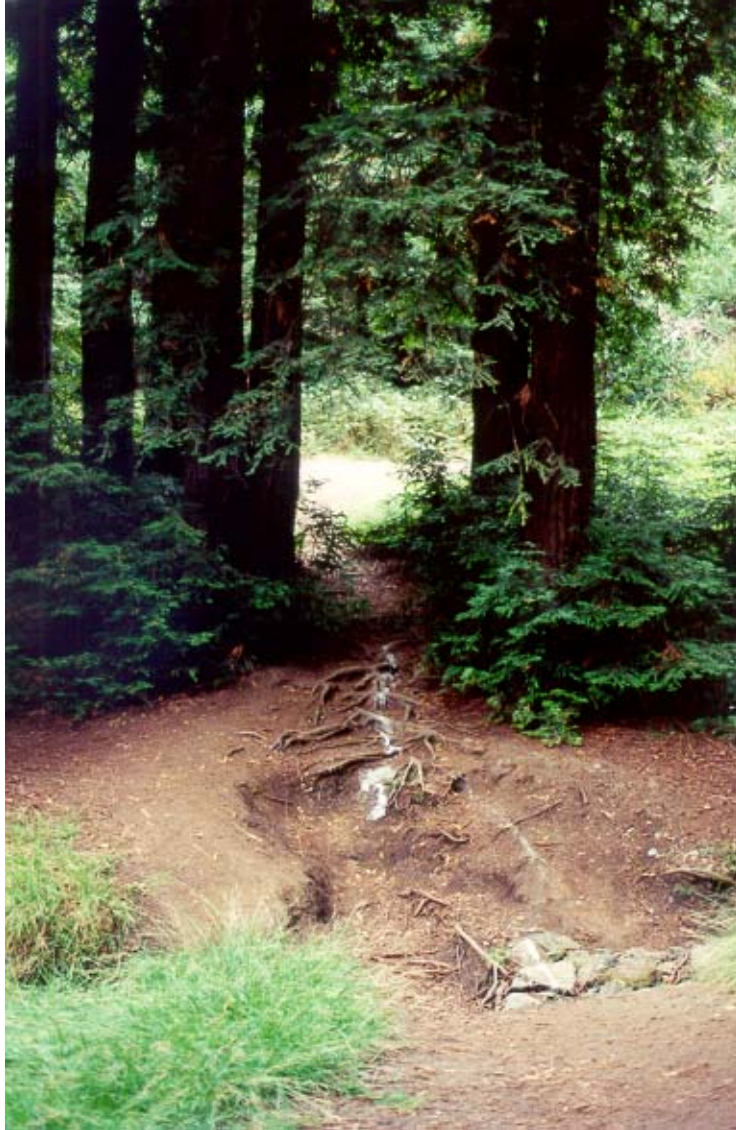
Figure 4: Area "K" of the Big Trees Trail at Junction of Sunset Trail

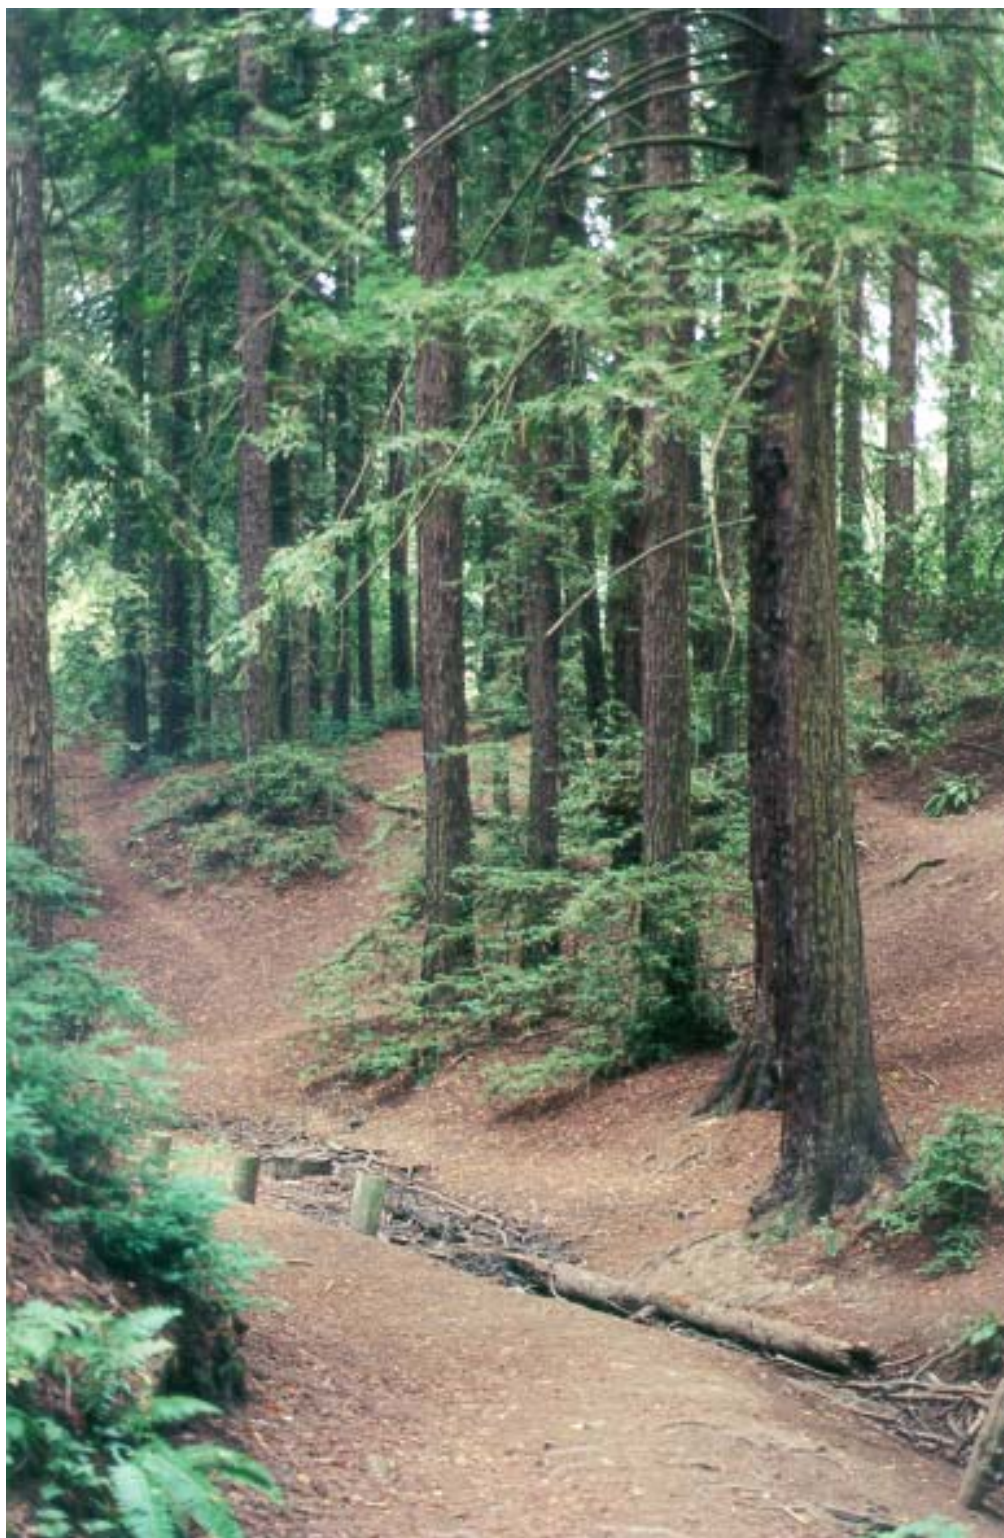
species diversity and native plant components. The vegetation trampling results from all types of off-trail traffic (pedestrian, equestrian, and bicycle) with no distinct difference in degree of impact between the types of off-trail traffic. The off-trail traffic causes direct physical impact to the plants as well as soil compaction, which can be a limiting factor for plants (especially the liliaceous species). Off-trail use was noted throughout the trail system. In particular, the flat and gentle slope areas, such as the ridgeline and spur ridges associated with the Ravine and Big Trees trail areas, were heavily impacted (see Figure 5).

Figure 5: Off-Trail Vegetation Trampling Impacts in the Redwood Forest (Ravine trail area).

To reduce recreation-related erosion on the trail system, we recommend that off trail or "bootleg" tracks be physically blocked off and signed. The split rail fences that were recently installed on the Sequoia Bayview Trail are an example of an effective barrier. These fences should be maintained regularly, and their effectiveness monitored. Other types of barriers include placement of large rocks, piles of debris, and large logs. All such barriers should be attractive and be seen to fit in with the natural environment. They should divert attention away from the tracks and onto the main trail. Tracks should be blocked off at both uphill and downhill ends. Restoration activities may help to reverse some of the impacts of these trails.

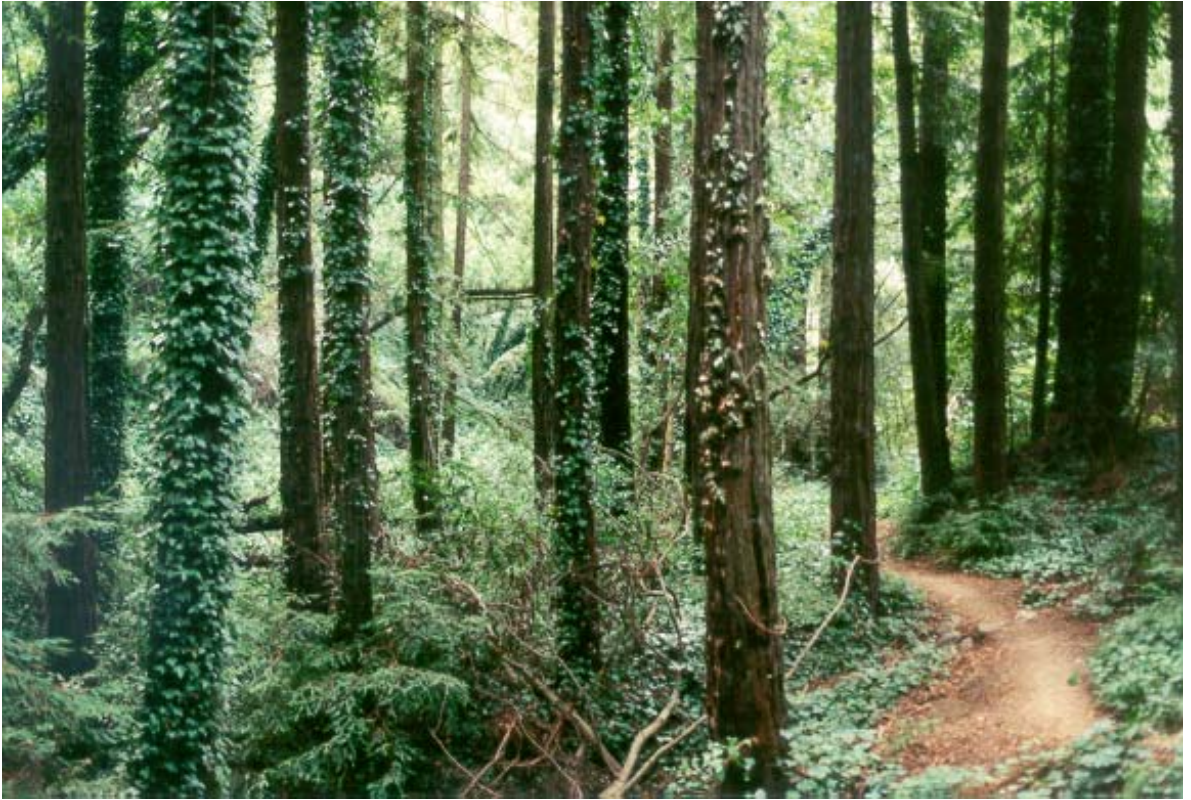
Figure 6: English ivy climbing redwood trees (along Palo Seco Creek).

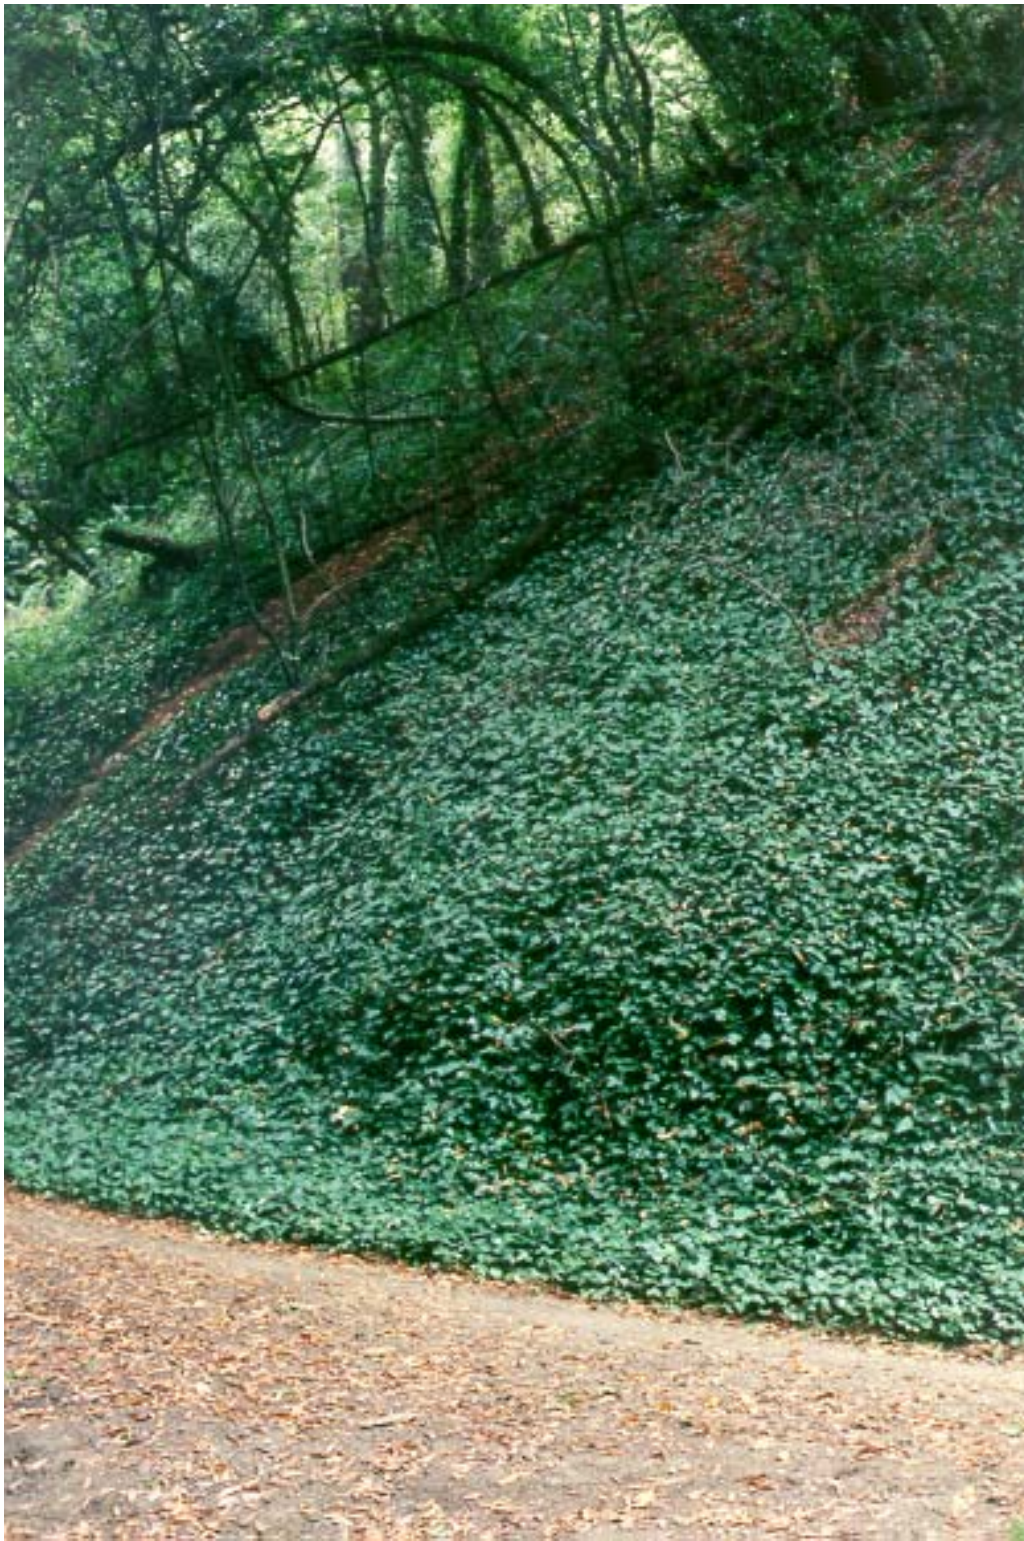
Figure 7: English ivy carpeting and smothering the herbaceous layer (along Palo Seco Creek).
