EVALUATION OF WATERSHED EROSION SITES

Sausal Creek Watershed Plan

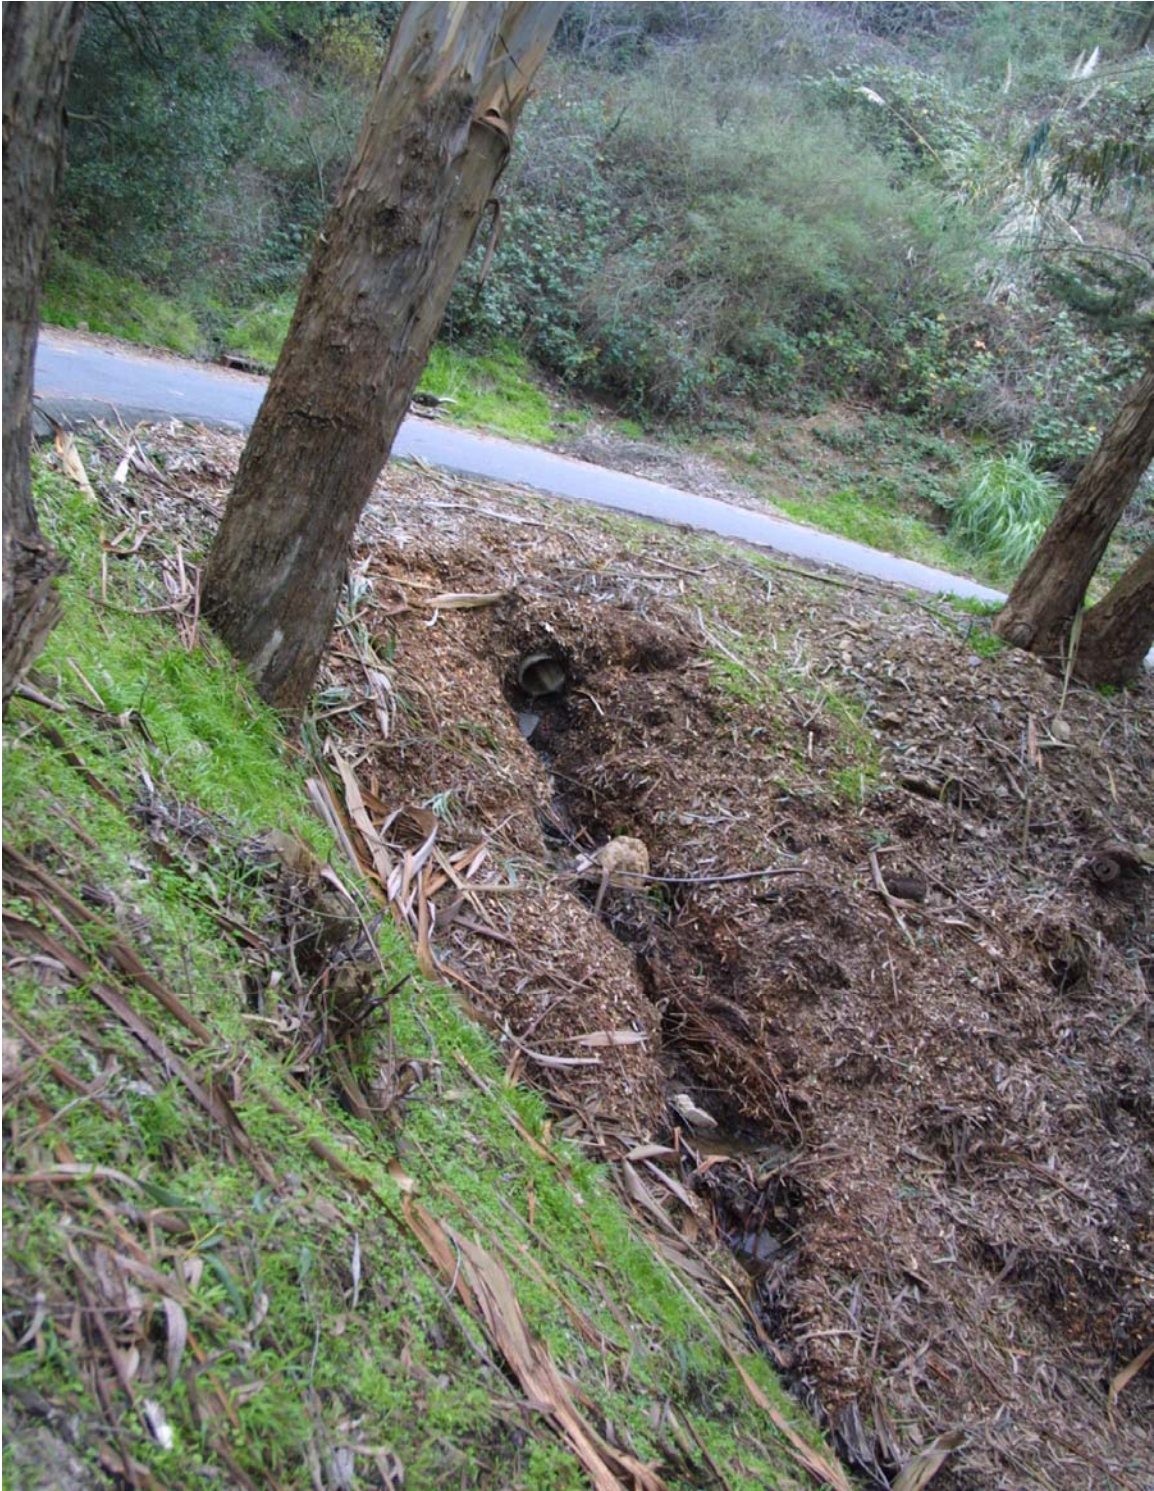
Many of the storm drains on these maps have been in place since the development of the area. Figure 85 depicts typical erosion at a storm drain outlet which has no rock dissipater to break up the energy of the concentrated flow. One of the effects of storm water runoff, observed as part of the storm drain outlet assessment, was erosion of ephemeral and main stem creek channels. Figures 86-89 show some of this channel erosion and the effect of undercutting house and deck foundations on piers. Even one of the newest developments in the watershed, the Chabot Space and Science Center, has caused significant erosion to surrounding lands from its storm water outlets. This facility has large parking lots, roofs, and other paved areas which drain to a few outlets. There is significant erosion at these storm drain outlets and further downstream in the creek channels. The affected creeks are all on public property.

Figure 85: Erosion at storm drain outlet where concentrated flow is released onto the slope without a rock energy dissipater.

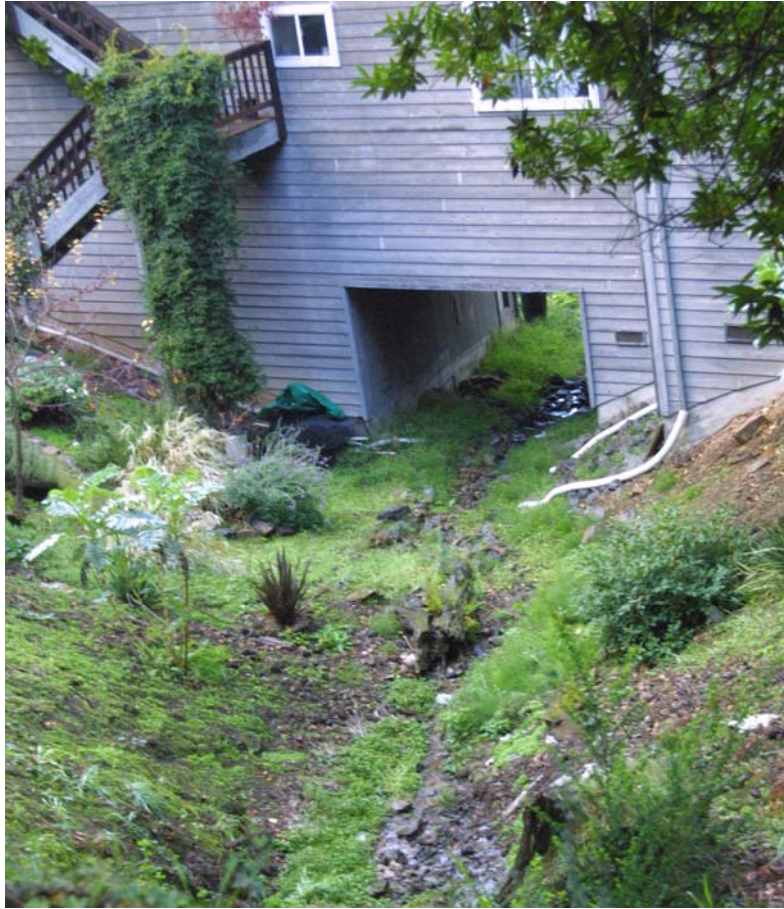
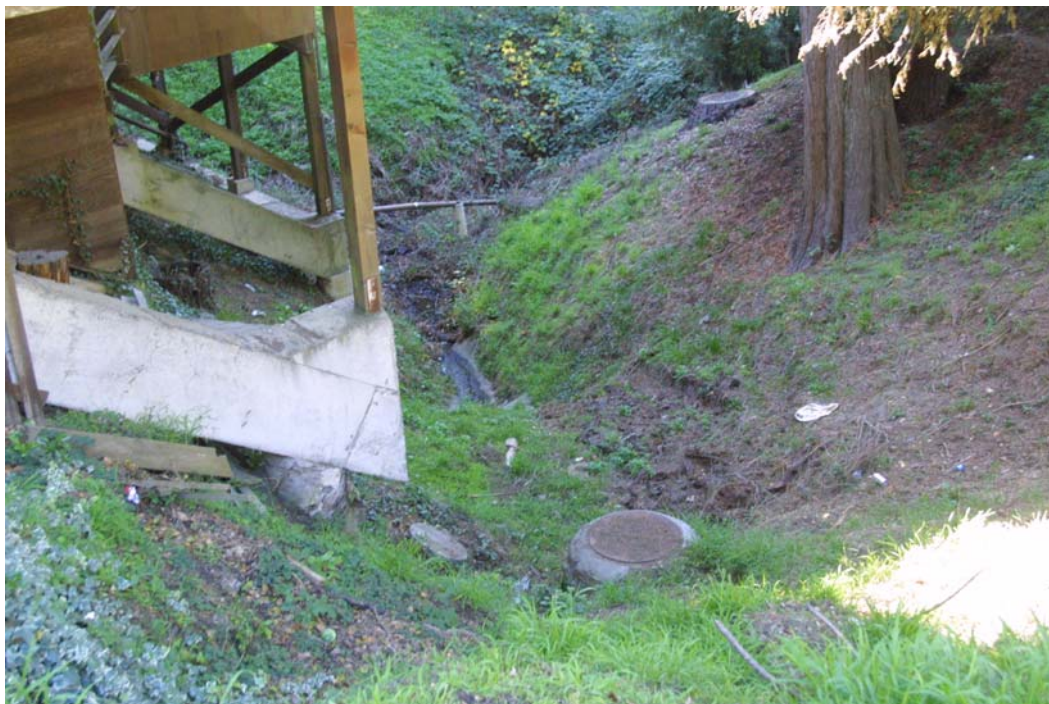
**Figure 86: Top: House built over creek channel in Sausal Creek watershed.
Bottom: Ephemeral creek with sanitary sewer and house foundation.**

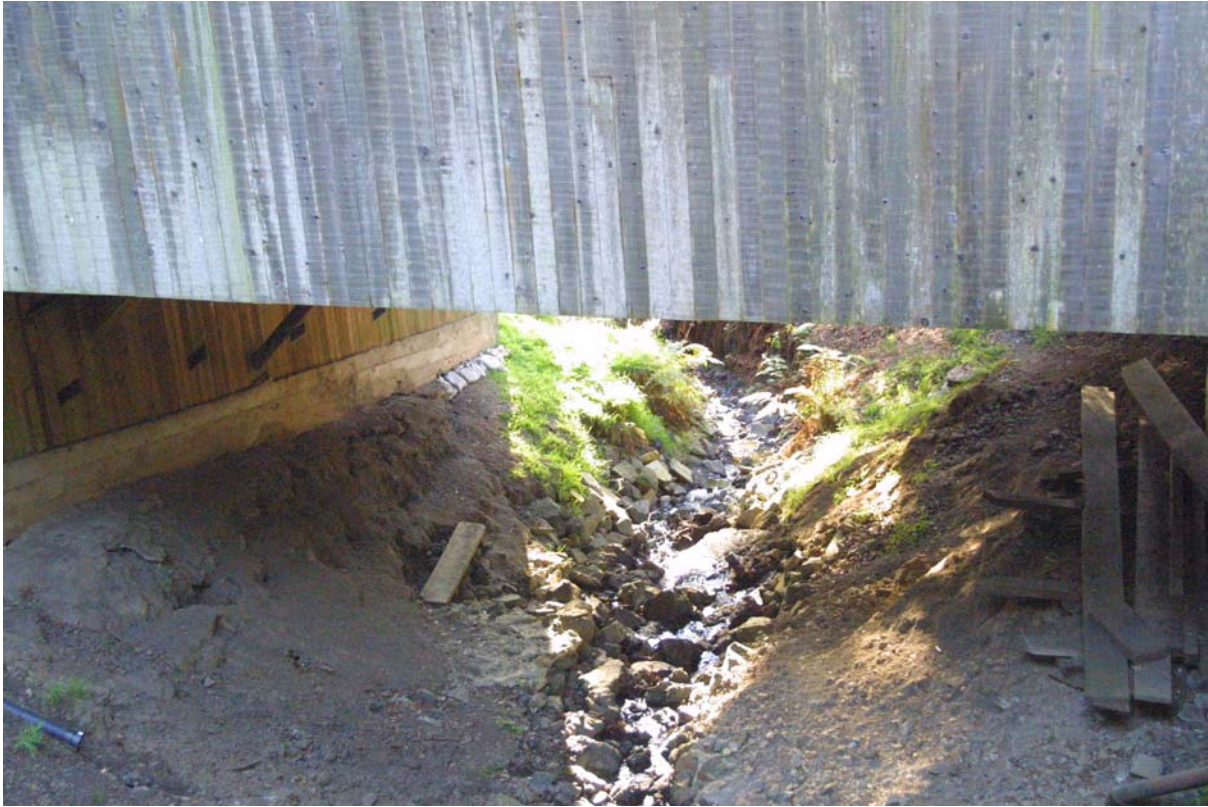
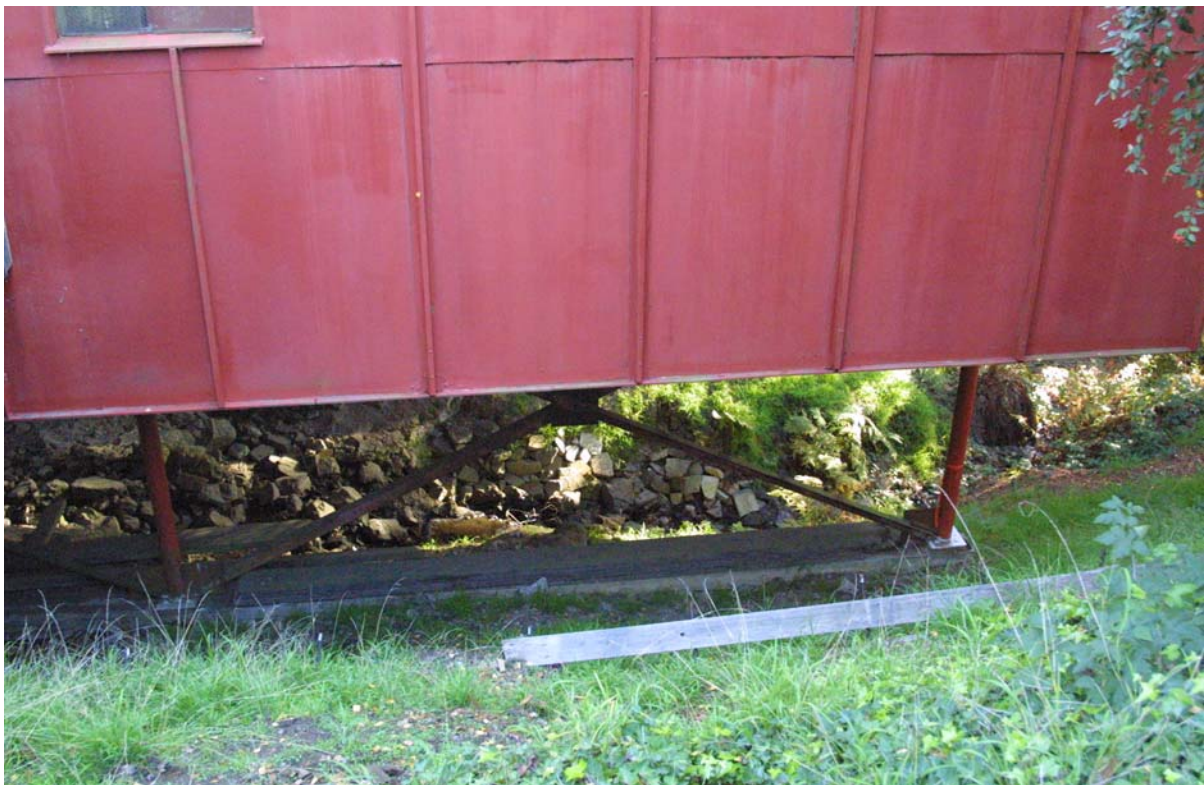
Figure 87: Ephemeral creek channels adjacent and under house with signs of erosion likely from increased volumes of runoff from urbanization of upper Sausal Creek watershed.

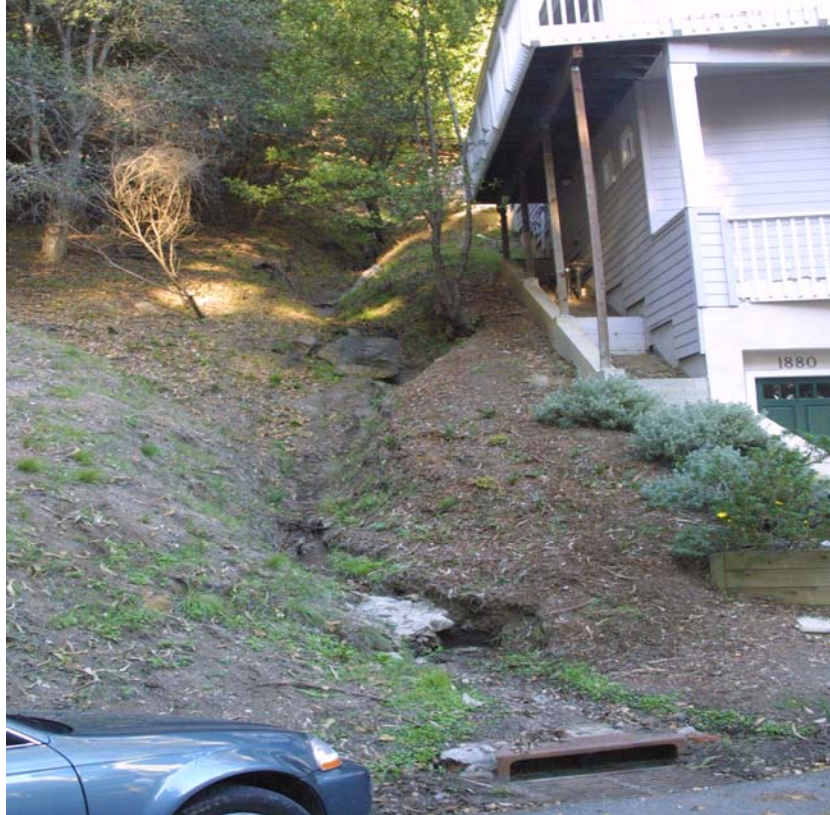
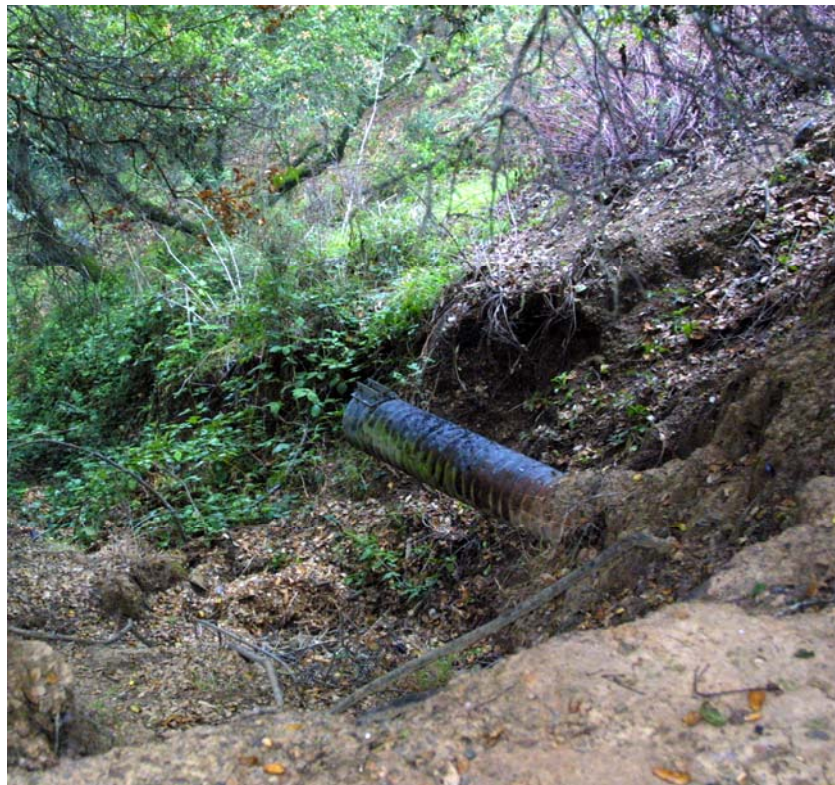
**Figure 88: Top: Erosion of ephemeral creek from urban runoff in upper Sausal Creek watershed.
Bottom: Erosion from storm drain outlet.**

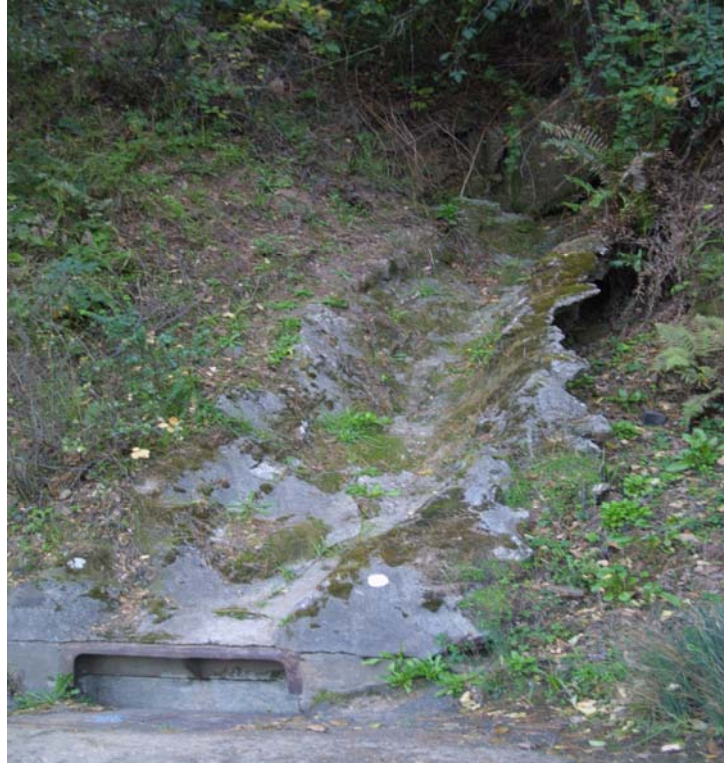
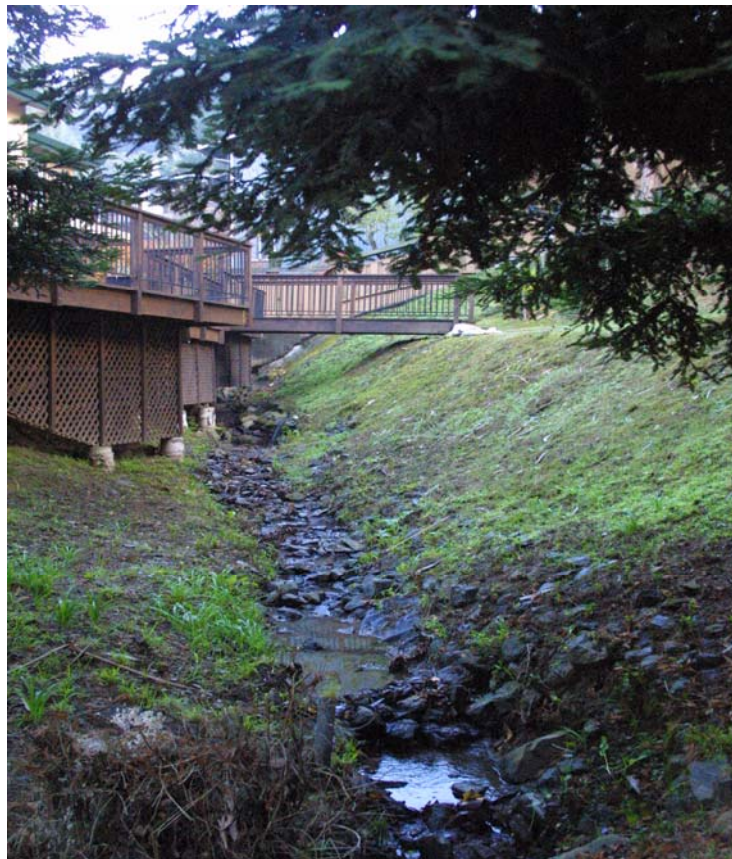
Figure 89: Lining creeks with cement or rock riprap to reduce erosion can result in storm flows undercutting or going around the improvement.

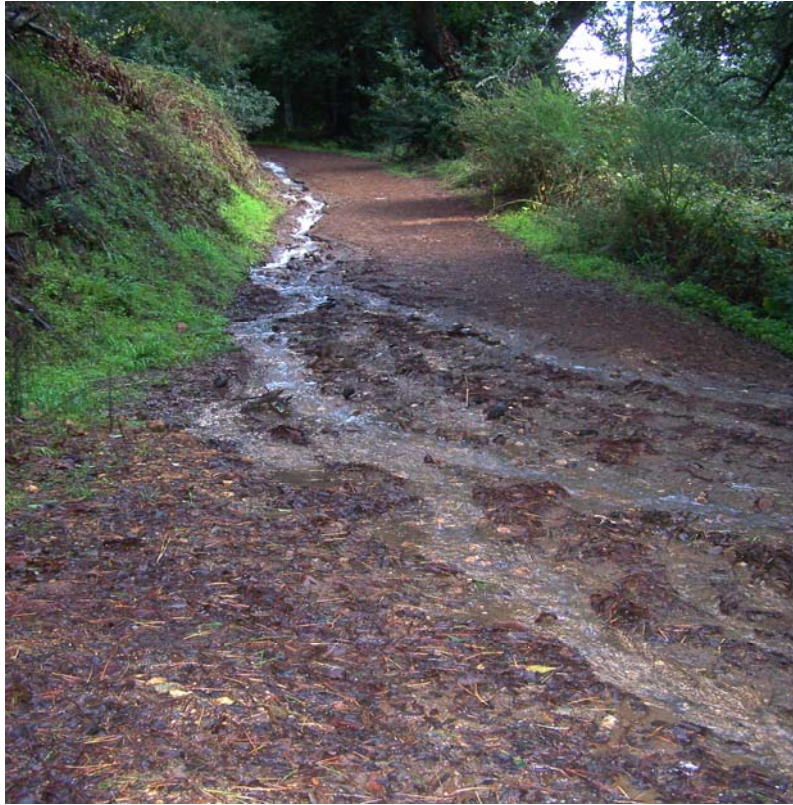
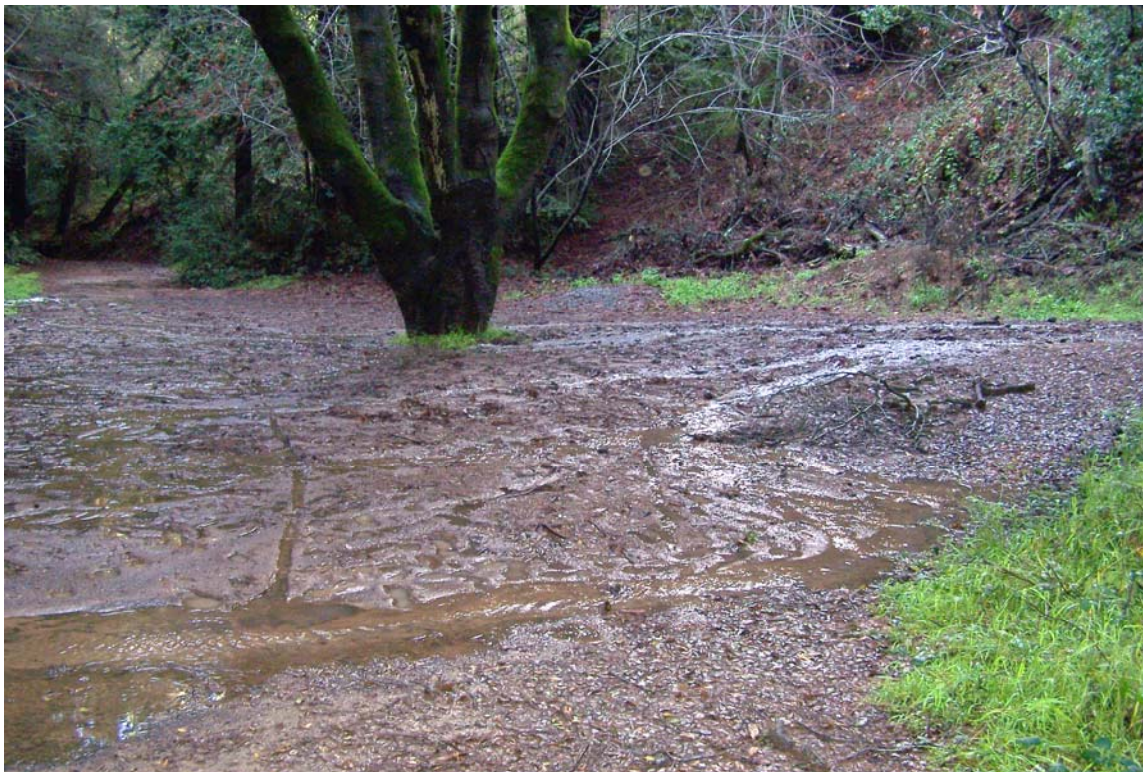
Erosion Site	Priority for Repair	Comments and Recommendations	Figure
1	High – direct delivery to creek; trail damage	Sequoia-Bayview Trail crosses an ephemeral creek with no bridge or culvert. Creek flow is eroding trail and directly delivering fine sediment to Palo Seco Creek. Culvert needs to be installed and sized for 100-year flood event on creek, and set at the level of the streambed to minimize erosion at the outlet. At least 18 inches of trail fill over the culvert is needed.	
2	High – direct delivery to creek; damage to vegetation and trail	The Sunset Loop Trail crosses an ephemeral creek with no culvert and captures the creek flow. Consequently, creek flow courses down the trail, eroding 3-4 inch deep rills and delivering fine sediment to the base of the oak tree on Sunset Trail and into Palo Seco Creek. A culvert needs to be installed to route the stream flow under the trail and back into the creek.	91

Figure 91: Erosion site #2. Lack of a culverted stream crossing causes water to flow down Sunset Loop Trail, eroding the trail and creating a pile of mud on Sunset Trail (bottom) and in Palo Seco Creek.

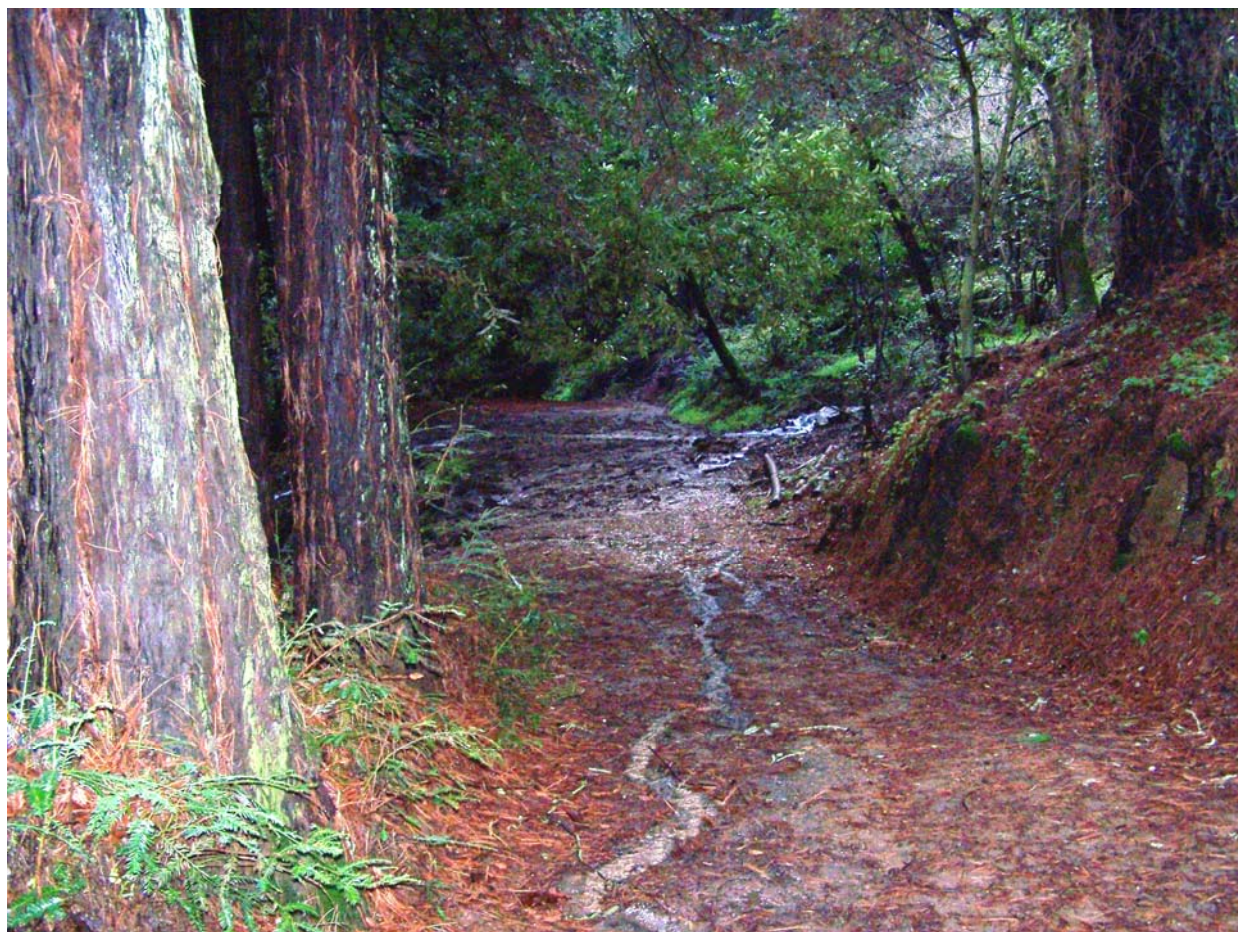
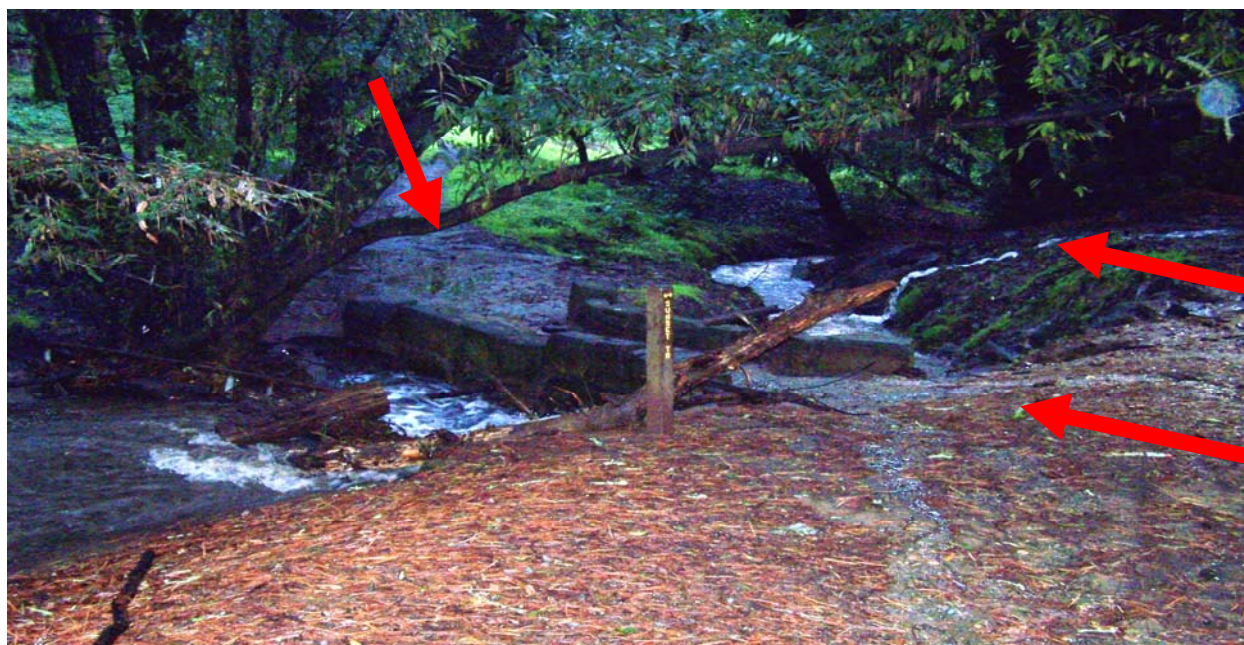
3	High – direct delivery to the creek	This is the most upstream grade control on Palo Seco Creek and consists of a trail bridge with three 20-inch culverts and an upstream trash rack. Trails at this junction are rilling, particularly Sinawik Loop Trail. In addition, the ephemeral creek on the north side of Sunset Trail is actively eroding from storm drain runoff along Skyline Blvd. directed into this small creek. A major repair will be needed here as major runoff events deepen Palo Seco Creek at the downstream side of the bridge. Trail and ephemeral creek runoff flows down the creek banks, eroding and widening the channel. The channel bed is up to seven feet deeper below the bridge than in the areas upstream of the trash rack. The bridge and trash rack cannot simply be removed, as removal will cause the channel to adjust and undercut numerous redwoods along the creek banks. Any replacement structure should be designed as a grade control structure. Stream banks should be revegetated and the culvert under Sunset Trail between the northern ephemeral creek and Palo Seco Creek replaced with a much larger culvert which will not clog with rocks but will allow for the transport of rock into Palo Seco Creek.	92; 62

Figure 92: Trail erosion (red arrows) flowing directly into Palo Seco Creek near Erosion Site #3.

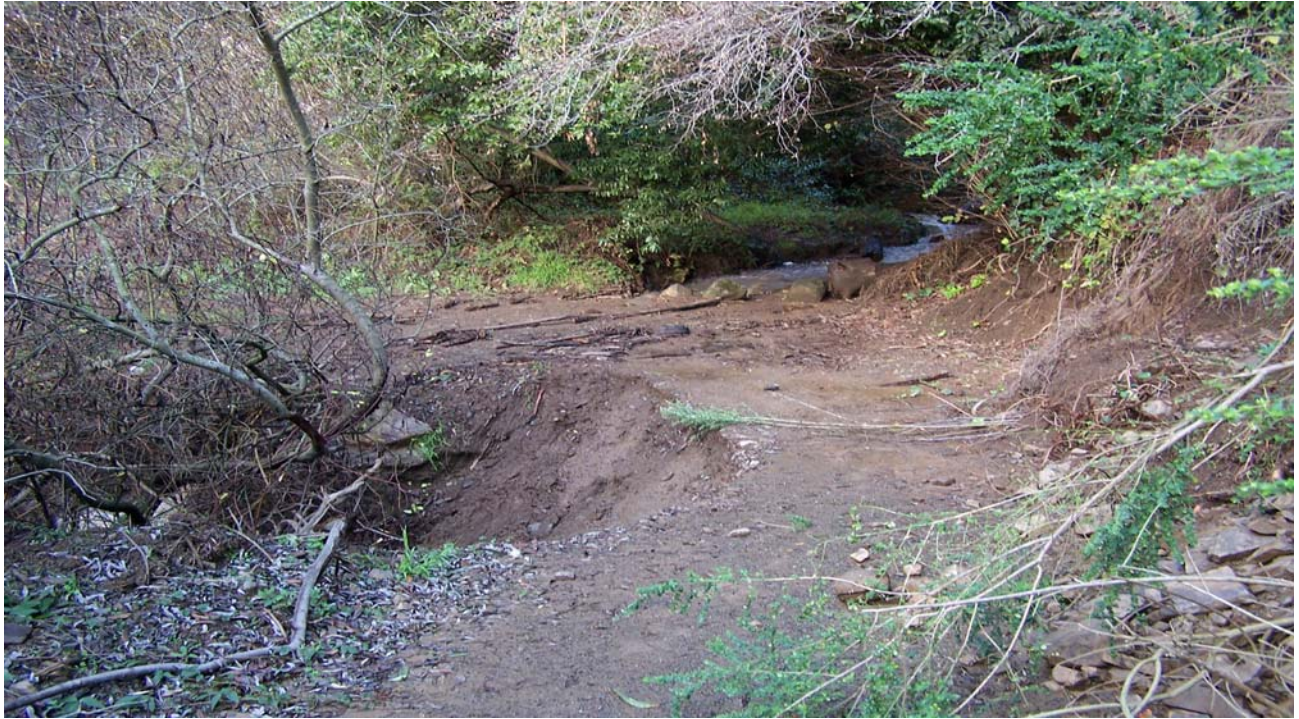
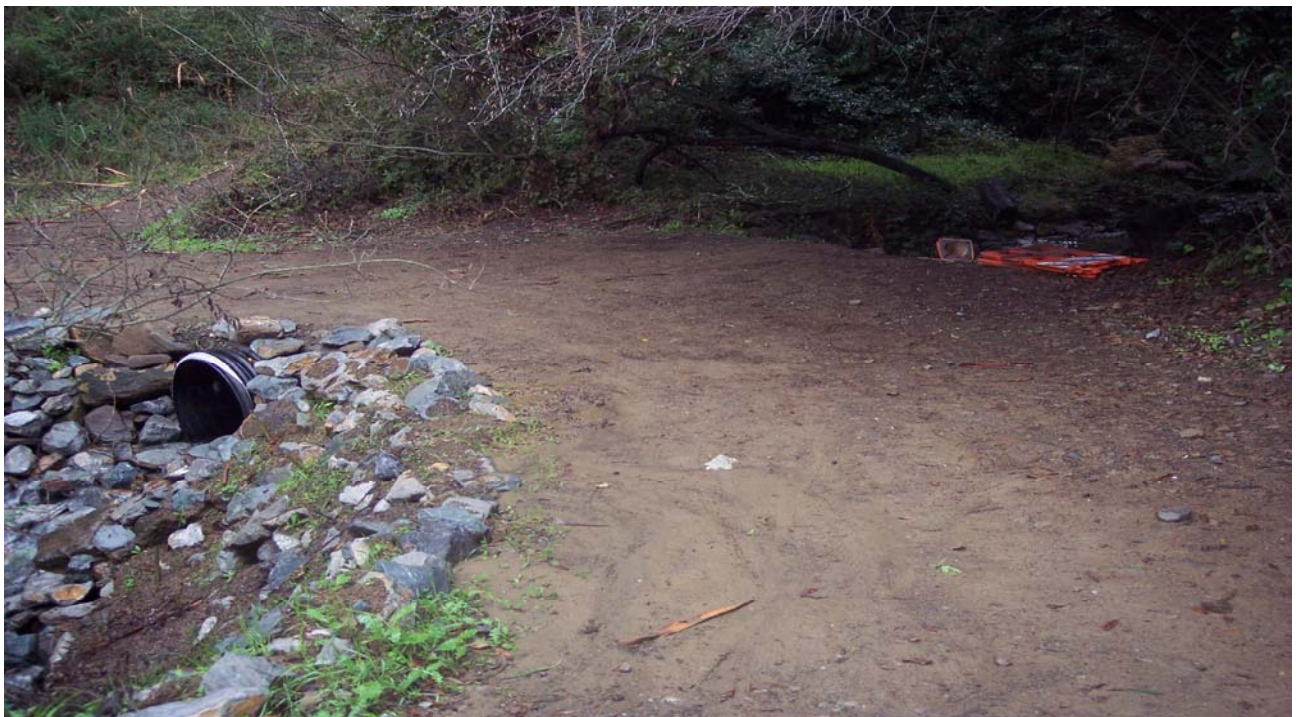
4	High – direct delivery to creek	This is another major knickpoint in Palo Seco Creek at a casual creek crossing. The knickpoint is over five vertical feet and has eroded approximately five feet upstream in the past ten years. Several tree roots are temporarily preventing the site from further erosion moving upstream. This site should have a rock grade control structure to avoid further upstream migration of this knickpoint. Downstream banks need to be set back to reduce erosive velocities and allow willow sprigging. Large wood debris in the channel should also be retained at this location.	61
5	Moderate	Sunset Trail crosses Cinderella Trail and a very large erosion site occurs in the channel of Cinderella Creek downstream of this crossing. The addition of urban runoff from Chabot Space & Science Center greatly increased the level of erosion at this site. The channel downstream of this crossing is over 20 ft. lower in elevation from the upstream side. Unfortunately, a culvert replacement completed in 2007 was installed incorrectly. Stream crossing culverts need to be installed at the same slope as the stream channel. The repair set the culvert at no slope, resulting in a large drop for the water at the outlet. The culvert also appears undersized, with flow overwhelming the culvert during the 2006 flood and flowing over the trail. This site should have a critical dip installed to avoid flow coursing down the trail and causing additional erosion.	93

Figure 93: Top: Cinderella Creek with culverted crossing at Sunset Trail erodes and overflows the culvert. Stormwater from the Chabot Space and Science Center has increased the volume of flow in Cinderella creek, increasing erosion. Bottom: Repair in 2007 was done incorrectly by setting the culvert at a flat angle; the proper method is to set the culvert at the slope of the creek bed to reduce downstream erosion. Culvert is also undersized and continues to be overwhelmed by storm flows.

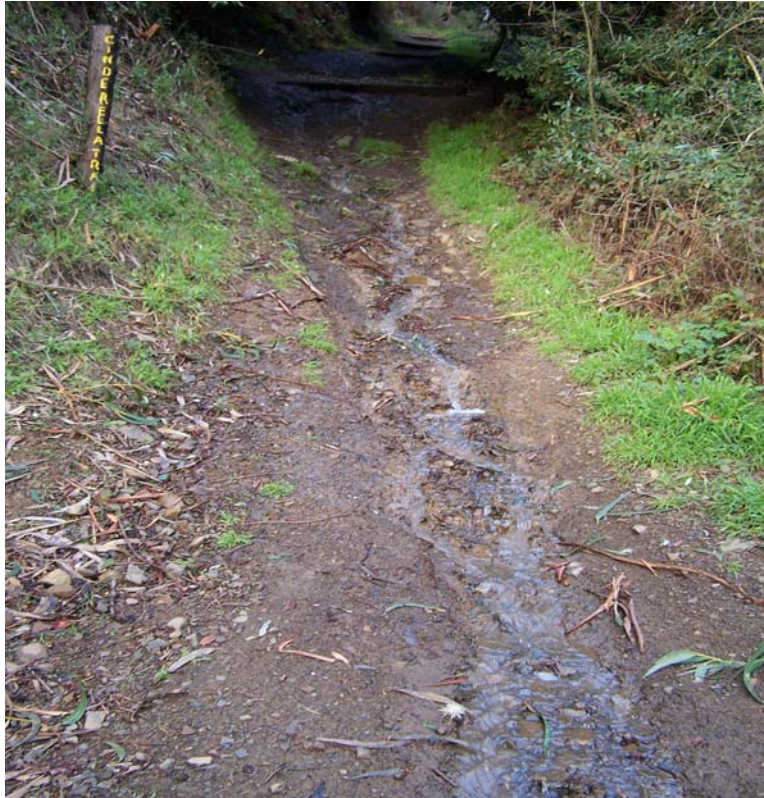
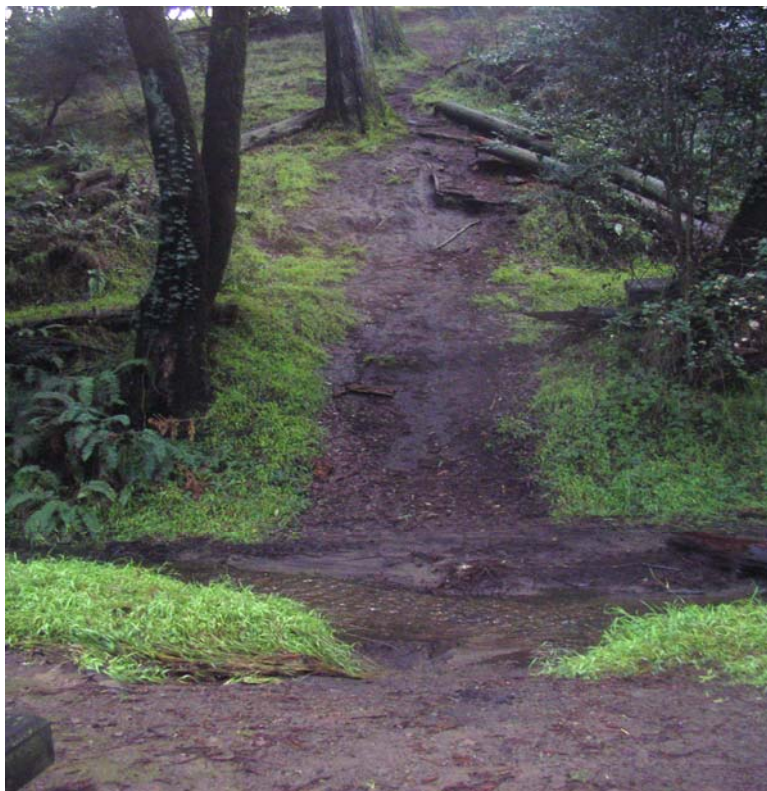
Erosion Site	Priority for Repair	Comments and Recommendations	Figure
6	High – direct delivery to creek; trail damage	Cinderella Trail borders Cinderella Creek and probably was originally constructed as a skid trail for logs. This trail is very steep and highly eroded. It currently functions as a bucket road: the convex road surface concentrates flow in the low point at the center of the trail and erodes fine sediment in storms. These fines are deposited on Sunset Trail and in Cinderella Creek. This trail needs to be re-graded to an outsloped condition with rolling dips to intercept sheet flow from the road. Several ephemeral tributaries and one spring to Cinderella Creek also course over the trail, adding to the runoff on the trail. These tributaries need culverts to move the water to Cinderella Creek. This trail should be considered for closure due to the high cost to repair and stop the environmental damage it causes.	94

**Figure 94: Top: Cinderella Trail is a major erosion site and needs to be re-designed or re-located.
Bottom: Casual trails cause soil erosion directly into Palo Seco Creek.**

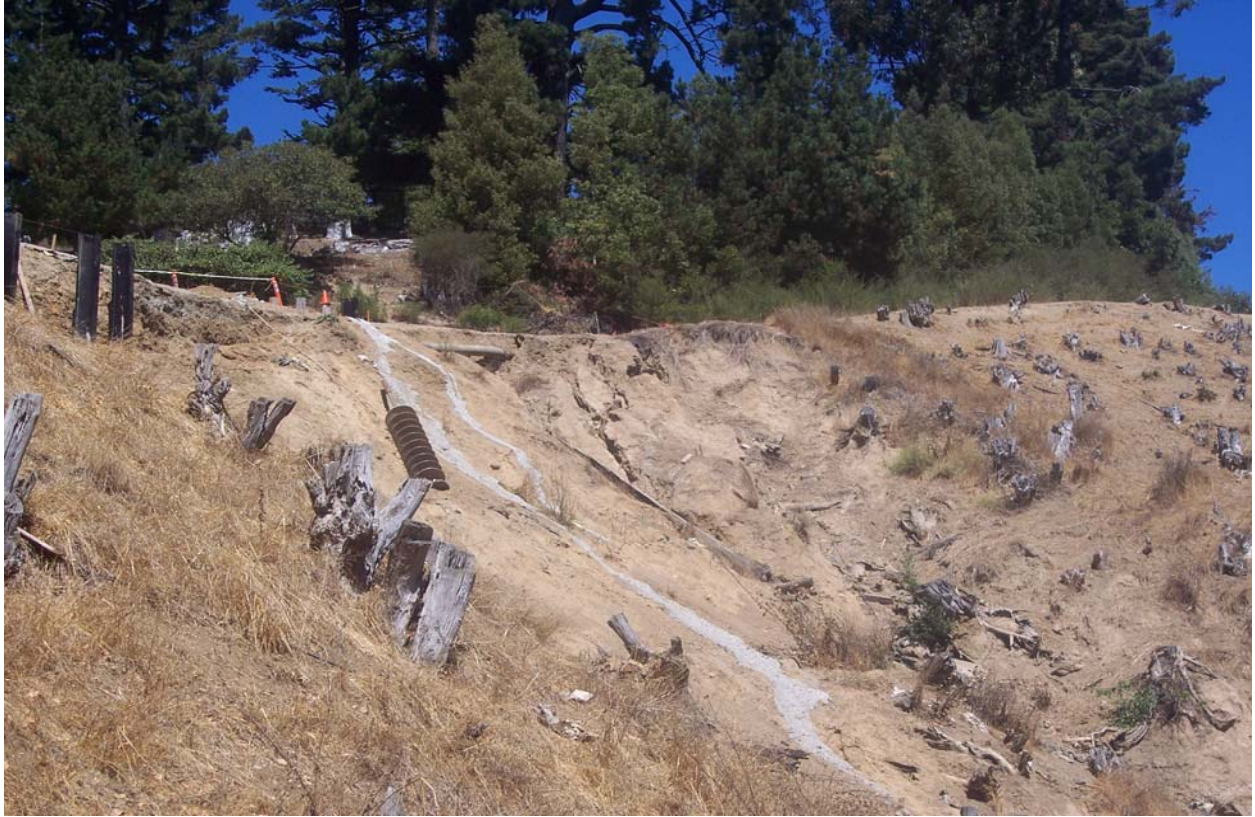
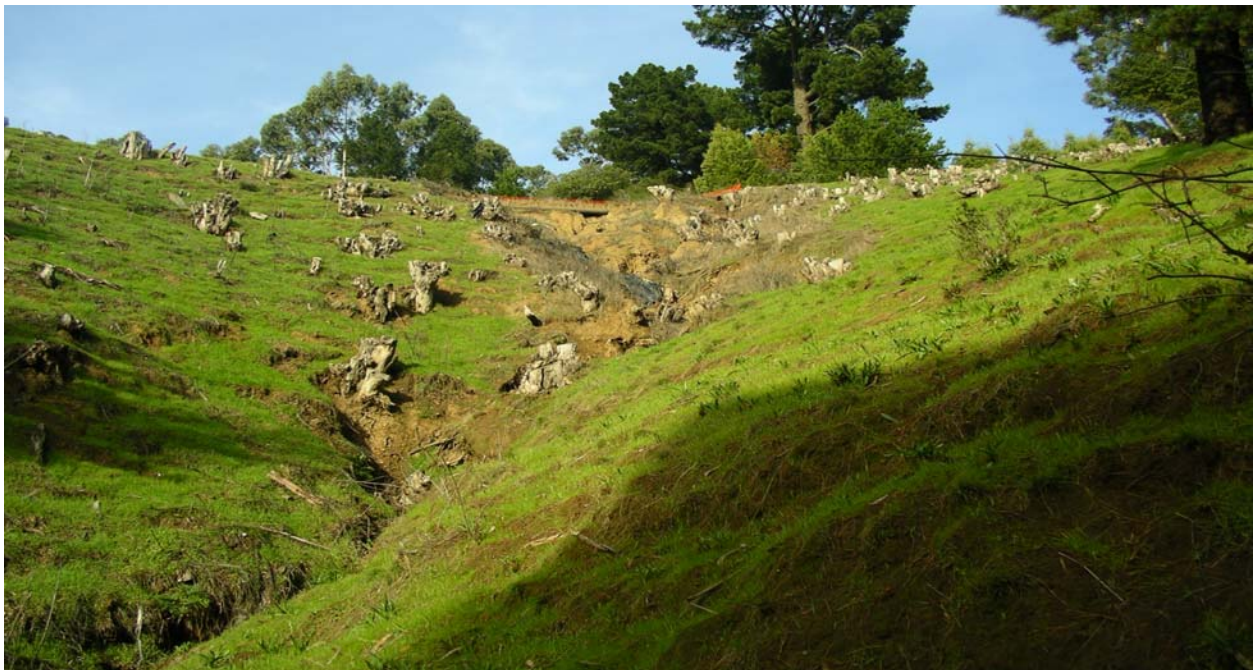
7	Moderate	Chaparral Trail has numerous rills and gullies and needs to be rebuilt in sections using new grade control steps to stabilize the trail and reduce erosion.	
8	Moderate – monitor repairs for downstream effects	A storm drain at the top of the ridge on Castle Drive combined with clearcutting of Eucalyptus caused a major erosion site in an ephemeral creek channel. An expensive repair was installed following over 10 years of erosion, ineffective repairs, direct delivery to Palo Seco Creek, and environmental damage. Several temporary repairs, installed prior to current project, failed. Current repair includes a pipe to move runoff through the gully and beneath the trail. The pipe outlets in the ephemeral creek channel just downslope from the trail crossing. This creek has significantly eroded and needs to be carefully monitored to avoid continued erosion. Pipe should be extended to culvert at Palos Colorados Trail to avoid eroding the creek.	95-98

Figure 95: The headwaters of this small creek were clear-cut of Eucalyptus and had storm drain runoff from Castle Drive, causing a major erosion site to form. The erosion produced from this site filled in portions of Palo Seco Creek in the January 1, 2006 flood. Photos are from 2004 and 2006.

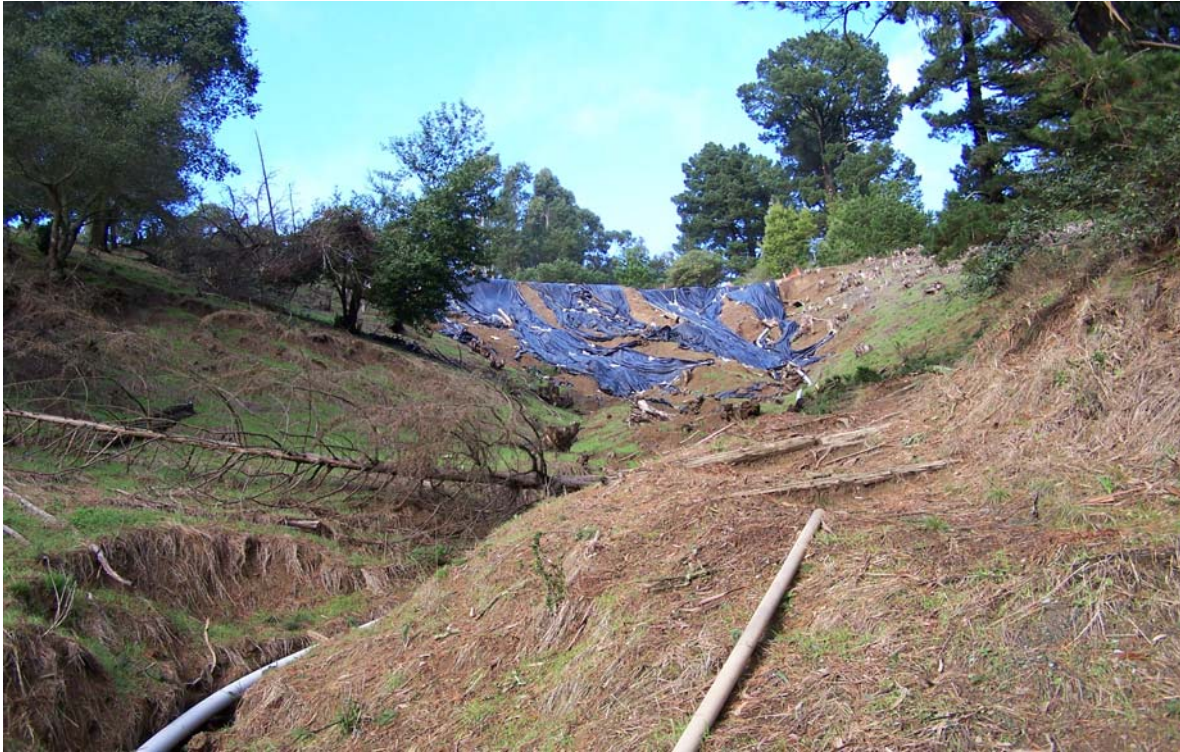
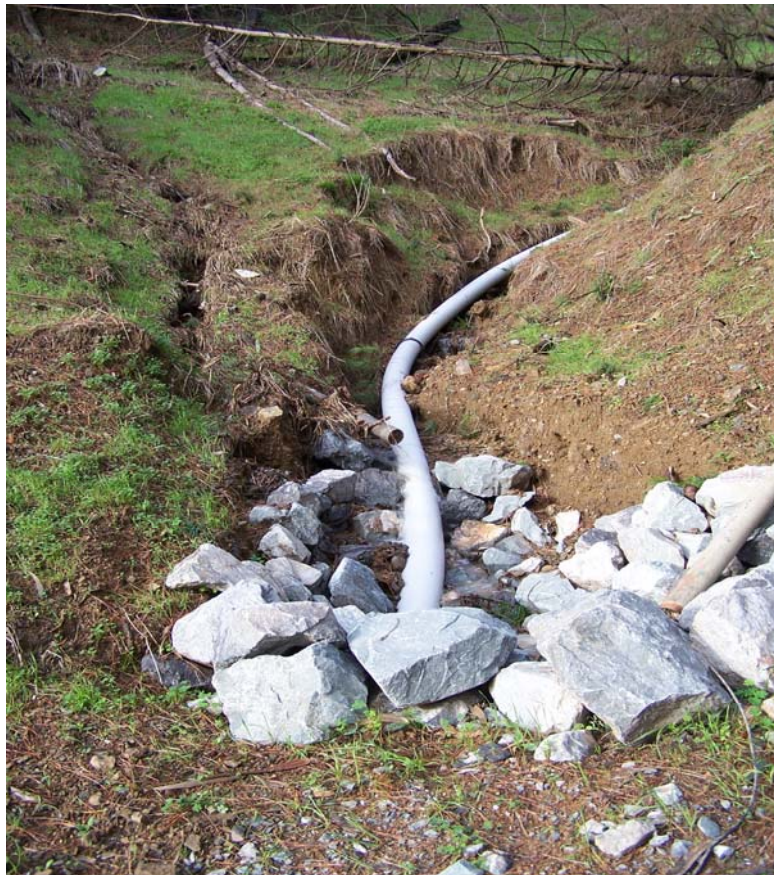
Figure 96: One of many temporary and ineffective repair projects done at Castle Drive erosion site.

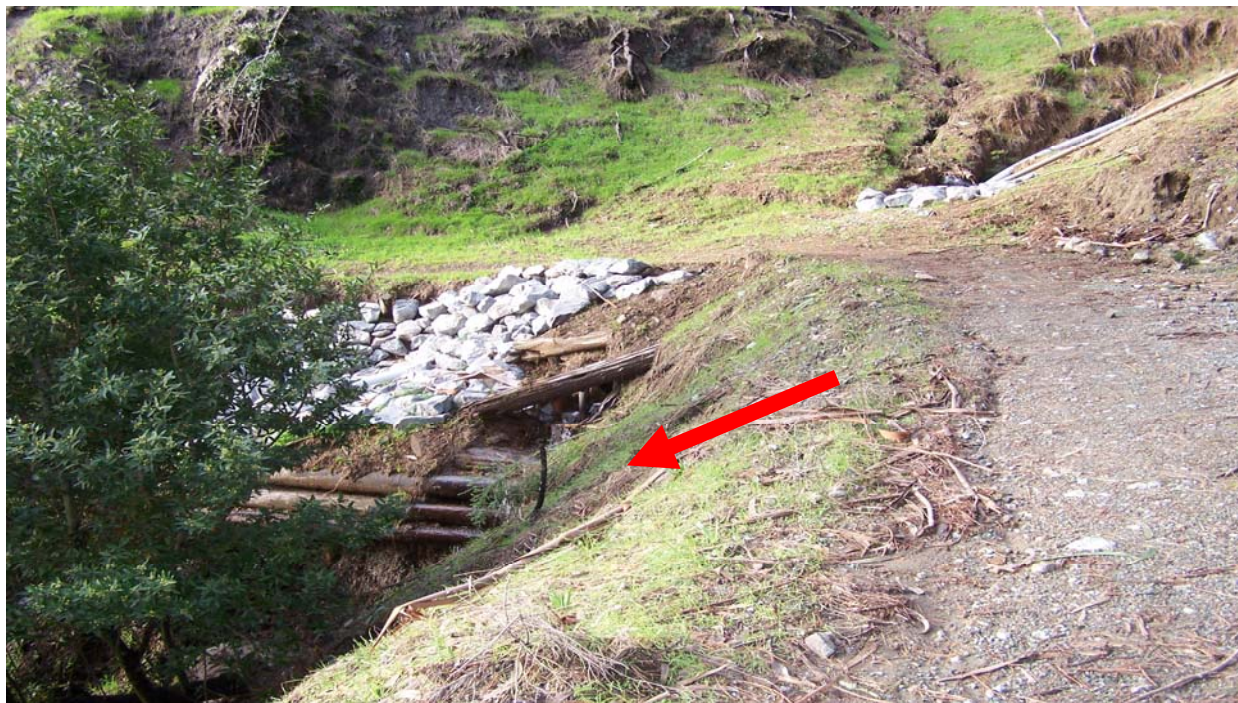
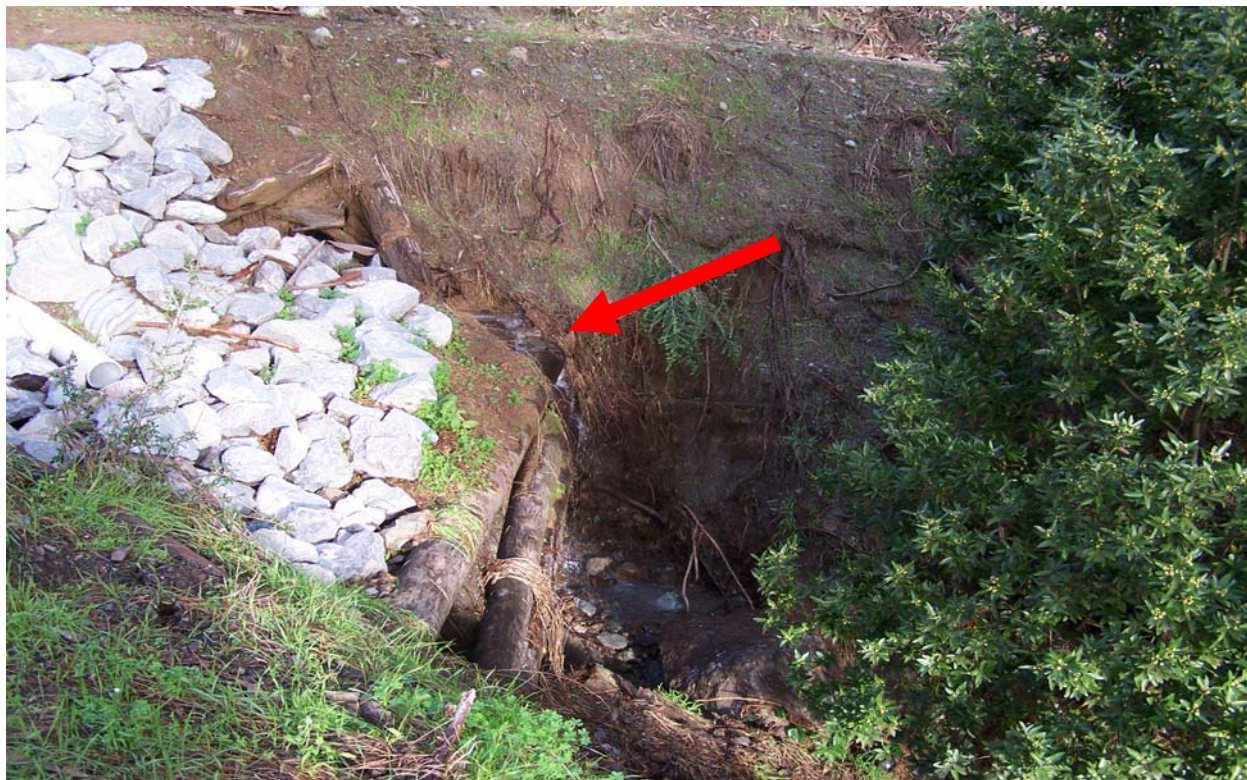
Figure 97: Sunset Trail crossing of small ephemeral creek below Castle Drive erosion site in 2006. Logs indicate this is an historic Humboldt crossing from logging days. Despite rock and plastic pipe, water is flowing along right side of crossing and eroding slope. Humboldt crossing is failing and not able to support rock dumped on it as part of ineffective repair.
