EVALUATION OF WATERSHED EROSION SITES

Sausal Creek Watershed Plan

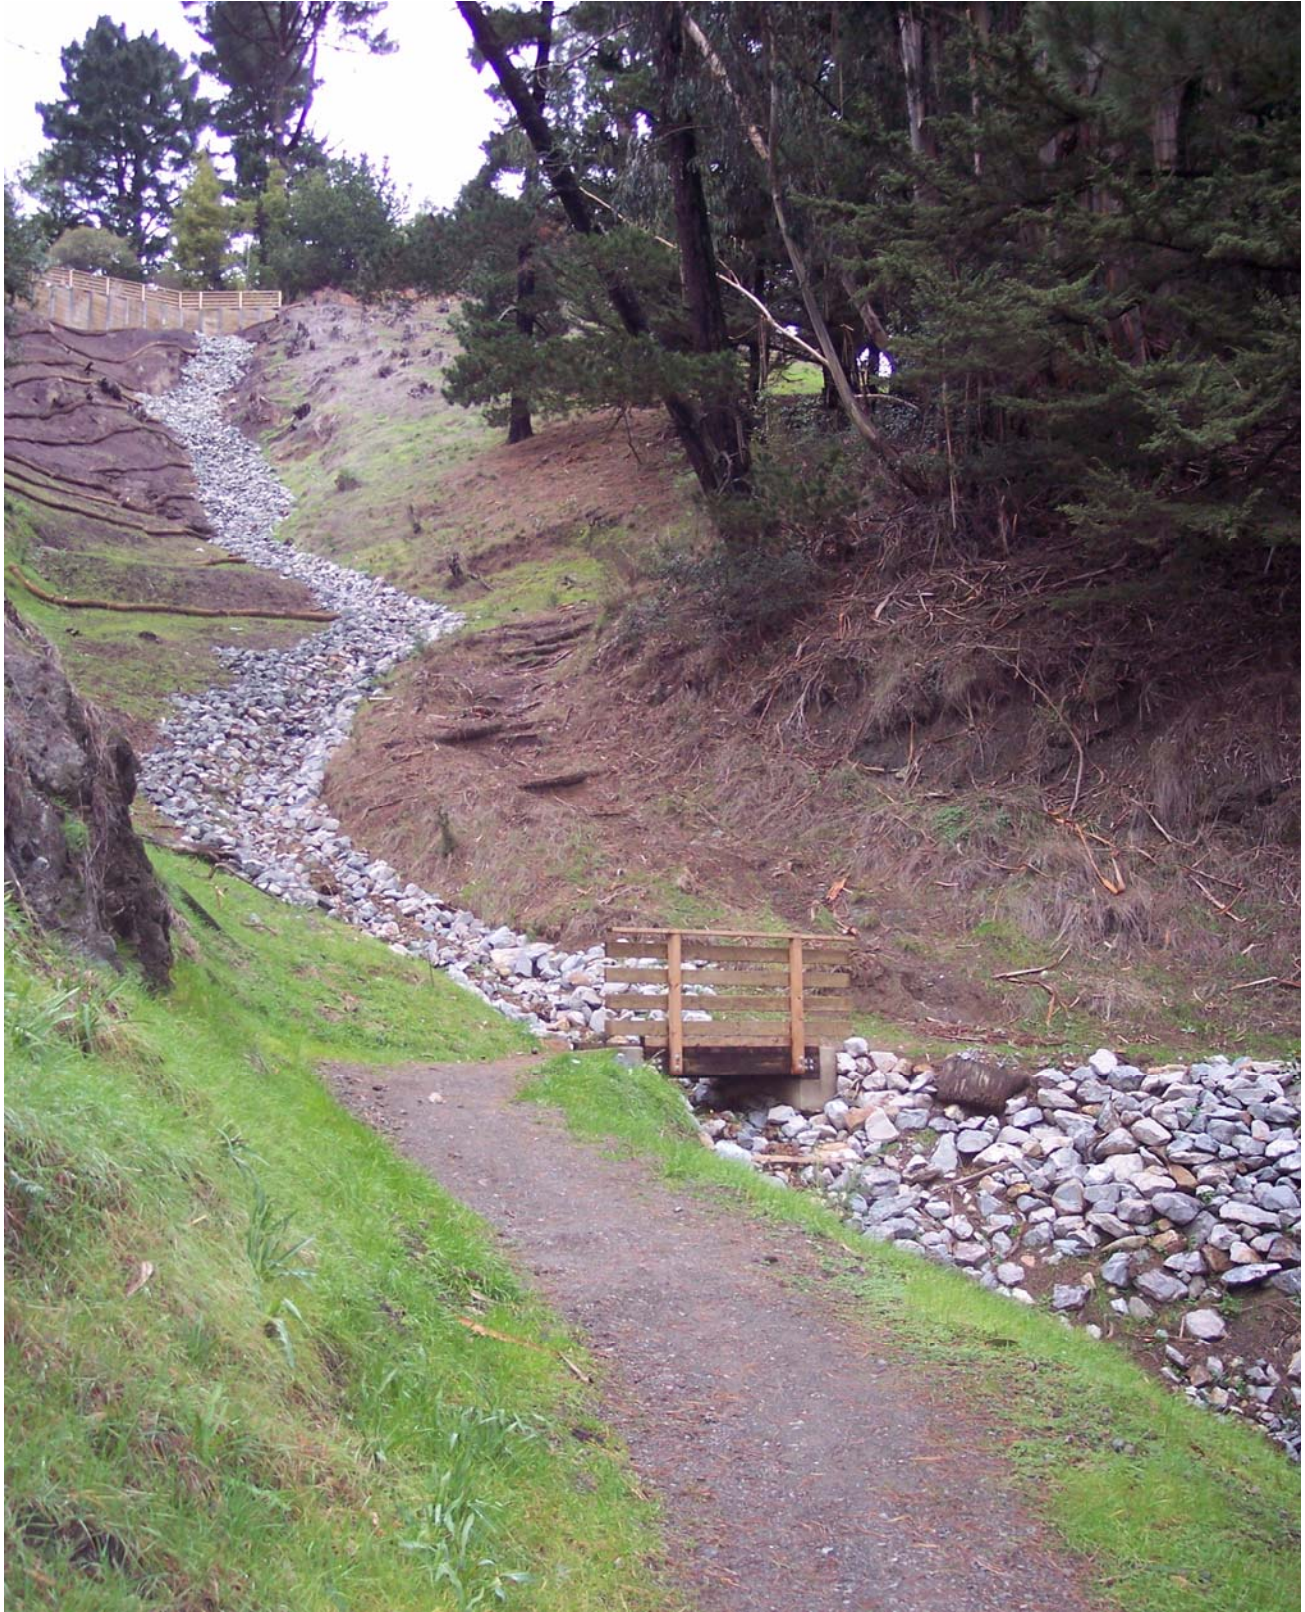
Figure 98: After over 10 years of erosion and several ineffective repairs, an engineered repair was implemented in 2008. Flow was placed in a pipe and buried in rock which fills the gully.

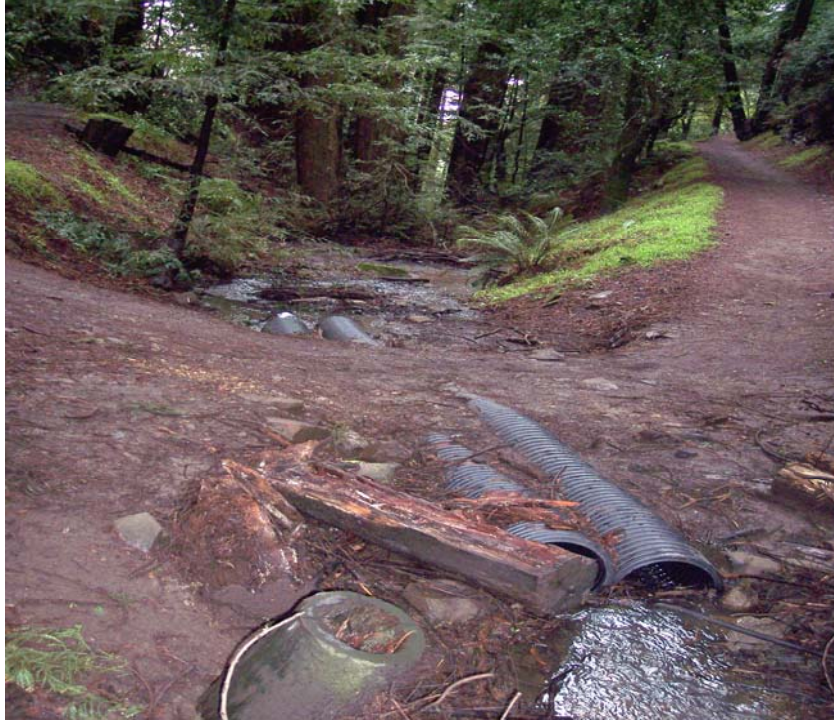
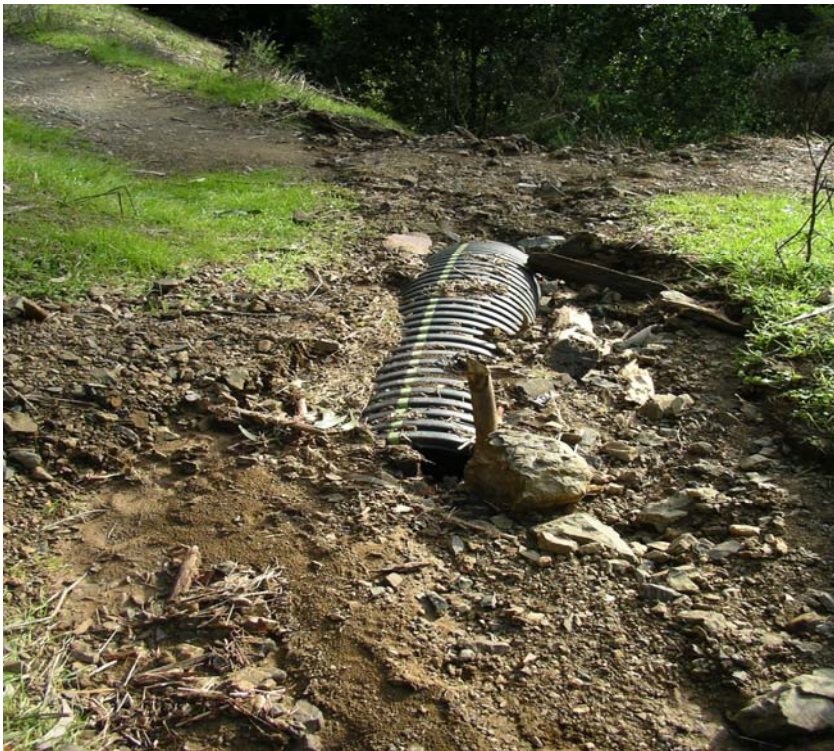
Figure 99: Two examples of ineffective trail crossing repairs. Plastic pipes are too small and can easily clog; both are not placed in the crossing at the proper angle, and are not covered with enough soil to avoid damage. Top: Ineffective repair to trail crossing creek in Joaquin Miller Park. Bottom: Creek can easily flow over trail in higher water events and erode soil and pollute Palo Seco Creek.

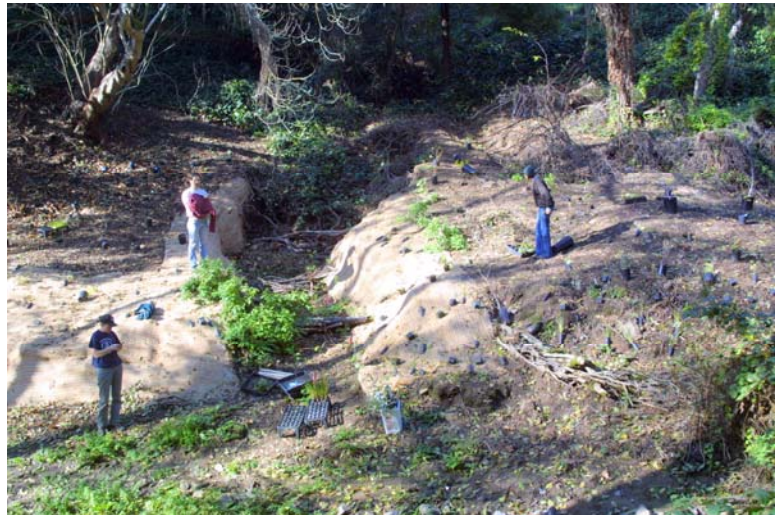
- The storm drain outlet near San Luis Avenue creates a huge gully in the restoration area, shown in this photo
- The storm drain outlet at the end of Benevides Ave. has created a small landslide into the creek.
