**SAUSAL CREEK WATERSHED ENHANCEMENT PLAN**

**SUMMARY**

Prepared by Laurel Marcus and Associates, NewFields River Basin Services, Hydrologic Systems Inc.

March 2010

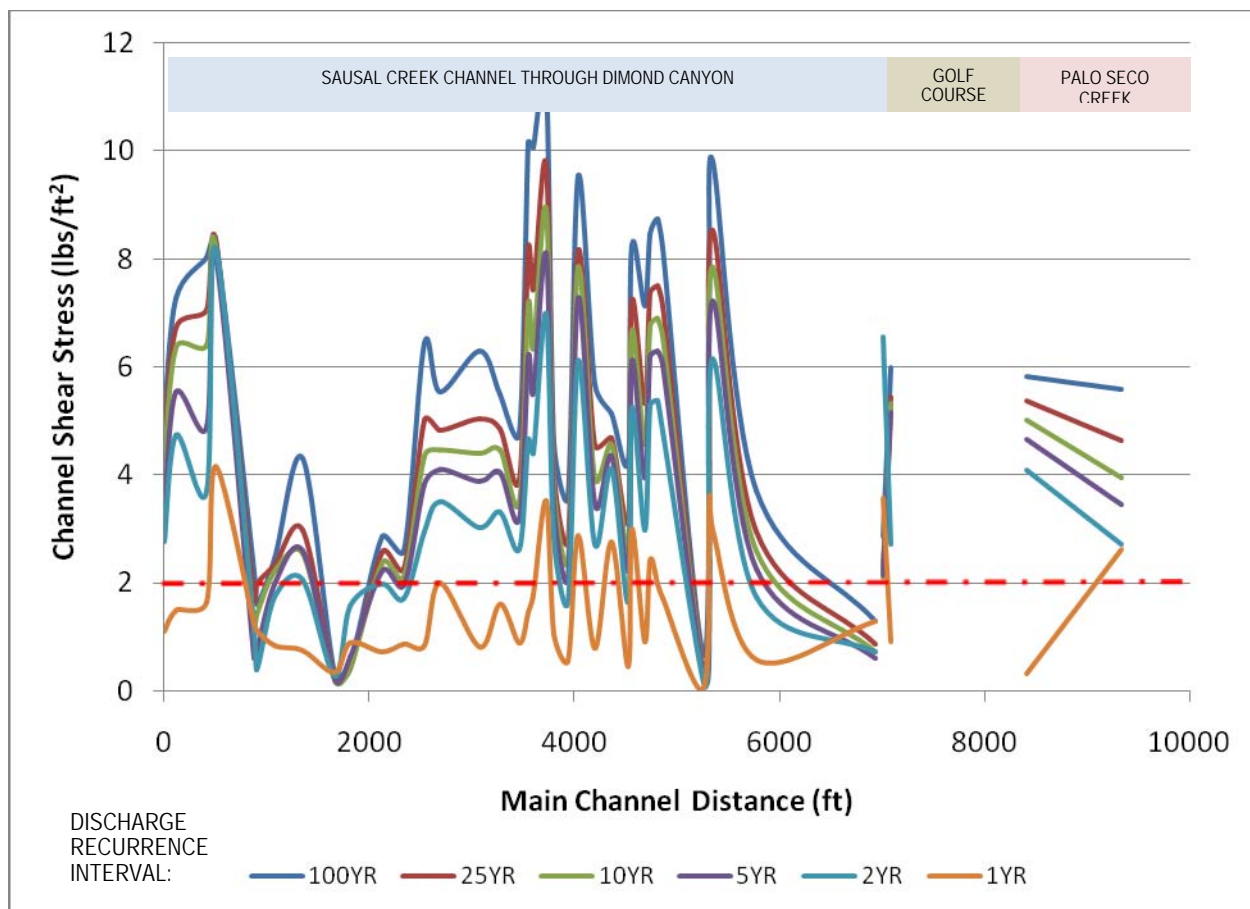
**Figure E: Existing conditions longitudinal shear stress plot. Dotted red line signifies approximate stability threshold for typical Sausal Creek sediment and vegetation characteristics. Velocities and shear stresses are largely controlled by channel geometry in this portion of Sausal Creek, with high velocities and shear stresses in narrow reaches.**

Channel bed and bank stability varies throughout the Sausal Creek watershed, however, in general, the channel bed and banks are likely stable for velocities up to approximately 7 ft/sec and shear stresses up to approximately 2 lbs/ft<sup>2</sup>. These values are based on the US Army Corps of Engineers' Engineering Research and Development Center "Stability Thresholds for Stream Restoration Materials" to determine permissible shear strengths reference for selection of stream restoration materials, and a useful guide to assessing the stability of existing stream materials. While conditions vary throughout the watershed, we made the assumption that the system has geomorphic controls such as riffles and artificial grade control structures with cobble and coarser particle sizes and some woody vegetation on the banks. As shown in Table A, the reaches with these characteristics would be stable for velocities up to 7 feet per second and shear stresses up to 2 pounds per square foot. Therefore, portions of the Sausal channel network are at risk of erosion under existing hydrologic and hydraulic conditions, even during the 1-year discharge. Even moderate reductions in peak flows could reduce the frequency and duration of erosive flows and contribute to long-term improvements in creek habitat conditions ( Figures D and E)

To revegetate the riparian corridor and achieve conditions which support natural ecosystem processes of succession and diversity, the effects of urbanization on flow volumes, velocities, and channel form have to be mitigated. Willow, the species most adapted to high velocity flows, can withstand a flow velocity of up to 7 ft./sec. and shear stresses of 2 lbs./ft<sup>2</sup>. Sausal Creek typically exceeds these conditions during the 1-year frequency event (Figures D and E).

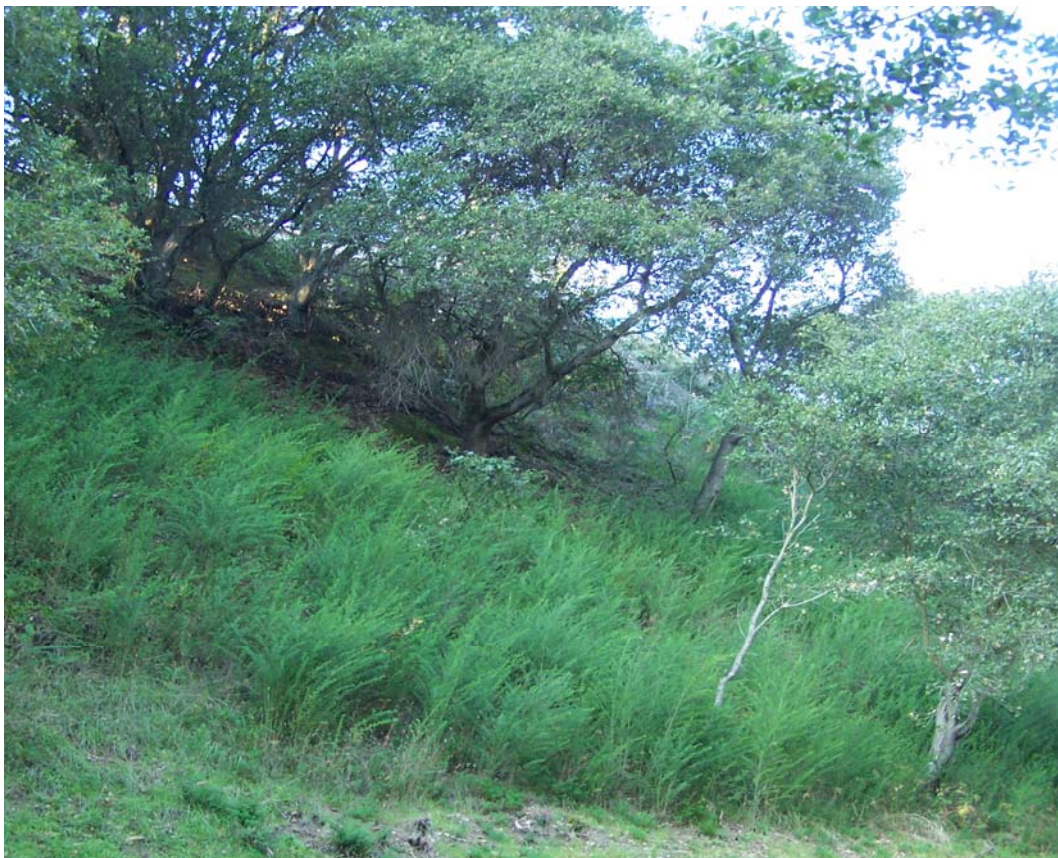
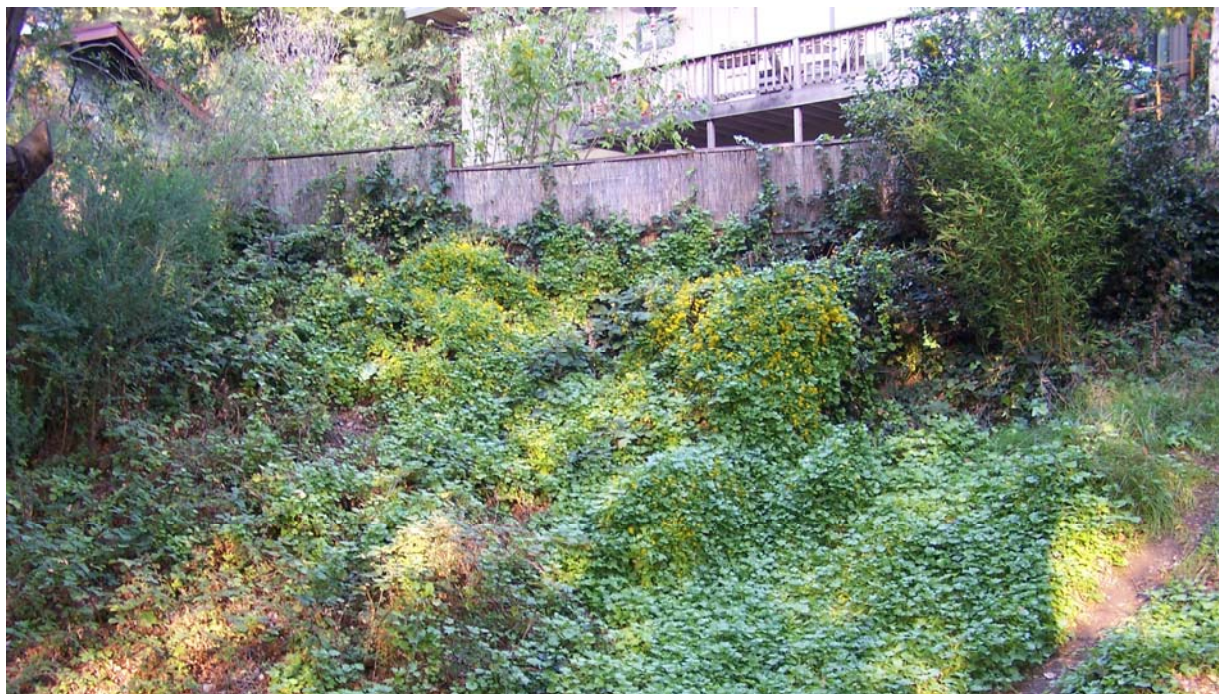
**Figure G: Top: Invasive non-native cape ivy adjacent to a residential area in the Shepherd Canyon sub-basin. Bottom: French broom, a highly flammable invasive plant, is widespread in the Sausal Creek watershed and is seen here as an understory plant in both native vegetation**

The native vegetation areas that remain in the Sausal Creek watershed are under constant threat of invasion and replacement by invasive, non-native plant species. These plants were typically brought to California as garden plants or by the government to provide erosion control along streams or on agricultural lands. Some, such as Eucalyptus, were widely planted in the East Bay hills under the mistaken assumption that Eucalyptus would produce good lumber in California. The spread of invasive non-native plants is a primary cause of the degradation and loss of native habitat in California. Most invasive plants are adapted to rapid germination and growth following ground disturbance. Some produce chemicals which suppress the growth of other native plants, resulting in complete dominance by the invasive species. Most invasive plants do not provide habitat values for wildlife, nor do they have natural predators outside their native land to reduce their rapid spread.

Replacement of native species by invasives can exacerbate the effects of fires and floods. Most of the invasive plants that cover the understory areas along streams provide little to no erosion control, allowing streambanks to fail in floods. Some invasives are extremely fire-prone; the 1991 Oakland firestorm was spread as Eucalyptus stands exploded, sending burning embers across major freeways to start additional fires.

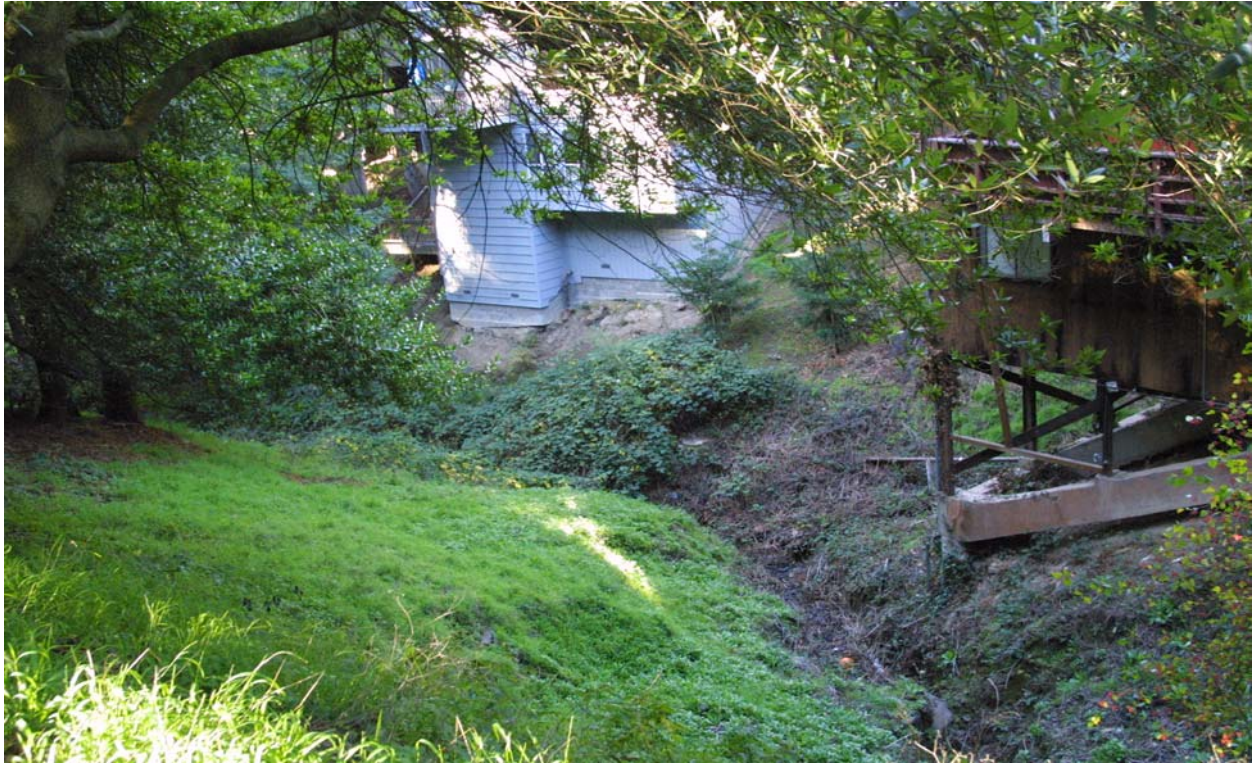
**Figure J: Houses line the tributary channels in the Cobbledick Creek sub-basin. House and deck foundations are located within the area of the channel that is subject to bank erosion and failure.**

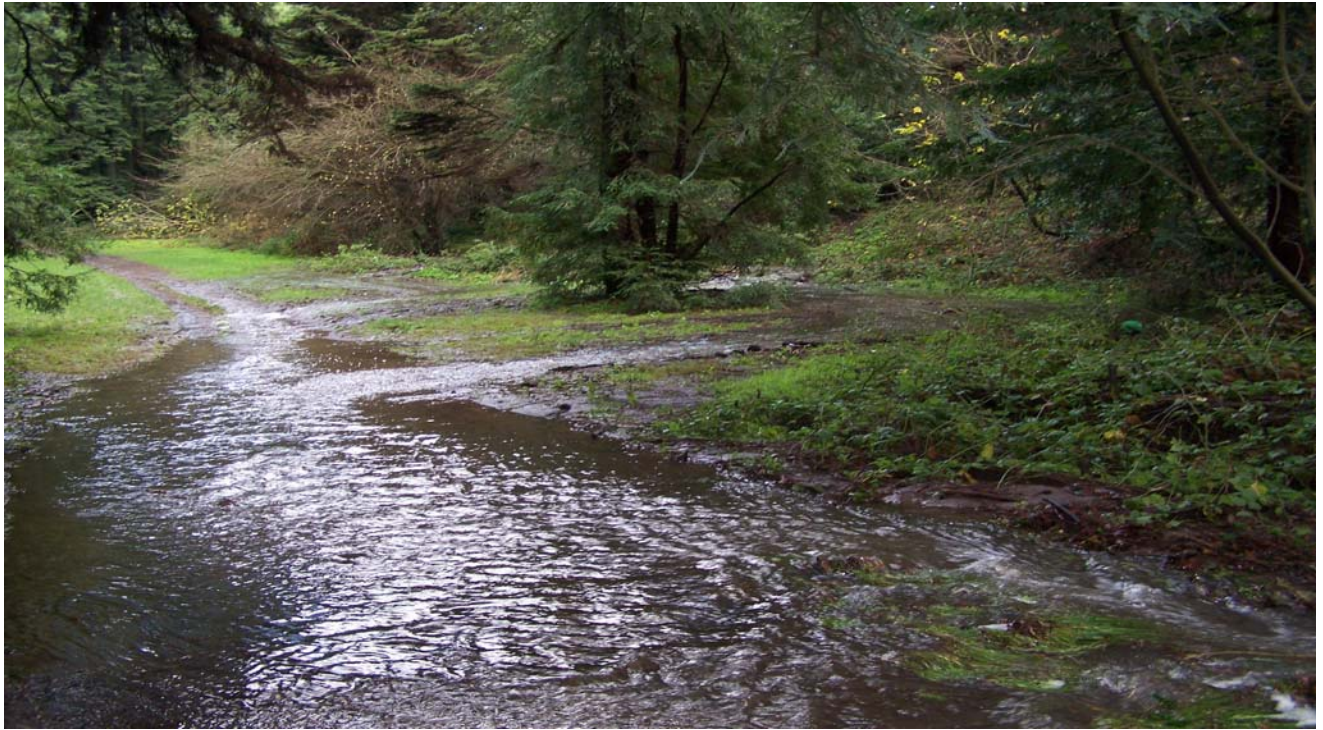
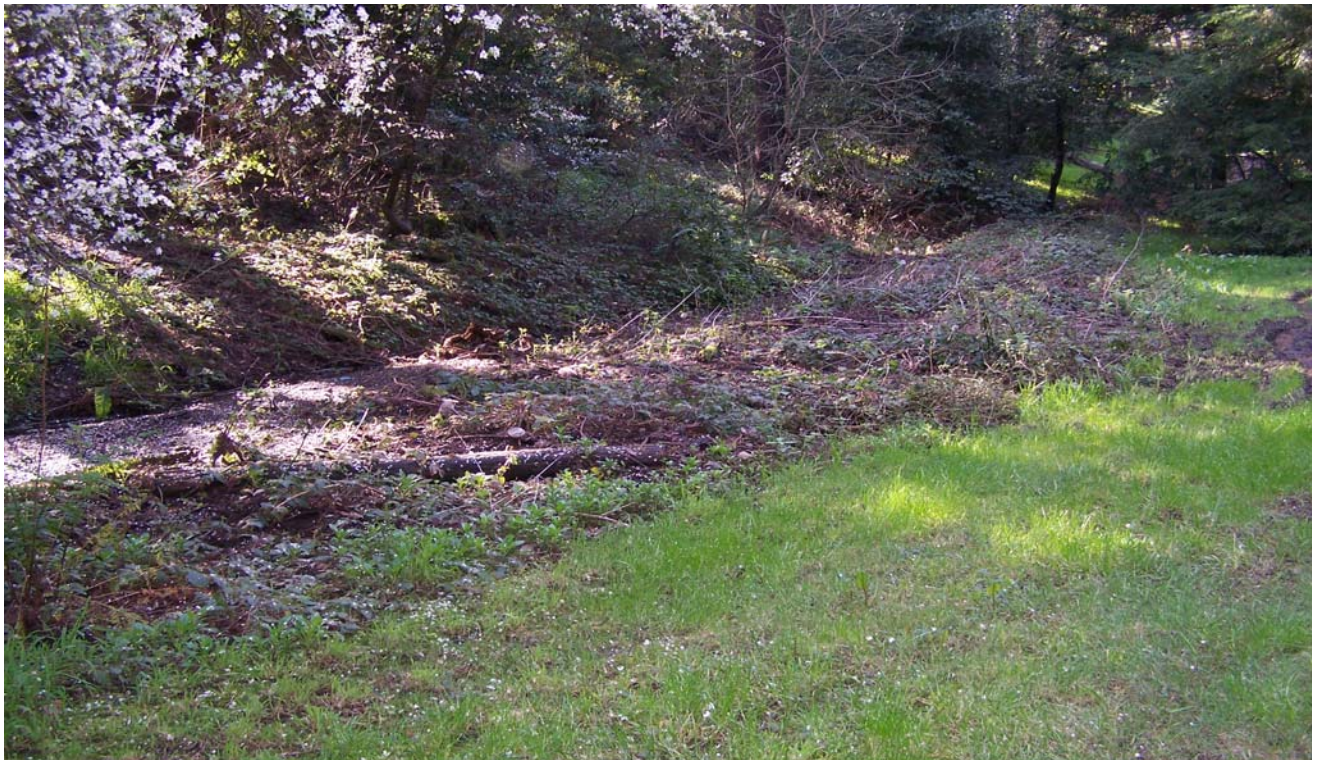
**Figure K: Palo Seco Creek (PSC1) overflows onto a grassed floodplain and trail during larger flow events This reach could be easily restored.**

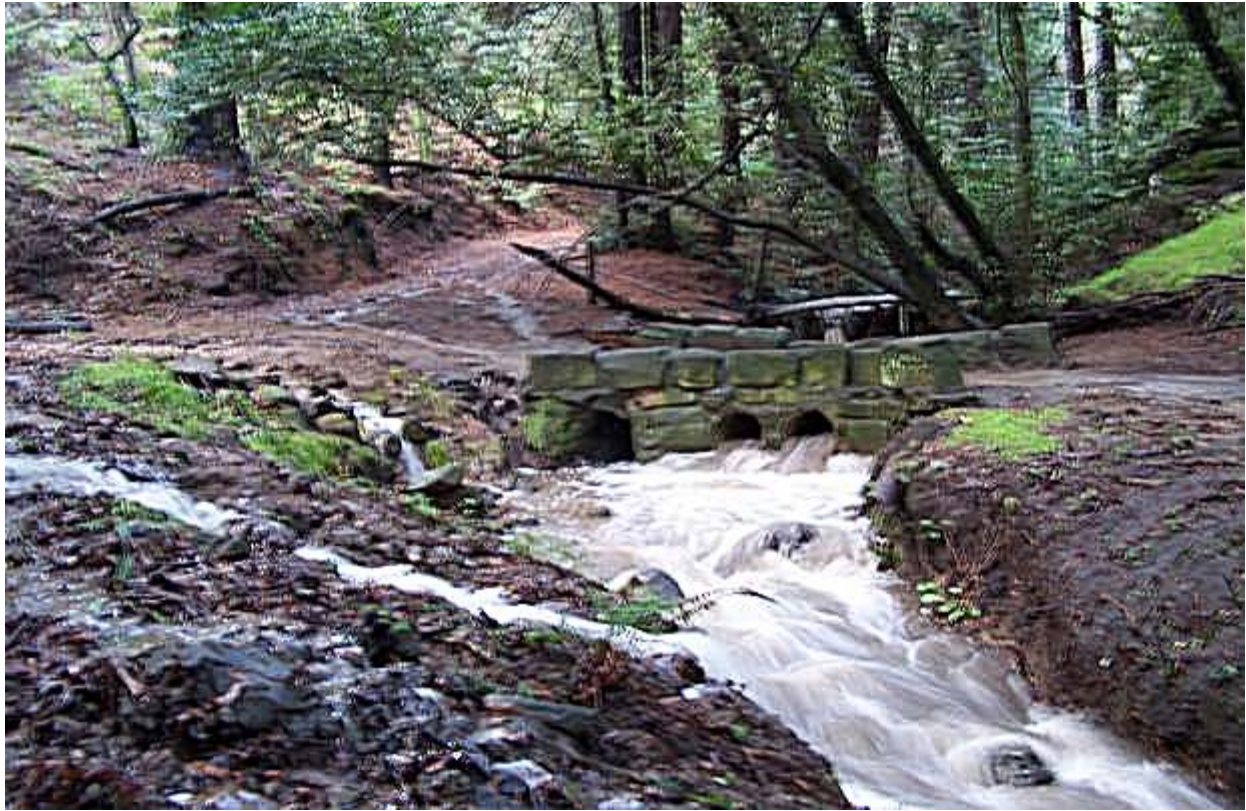
**Figure L: Top: Palo Seco Creek (PSC3) in the Jan. 1, 2006 flood event. Bottom: Small trail bridge with culverts serves as a grade control structure for Palo Seco Creek. Small trash rack visible upstream is also a grade control structure. Note sediment runoff from adjacent trails.**

This reach of Palo Seco Creek stretches from the culvert outlets at the downstream end of the meadow to the confluence with Cinderella Creek. The slope of the creek bed increases over this reach and contains several knickpoints. The creek channel is incised below these knickpoints and several trees have been undercut on the banks. Aquatic insect monitoring showed good aquatic conditions (Figure L).

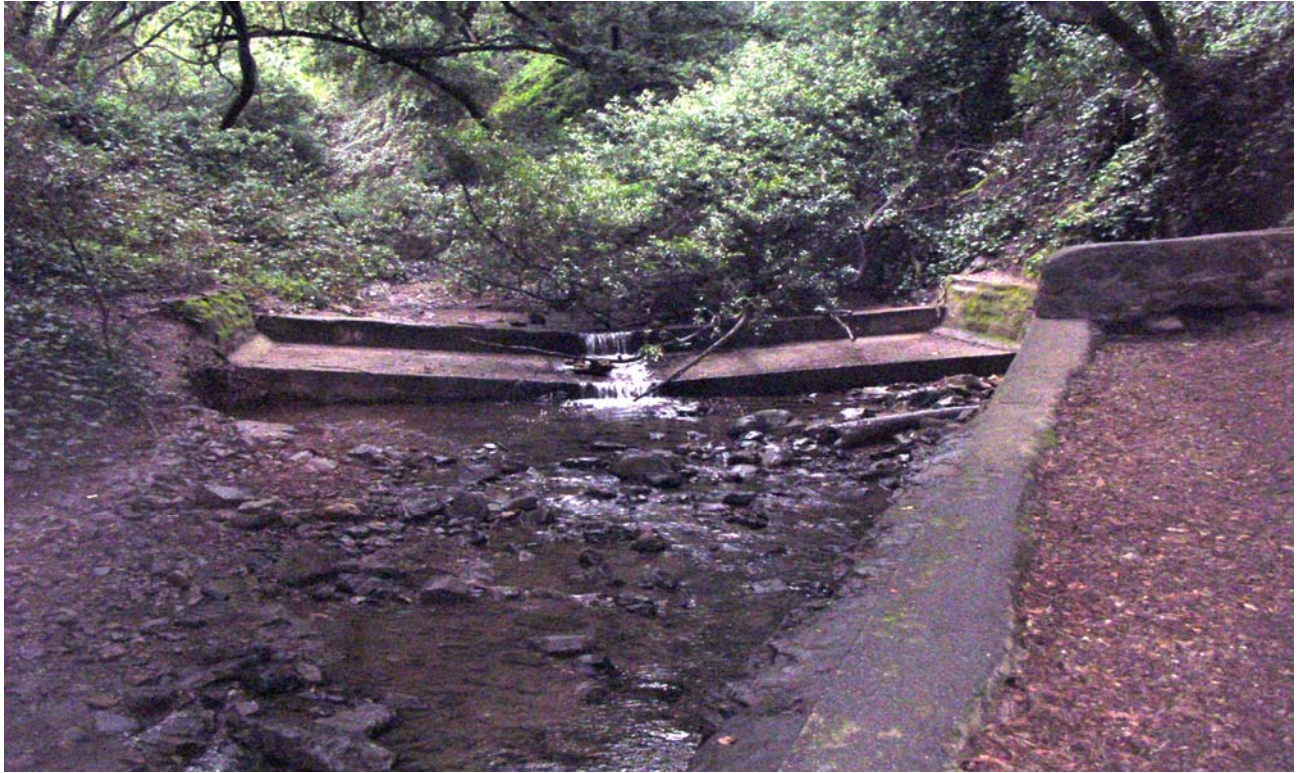
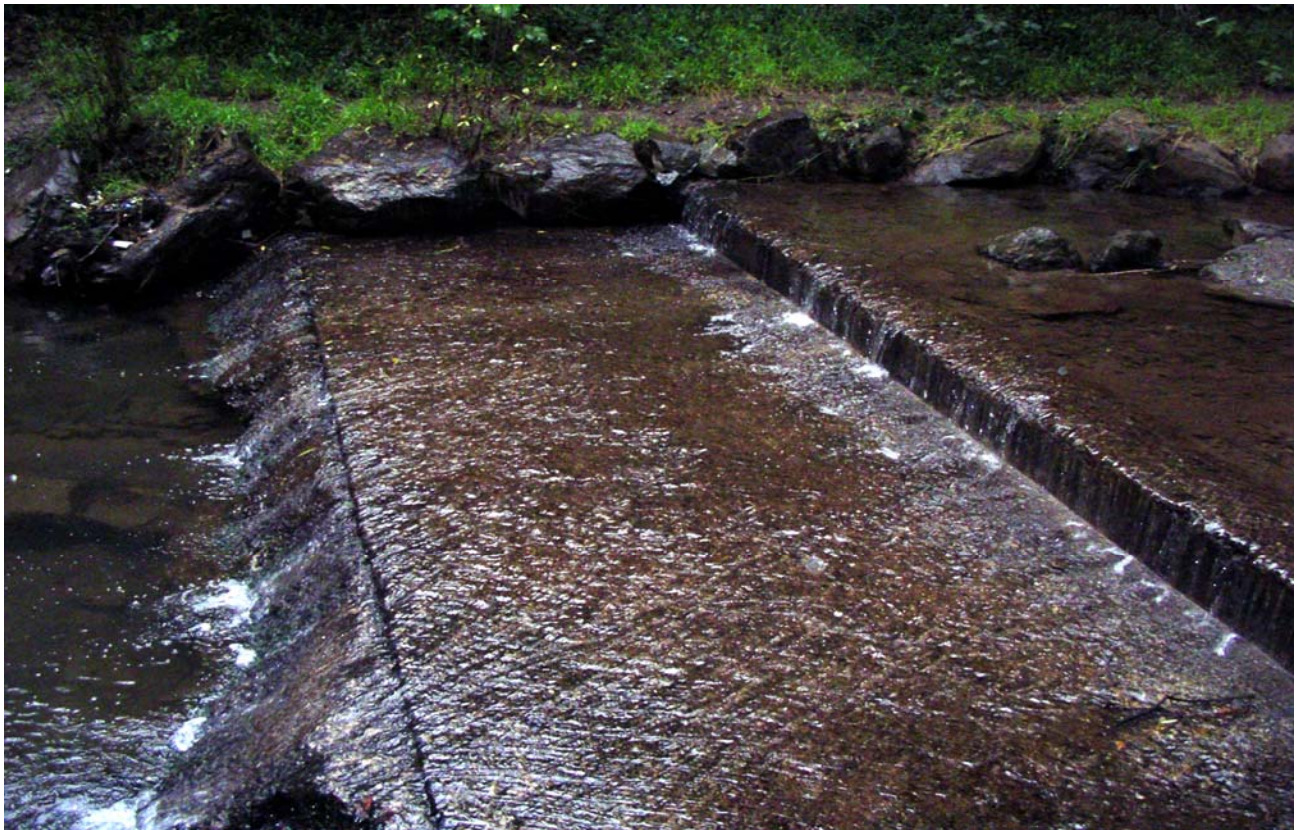
**Figure M:** These photos are examples of the drop structures in Sausal Creek (SC1) in Dimond Canyon.

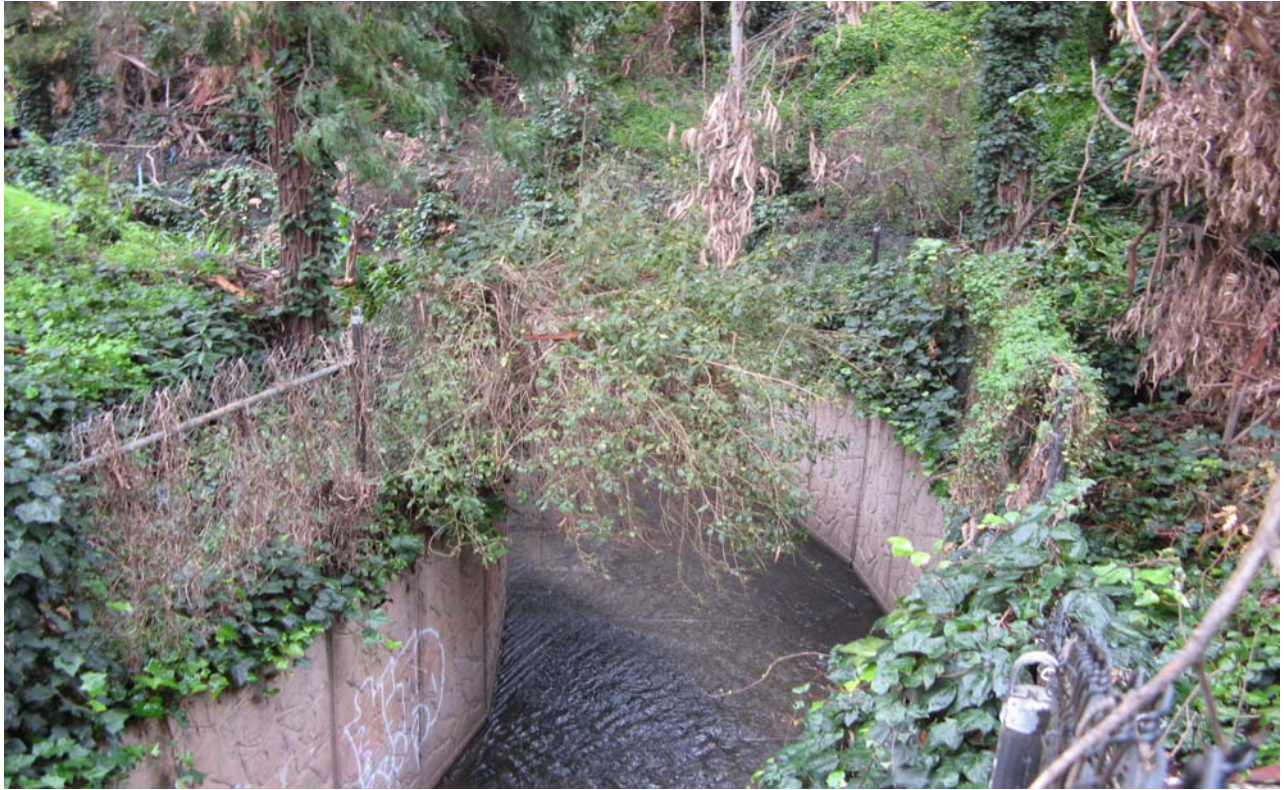
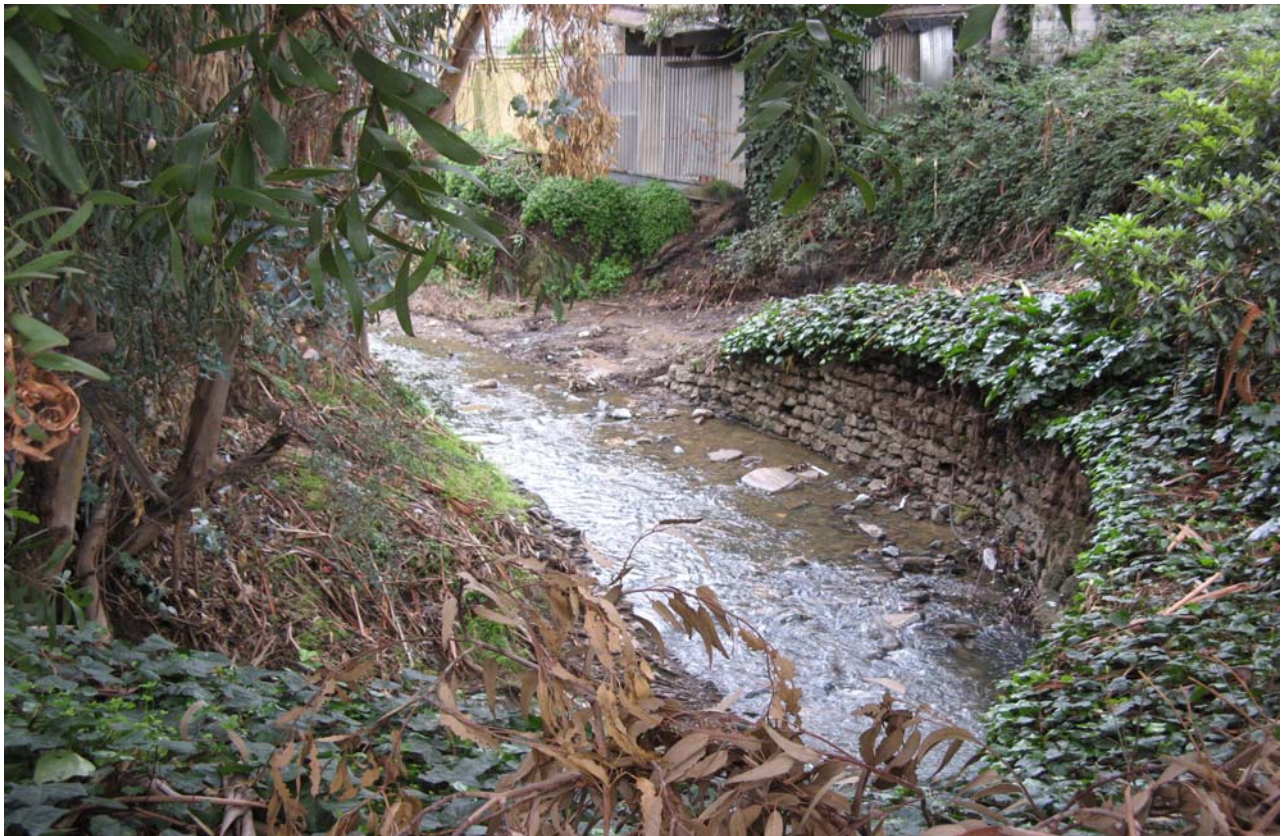
**Figure O: Top: Sausal Creek at Logan Road. Bottom: Sausal Creek at E. 22<sup>nd</sup> St (SC5).**

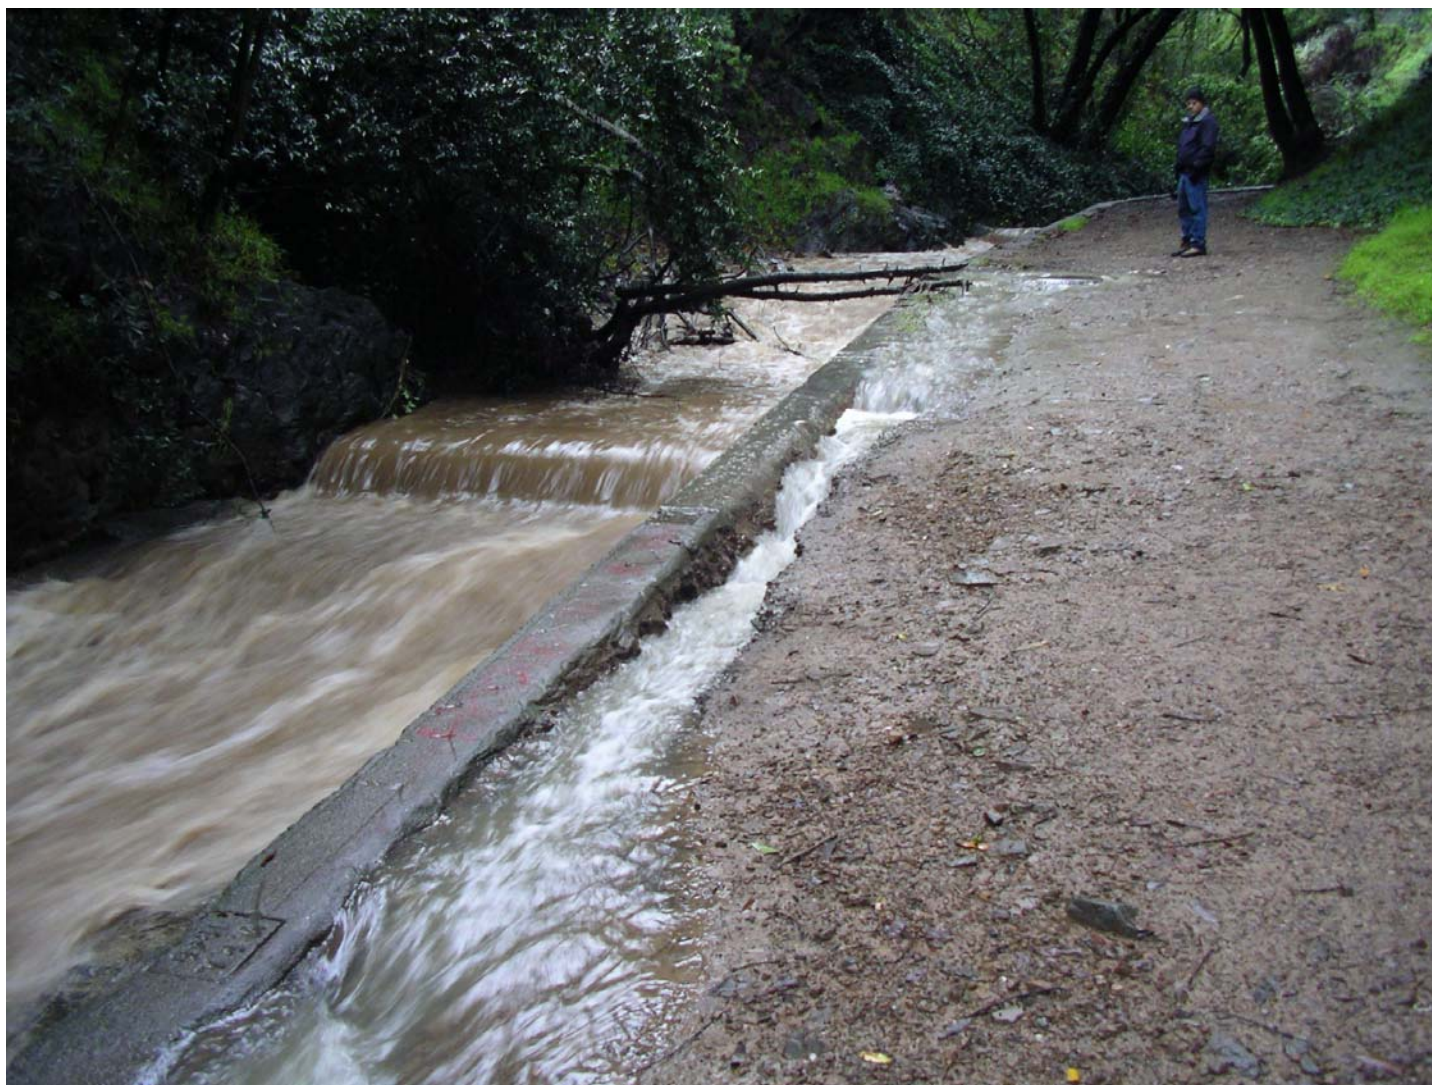
**Figure S: Sanitary sewer overflow following the January 1, 2006 flood**

The sanitary sewer system carries raw sewage from residential and commercial areas to the East Bay Municipal Utilities District (EBMUD) wastewater treatment facility in west Oakland. The maze of sewer lines in the hilly residential areas of Shephard Creek and Cobbledick Creek sub-basins appear to feed into main lines along the major creek courses. This system of sewer pipes from the upper watershed feeds into the main sewer, which follows Sausal Creek through Dimond Canyon. Several major lateral pipes feed into the main sewer in Dimond Canyon. Sewer pipes also cross Sausal Creek at several points in the lower watershed. The route of the main sewer line leaves the Sausal Creek bed at the end of Dimond Park and follows Dimond Avenue and then Fruitvale Avenue. There are several locations where the sanitary sewer system is known to overflow during large rainstorms. Where the main sewer extends down Sausal Creek from Highway 13 to Dimond Avenue, the manhole covers pop off the sewer in large storms and raw sewage flows into Sausal Creek. Sewage also flows out of the sewer manhole into Palo Seco Creek just upstream of the Highway 13 crossing on Joaquin Miller Court. There are likely additional locations where similar problems occur (Figure S).
