Conservation and Management Plan for Sausal Creek Wild Rainbow Trout

July 7, 2020

Friends of Sausal Creek
PROMOTING WATERSHED AWARENESS

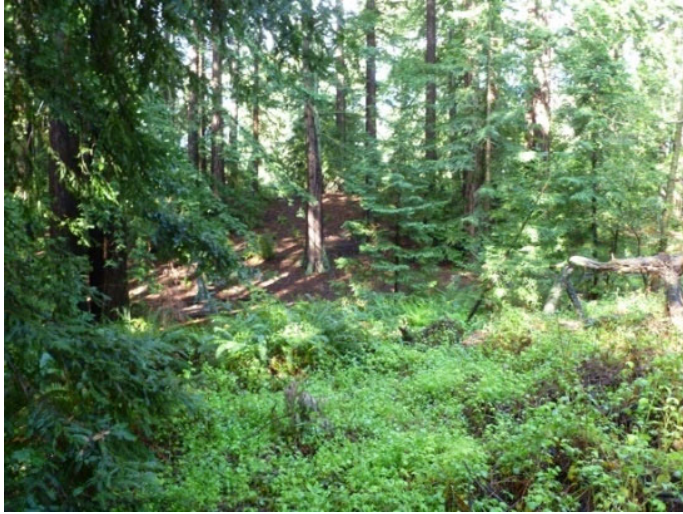
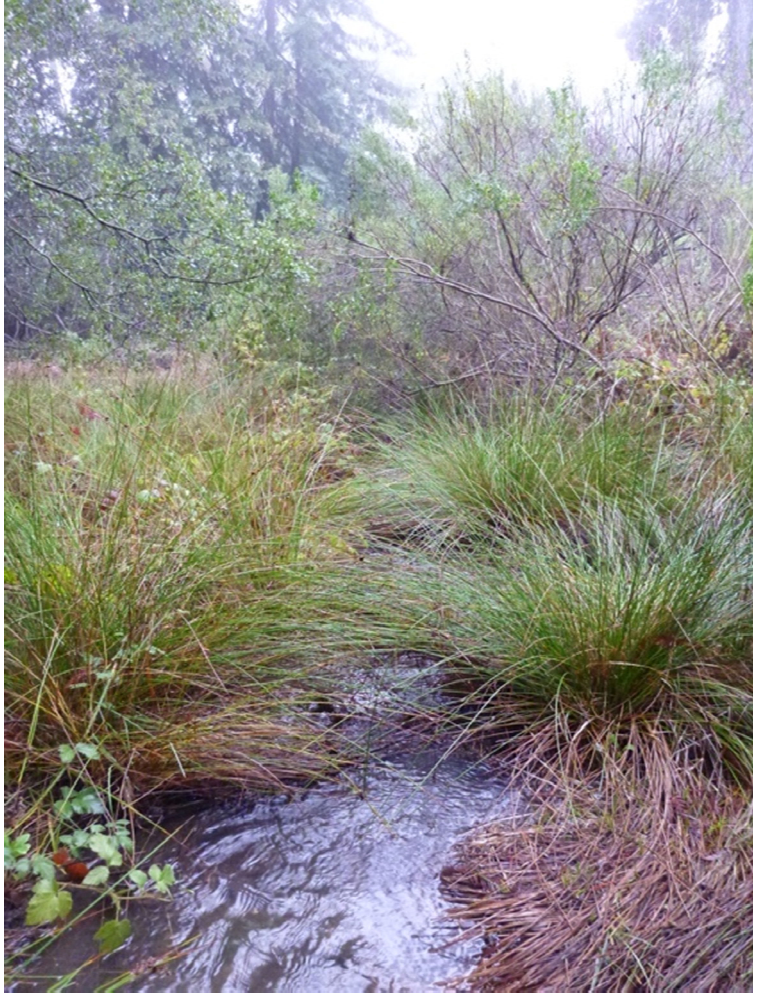
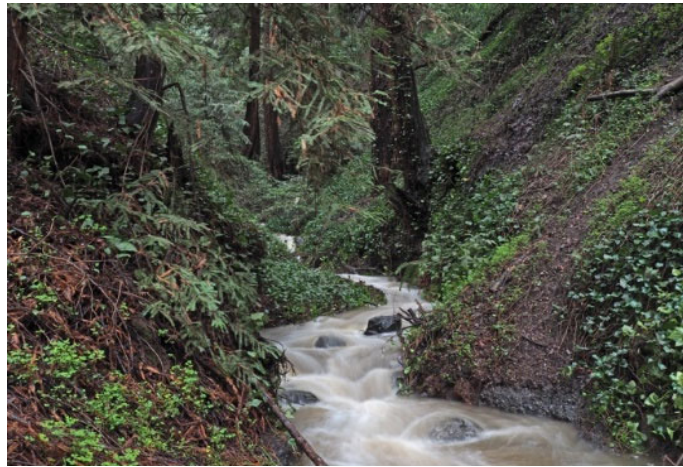
Figure 3. Palo Seco Creek is a major perennial tributary to Sausal Creek that originates from seeps and springs in Joaquin Miller Park and flows through redwood forest. Upper left and right photos by R. Leidy, lower left photo by Andrew Aldrich.

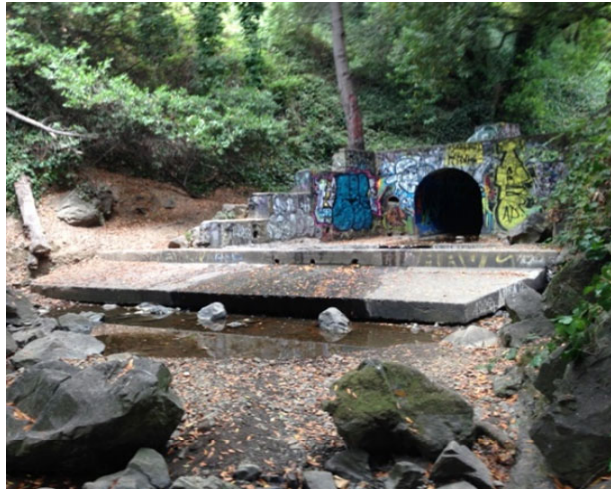
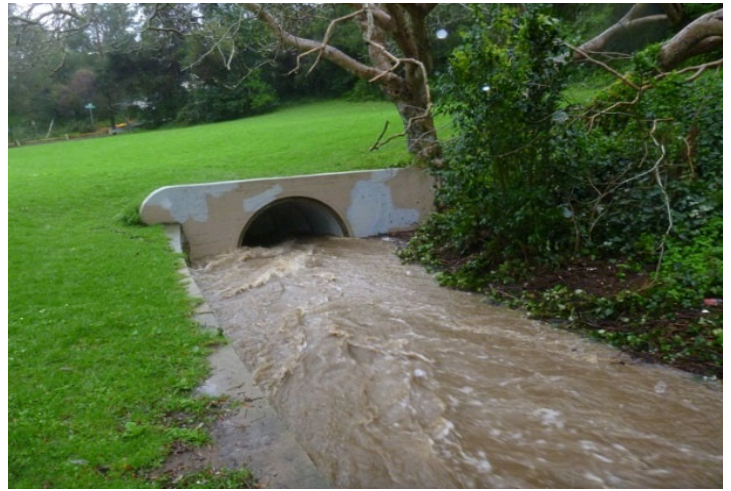
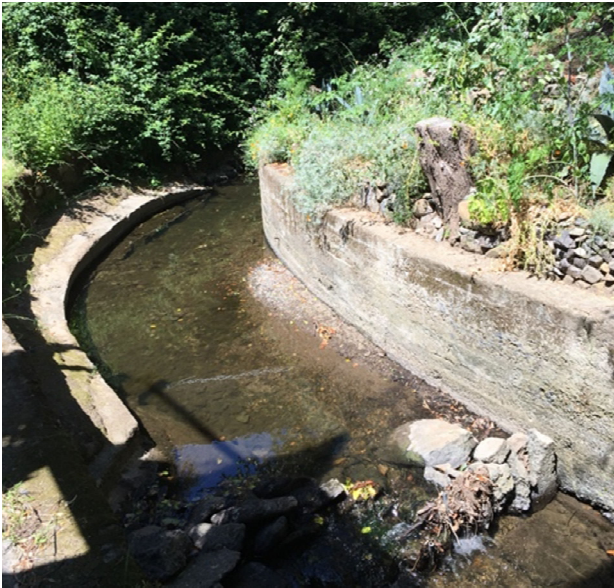
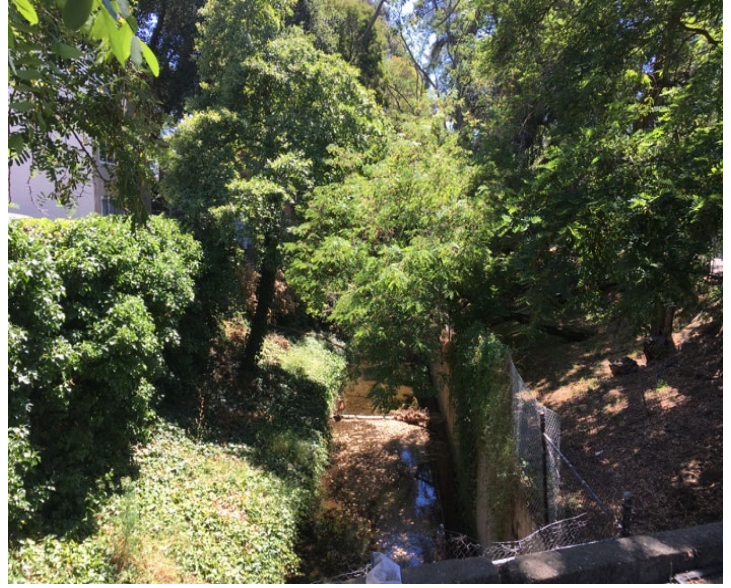
Figure 4. Urbanization has altered the natural channel forms and functions of Sausal Creek that affects the distribution and abundance rainbow trout. Clockwise from upper left: Underground culvert outlet in Dimond Canyon. High flows entering underground pipe in Dimond Park. Concrete-channelized reach flowing through residential backyards along Canon Ave. Rectangular concrete culvert downstream from Foothill Blvd. Photos by R. Leidy.

Urbanization has resulted in physical alteration of natural channels in the Sausal Creek watershed (Figure 4). Residential and commercial land uses increase the area of impervious surfaces that alters the volume and rate of stormwater runoff throughout the watershed. Stormwater drains, culverts, and pipes intercept and carry water from impervious surfaces into the creek during rainfall events. This drainage system rapidly and dramatically amplifies the volume and velocity of peak flows above the historical levels that formed the stream course and contributes to the destruction of the streambanks and the down-cutting of the stream bed. These changes to hydrology and the historical configuration of the landscape impair the quality of rainbow trout habitat.

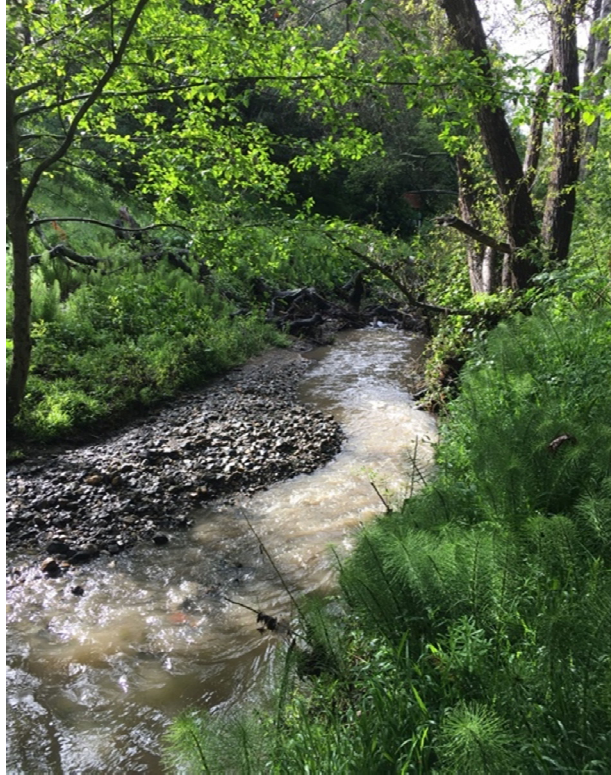
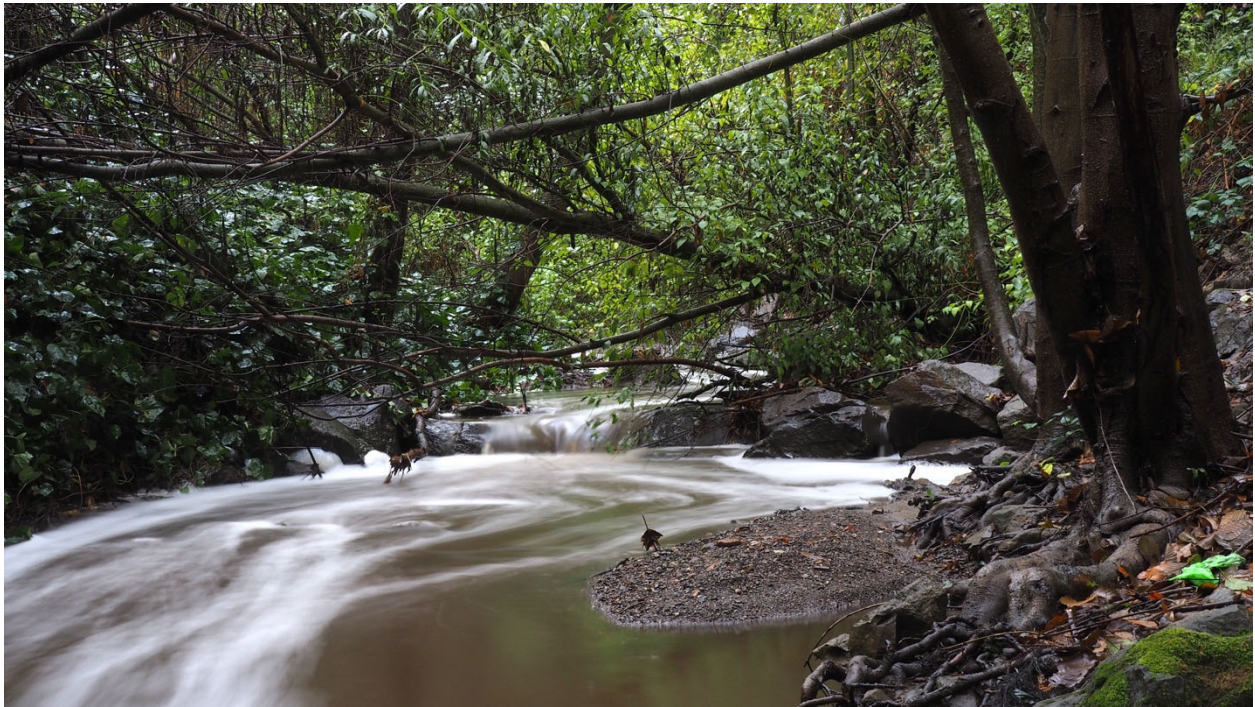
Figure 5. Perennial reaches of Sausal Creek in Dimond Canyon. Top photo by R. Leidy, bottom photo by Andrew Aldrich.

Various bedrock types, mostly sedimentary and ancient sea bed material, make up the upper watershed, and mudstone often occurs on the surface. Fault contact zones in the upper catchment create seismic fracturing and areas of abrupt changes in rock type, which influences vegetation type and moisture levels. Seeps and springs are common, and they provide a near-constant source of cold, clean water to Sausal Creek known as baseflow. This baseflow is very important for salmonids. The persistence of baseflow in Sausal Creek is one of the primary reasons why rainbow trout have survived in Oakland, despite multiple stressors and threats while mostly disappearing from other urban areas in California. Dimond Canyon forms a dramatic geologic feature below Highway 13, and Sausal Creek flows mostly year-round (perennially) through the Canyon, providing a critical “refugium” for the rainbow trout (Figure 5).

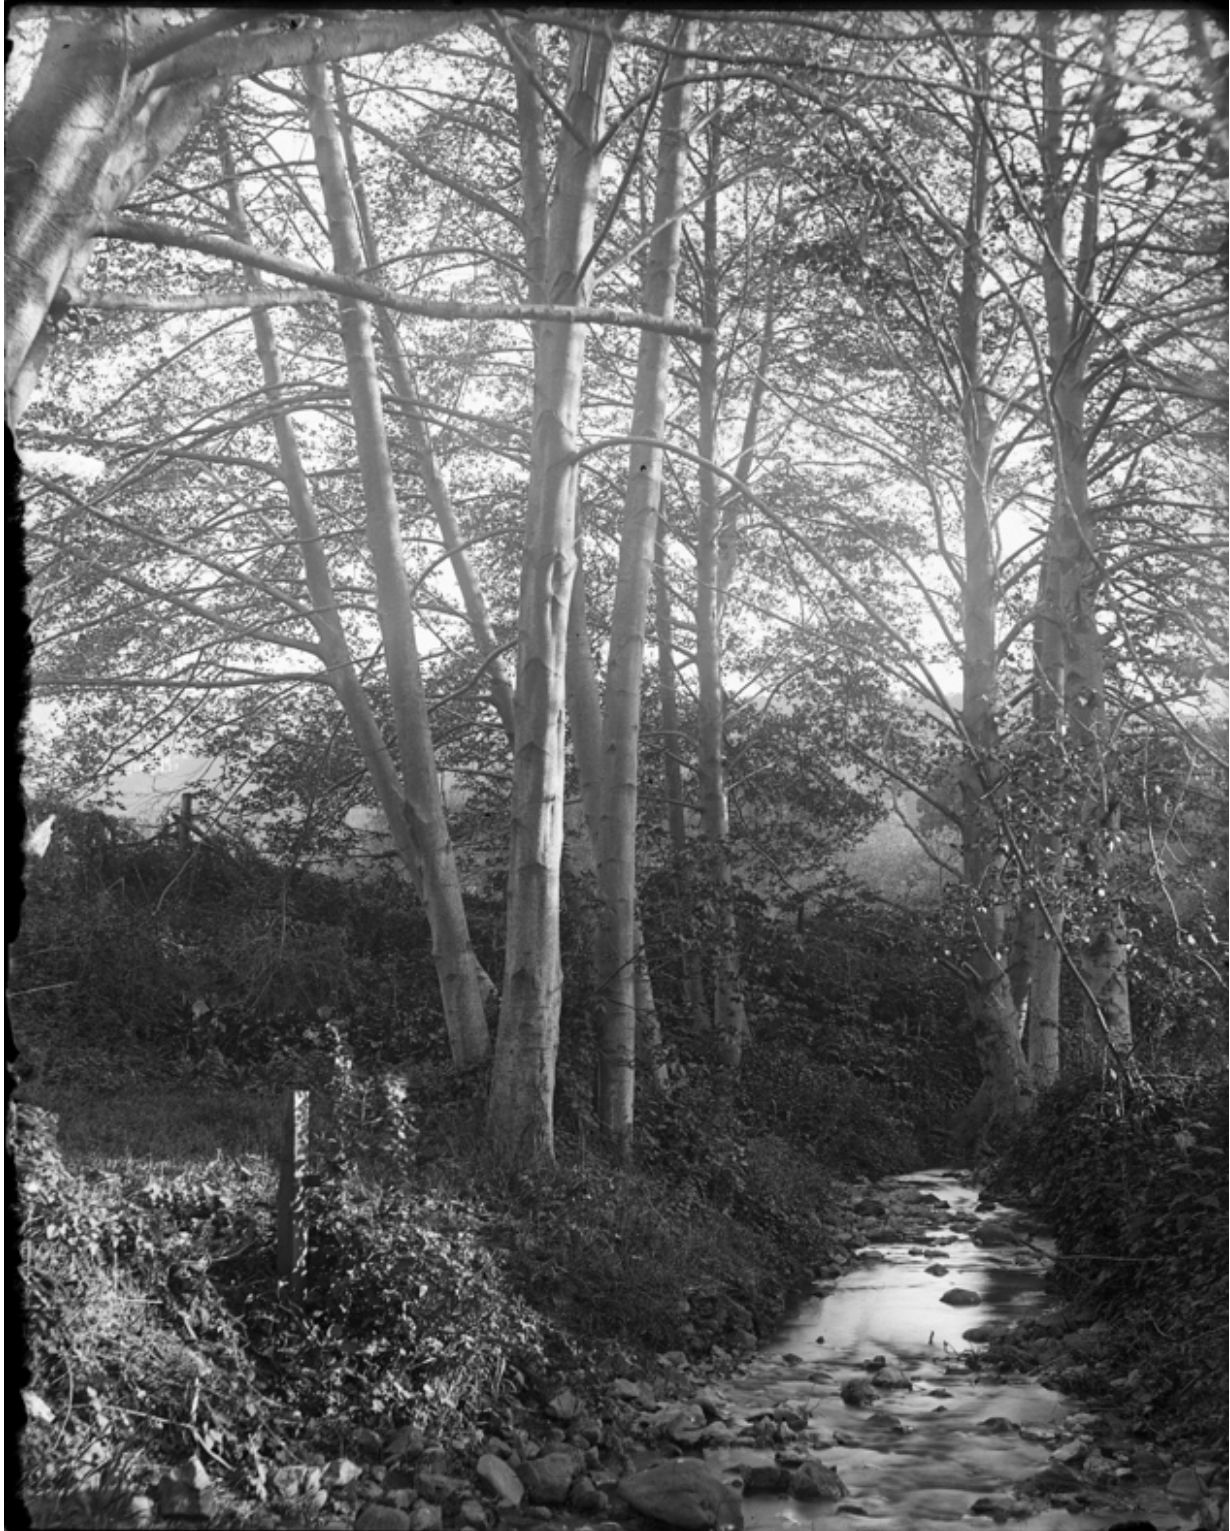
Figure 6a. View at *Diamonds Canon...May 19, 1901* by Henry King Nourse (source California State Library History Room). The banks of this well-shaded reach of Sausal Creek are lined with white alder and blackberries. Note the alternating sequence of riffles and shallow pools.

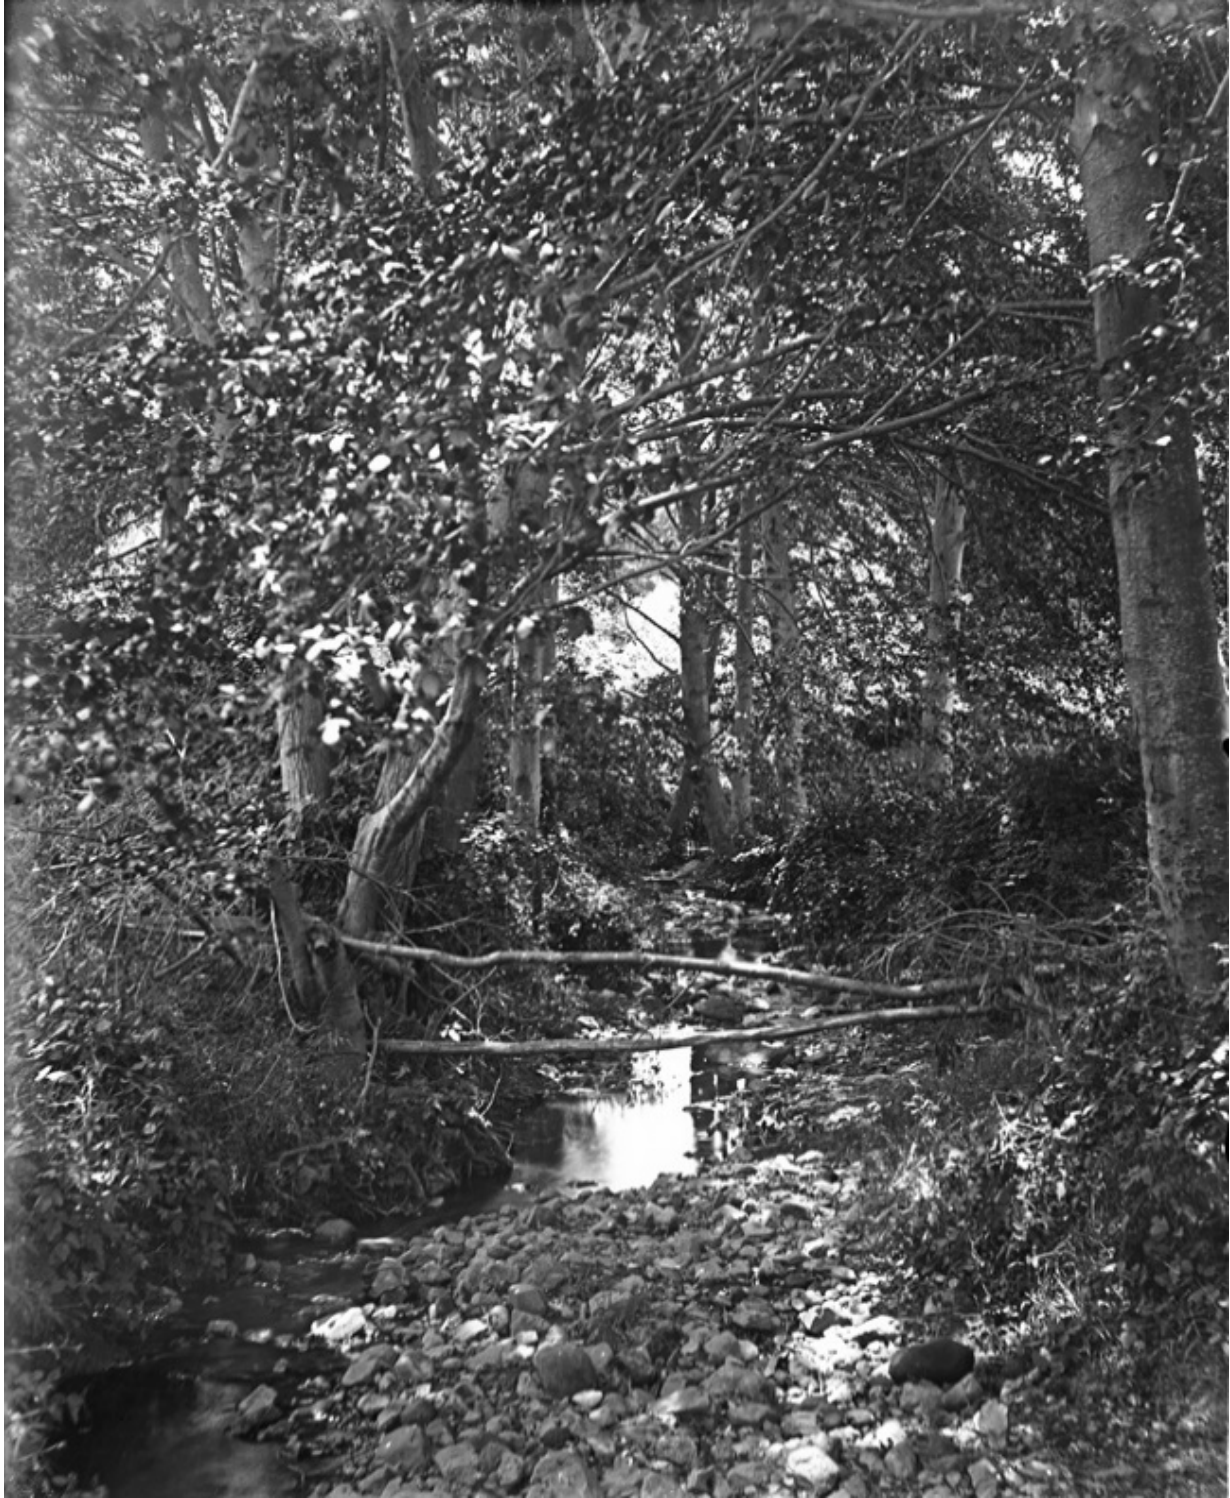
Figure 6b. *View at Diamonds Canon...May 19, 1901* by Henry King Nourse (source California State Library History Room). White alder lines both banks of Sausal Creek. The shallow pools would provide high-quality rearing habitat for young rainbow trout. This gravel substrate where riffles transition to pools is ideal spawning habitat for trout.

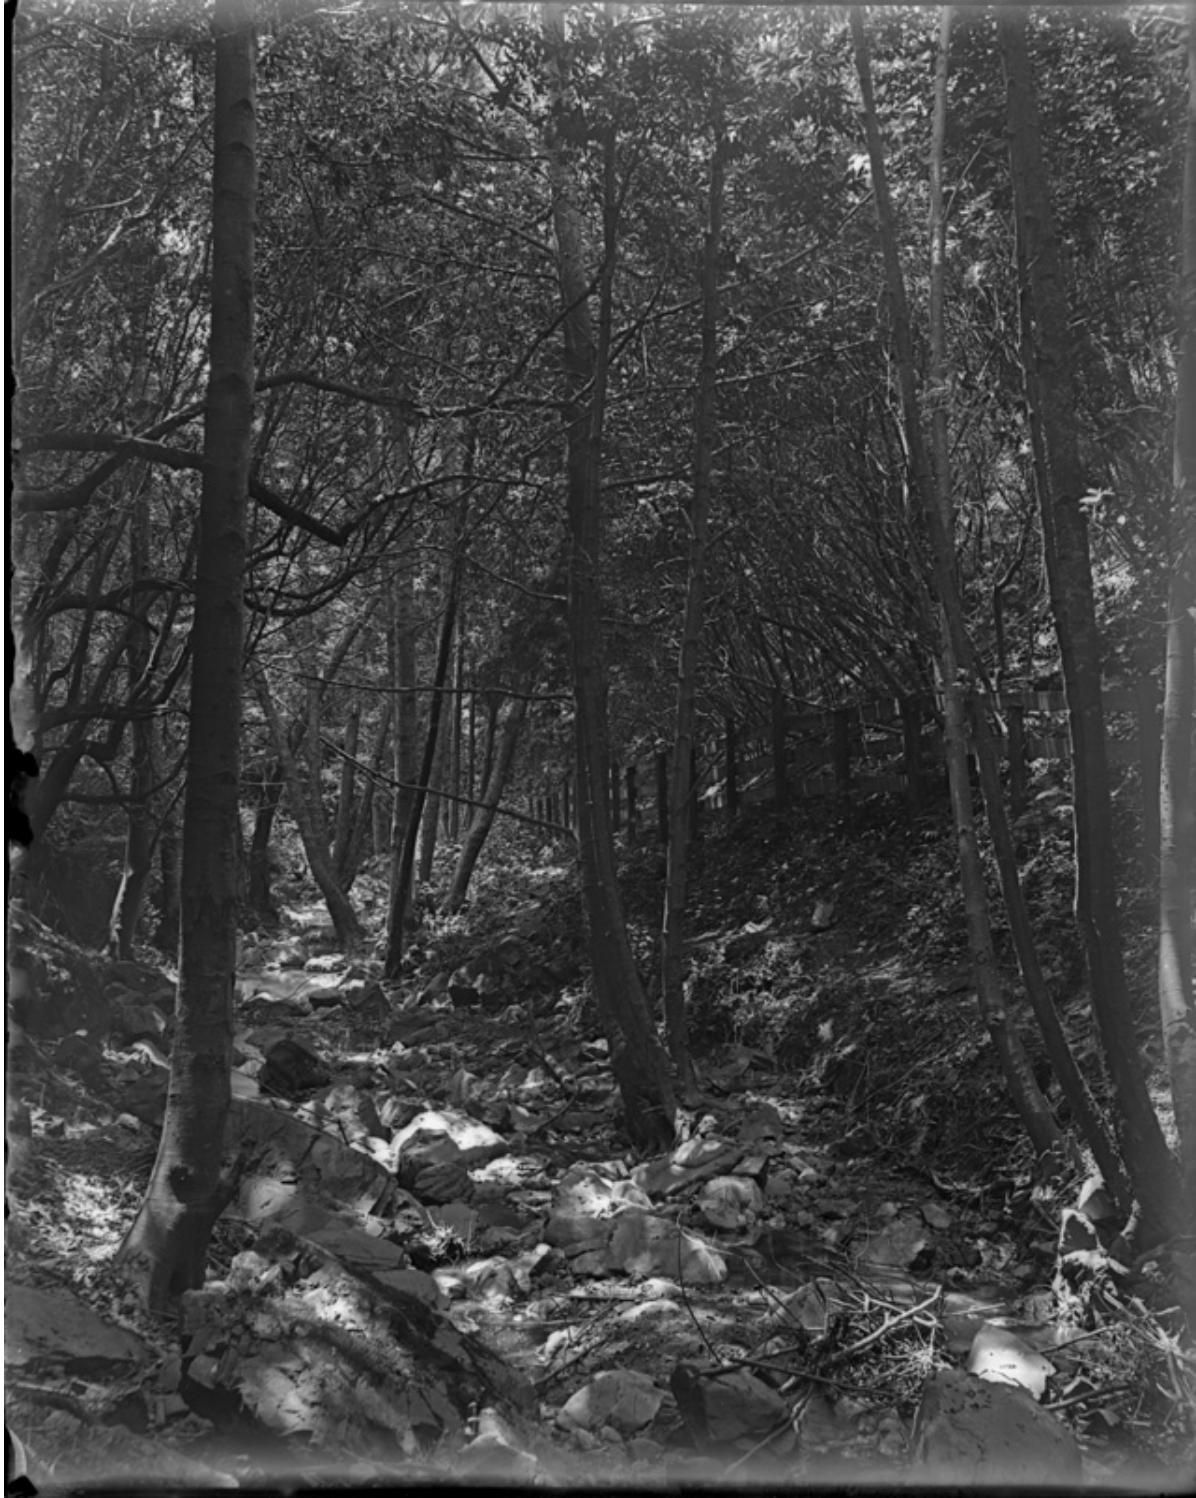
Figure 6c. *View at Diamonds Canon...May 19, 1901* by Henry King Nourse (source California State Library History Room). This high-gradient intermittent reach of Sausal Creek is lined with white alder and contains small pools that are visible near the top of the photo.

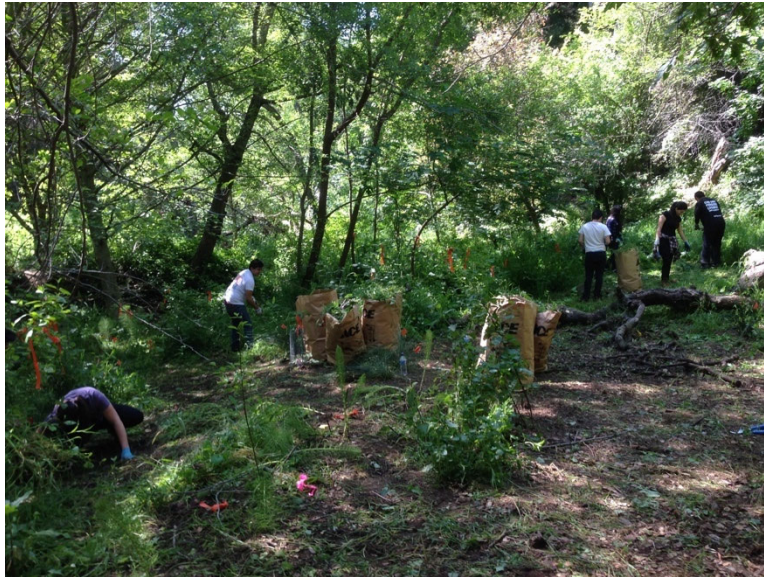
Figure 7. Functioning natural floodplains adjacent to Sausal Creek have been mostly eliminated from urbanization, channel incision, and flood control structures (armored channels and banks, and underground culvert). Volunteers remove invasive, non-native vegetation on one of the few remaining floodplains at the mouth of Dimond Canyon near El Centro Avenue (photo by R. Leidy).

Floodplains. Floodplains provide lateral connectivity between streams, riparian forests, and terrestrial habitats. Human activities have destroyed and fragmented floodplains, and this has decreased the complexity, diversity, and ecological functions of floodplains. Consequences include altered stream hydrology and hydraulics, diminished water quality, and degraded habitats needed by rainbow trout for spawning, rearing, feeding, resting, and refuge. Floodplains bordering Sausal Creek have been mostly filled and converted to urban uses or remain as abandoned fragments due to channel incision or flood control structures. Remaining floodplains throughout the watershed are often constricted, with only narrow bands of native riparian or ornamental vegetation remaining (Figure 7).

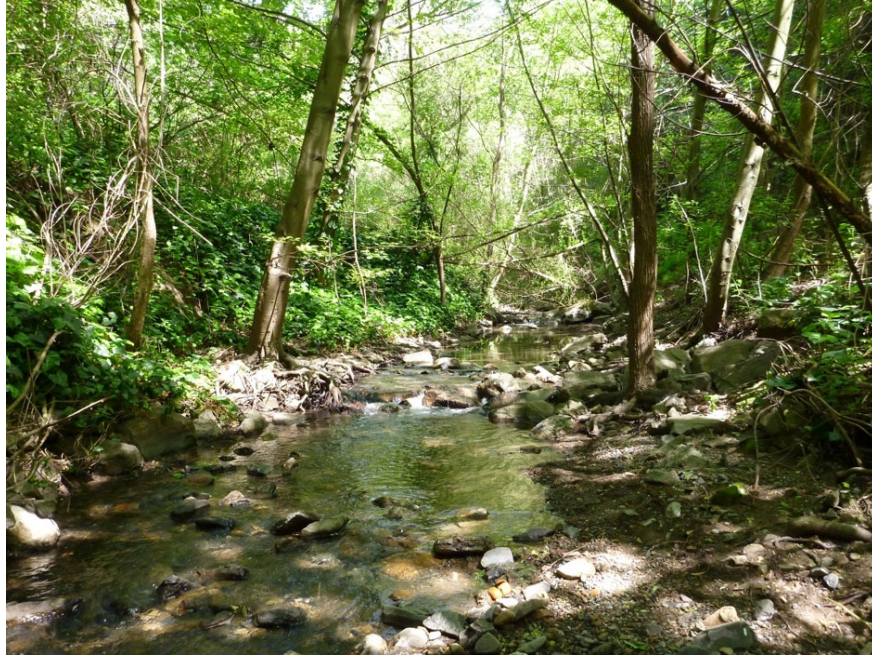
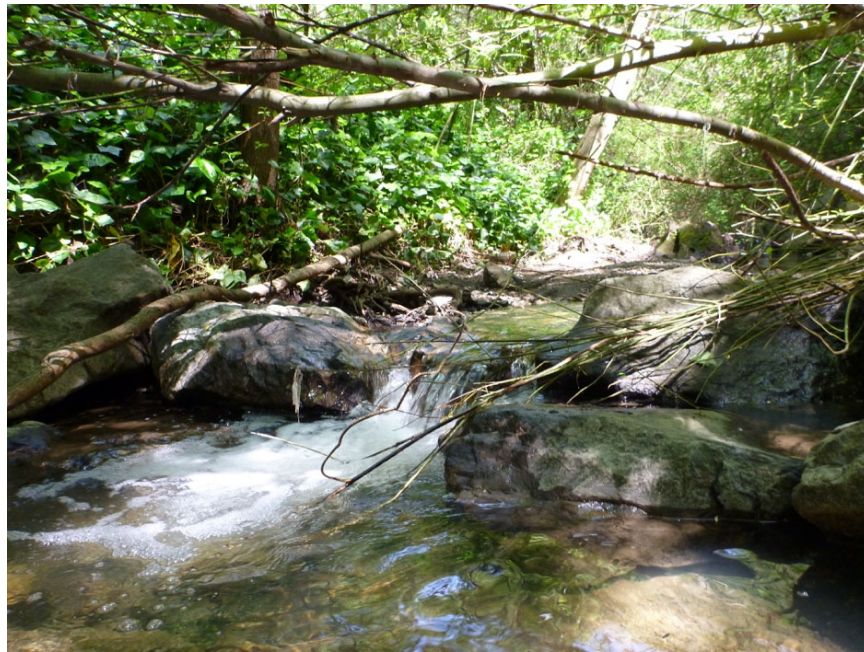
Figure 8. Top: A well-shaded alternating sequence of shallow pools and riffles in Dimond Canyon. Bottom: The natural rock weir visible in the center of the photo was installed as part of a channel restoration project to improve pool formation for fish. Photos by R. Leidy.

Pools and Riffles. A mix of pools to riffles and a diversity of pool and riffle depths provides vital habitat for rainbow trout populations (Figure 8). Also, high-quality riffles are typically characterized by oxygen-rich, clean gravels and cobbles with low percentages of embedded fine sediment (i.e., sand and silt). Urbanization has degraded pool and riffle habitats. Fine sediments mobilized by landslides and erosion within the watershed or pouring into the creek from roads and construction sites, can smother the gravels and cobbles, reducing habitat quality for trout eggs in spawning nests (redds). There is almost no high-quality riffle and pool habitat remaining within the Sausal Creek watershed. Suitable habitat is now restricted mostly to stream reaches within City-owned parklands in the headwaters, Dimond Canyon, and a few “daylighted” reaches in the lower catchment.³

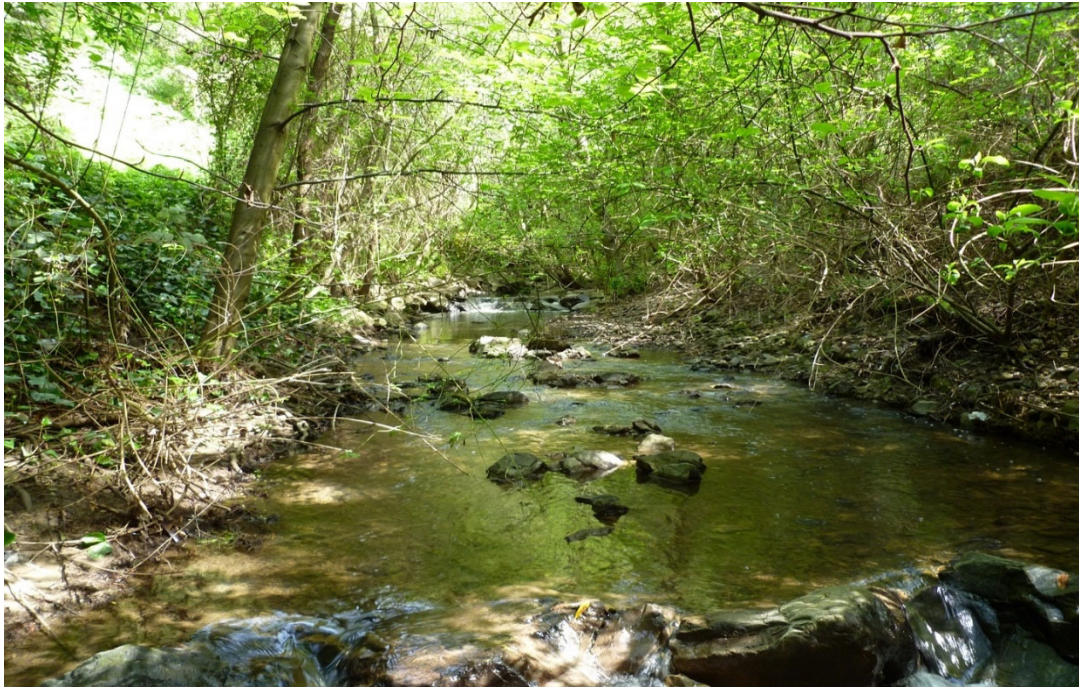
Figure 9a. A well-shaded reach of Sausal Creek characterized by a dense riparian overstory of white alder and Pacific dogwood. Shading from riparian vegetation maintains cool water temperatures during warm summer and fall months. This reach exhibits a mixture of shallow pools and riffles. Cover for trout is provided by riparian vegetation and submerged boulders. Photo by R. Leidy.

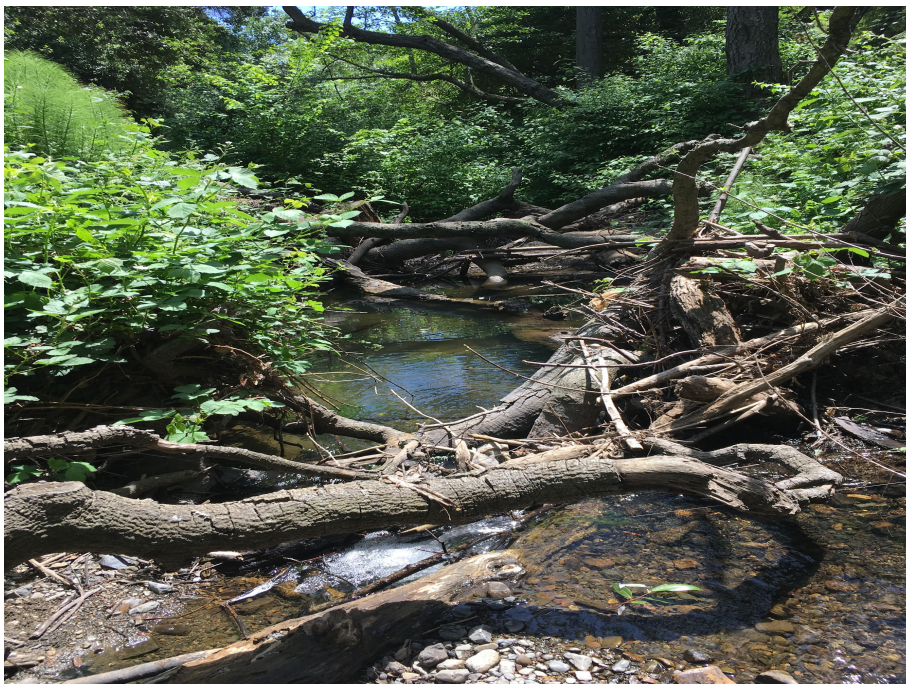
Figure 9b. Large instream woody debris such as this fallen coast live oak in Sausal Creek created a deep, well-shaded pool with complex hiding cover for rainbow trout. These pools are ideal habitat during hot summers and typically support a diversity of terrestrial and aquatic invertebrate prey favored by trout. The photo illustrates the importance of large instream wood in creating diverse habitat for trout, a condition that is rare in most densely urbanized watersheds. Photo by R. Leidy.

Diverse and well-developed natural instream and riparian cover are correlated with the abundance of rainbow trout (Bjornn and Riser 1991). Stable overhanging or undercut banks, instream (submerged or semi-submerged) large-woody-debris (LWD), overhanging riparian vegetation, aquatic vegetation, boulders, and deep and turbulent water provide cover from predators and shade that moderates water temperatures. See Figures 9a and b; Examples of riparian and instream cover (Bjornn and Riser 1991, NRCS 2000). Riparian vegetation and instream LWD are a source of insects and other invertebrates that serve as trout food while protecting streambanks from excessive erosion (Bjornn and Riser 1991, NRCS 2000)(Figure 9b).

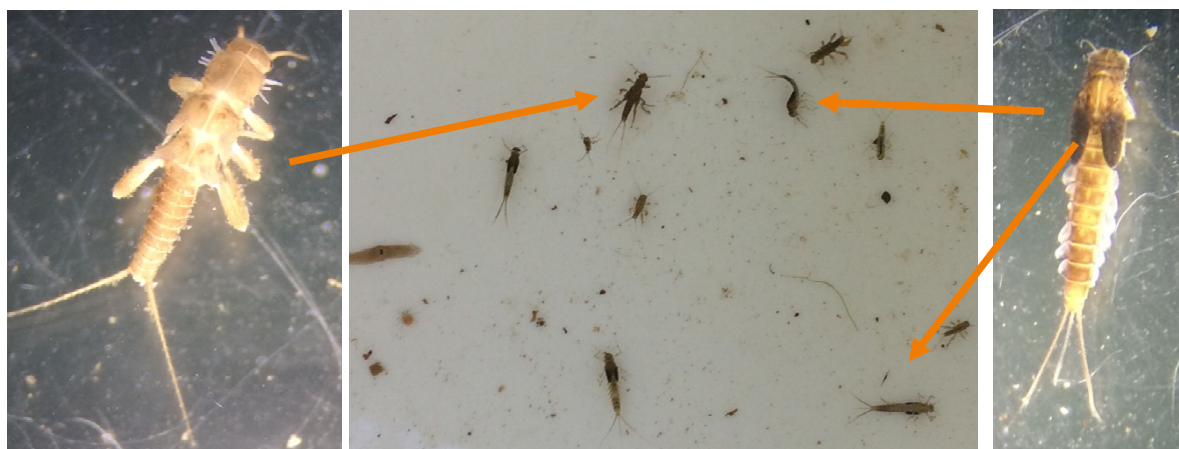
Figure 10. The benthic macroinvertebrate community in Sausal Creek in Dimond Park, as seen in late May 2020. The community was dominated by the mayfly (Ephemeroptera) *Baetis* sp., shown at right. *Baetis* is one of the most common aquatic insect taxa in Bay Area streams, and is present in a wide range of habitat and water quality conditions. Also present was the stonefly (Plecoptera) *Malenka* sp. (left), the most common stonefly in moderately impacted streams in the East Bay. Additionally, non-insects including flatworms (*Turbellaria*) and aquatic mites (*Hydrachnida*) were present (visible in the in the middle left of the center photo). Photos and description provided by Matt Cover.

Benthic macroinvertebrate (BMI) communities in Sausal Creek vary both spatially and seasonally (Figure 10). For example, in May 2020 the most abundant BMI in Dimond Park was the mayfly *Baetis* sp., while the most abundant taxon further upstream in Dimond Canyon was the stonefly *Malenka* sp. Most BMI are aquatic insects, which usually have aquatic larval stages and terrestrial, flying adult stages. As larvae, insects such as mayflies and stoneflies crawl on and within gravel and cobble on the streambed, and are major prey sources for rainbow trout.

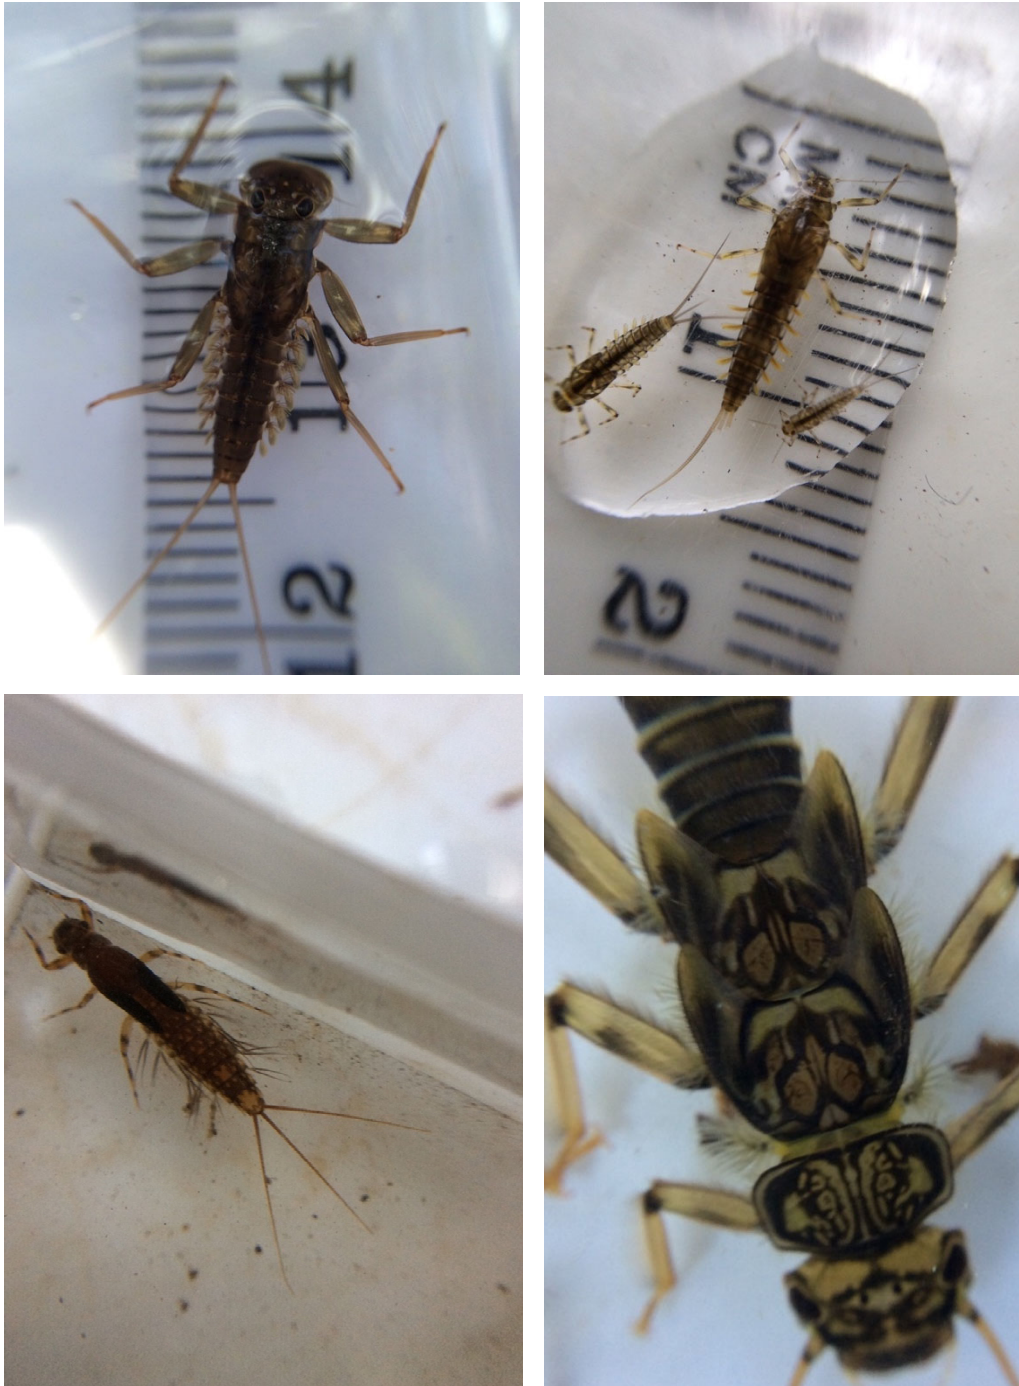
Figure 11. These invertebrates from Sausal Creek are prized food for rainbow trout. Clockwise from upper left. Prong-gill mayfly (*Leptophlebiidae*). Three generations of small minnow mayflies (*Baetids*). Flat-headed mayfly (*Heptageniidae*). Stonefly (*Perlidae*). Photos and invertebrate identifications by Kathleen Harris.

Benthic macroinvertebrate (BMI) communities in Sausal Creek vary both spatially and seasonally (Figure 10). For example, in May 2020 the most abundant BMI in Dimond Park was the mayfly *Baetis* sp., while the most abundant taxon further upstream in Dimond Canyon was the stonefly *Malenka* sp. Most BMI are aquatic insects, which usually have aquatic larval stages and terrestrial, flying adult stages. As larvae, insects such as mayflies and stoneflies crawl on and within gravel and cobble on the streambed, and are major prey sources for rainbow trout (Figure 11).

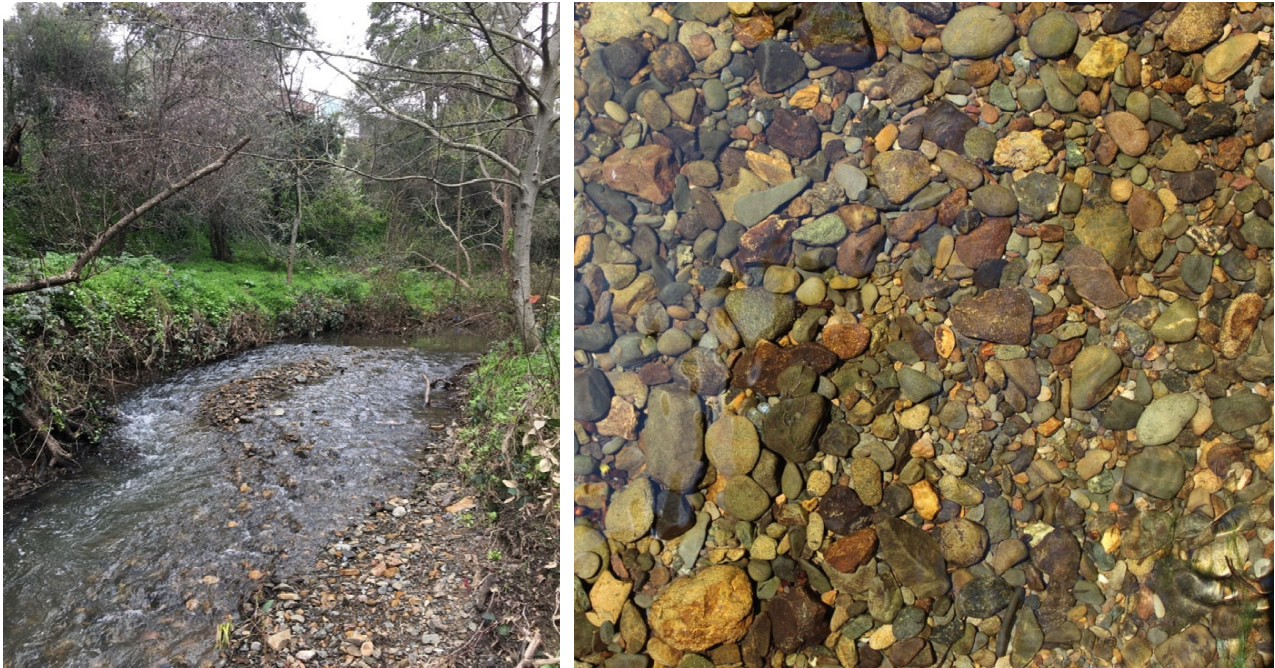
Figure 12. (Top) Rainbow trout typically spawn where pools transition to riffles as exemplified in the reach of Sausal Creek in Dimond Canyon upstream El Centro Avenue. (Bottom) Example of high-quality gravel substrate in Sausal Creek that is ideal for spawning rainbow trout. This substrate is characterized by small-to-medium-sized gravel with a low percentage of embedded fines such as silt and sand. Photos by R. Leidy.

Rainbow trout typically spawn at the pool-riffle transition where the down-welling water through the gravel carries oxygen to the trout eggs and eliminates metabolic wastes related from incubation and hatching, and fine sediment. See Figure 3: Spawning Habitat at Pool Riffle Transition (Bjornn and Reiser 1991, NRCS 2000). Rainbow trout spawn in gravel ranging from 3-100 mm in diameter, with trout < 50 cm in total length showing a preference for gravel 15-60 mm diameter (Orcutt et al. 1968, Bovee 1978, Raleigh et al. 1984). High-quality spawning gravels are characterized by < 5% fines (sediment < 2 mm diameter); survival of trout embryos and fry declines as fines make up 20-30% of total substrate sediment (Raleigh et al. 1984). (Figure 12).

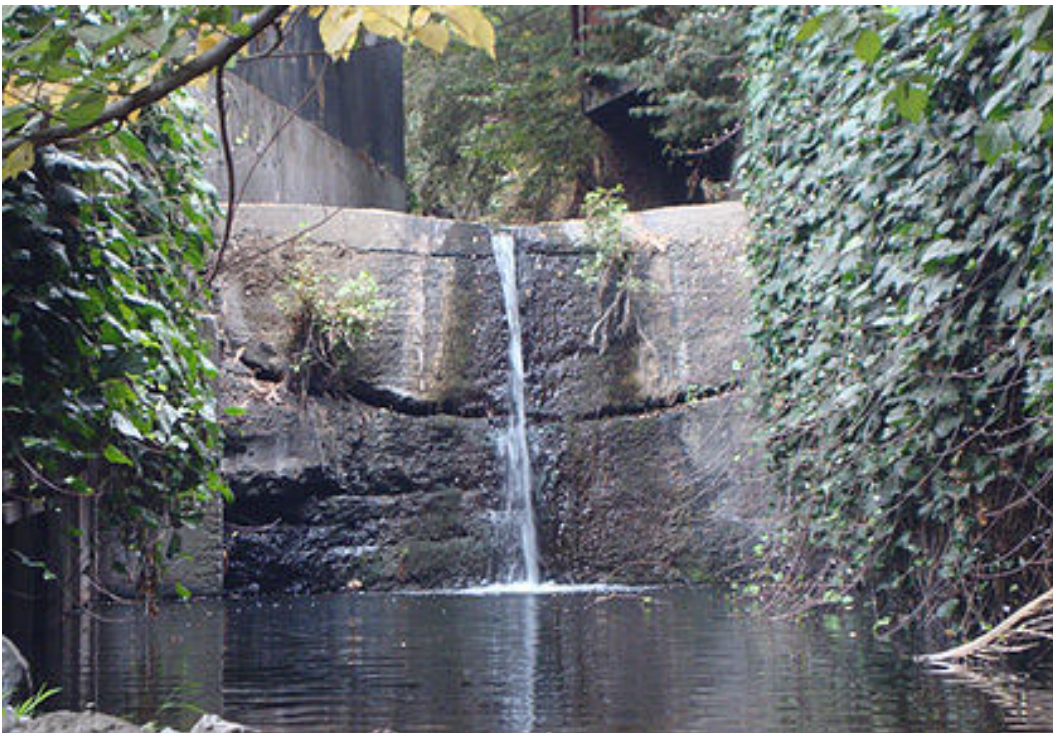
Figure 14. Grade-control structures such as this one at Barry Place are barriers to the upstream migration of rainbow trout.

Urbanization created barriers (e.g., culverts, drop structures, road crossings) that effectively block steelhead-spawning migrations into Sausal Creek (Figure 14). While urbanization degraded or destroyed much of the historically suitable habitat for fish, small numbers of rainbow trout persist and reproduce within several relatively short, less disturbed stream reaches (e.g., the mainstem of Sausal Creek in Dimond Park and Dimond Canyon Park, and the Palo Seco Creek tributary in the City's Joaquin Miller Park). Scientists have determined that the Sausal Creek rainbow trout are genetically "wild" descendants of their steelhead ancestors (i.e., the fish did not originate from a fish hatchery)(Nielsen and Fountain 1999). Thus, Sausal Creek rainbow trout are a remarkable environmental asset for the City of Oakland, and a key conservation priority.

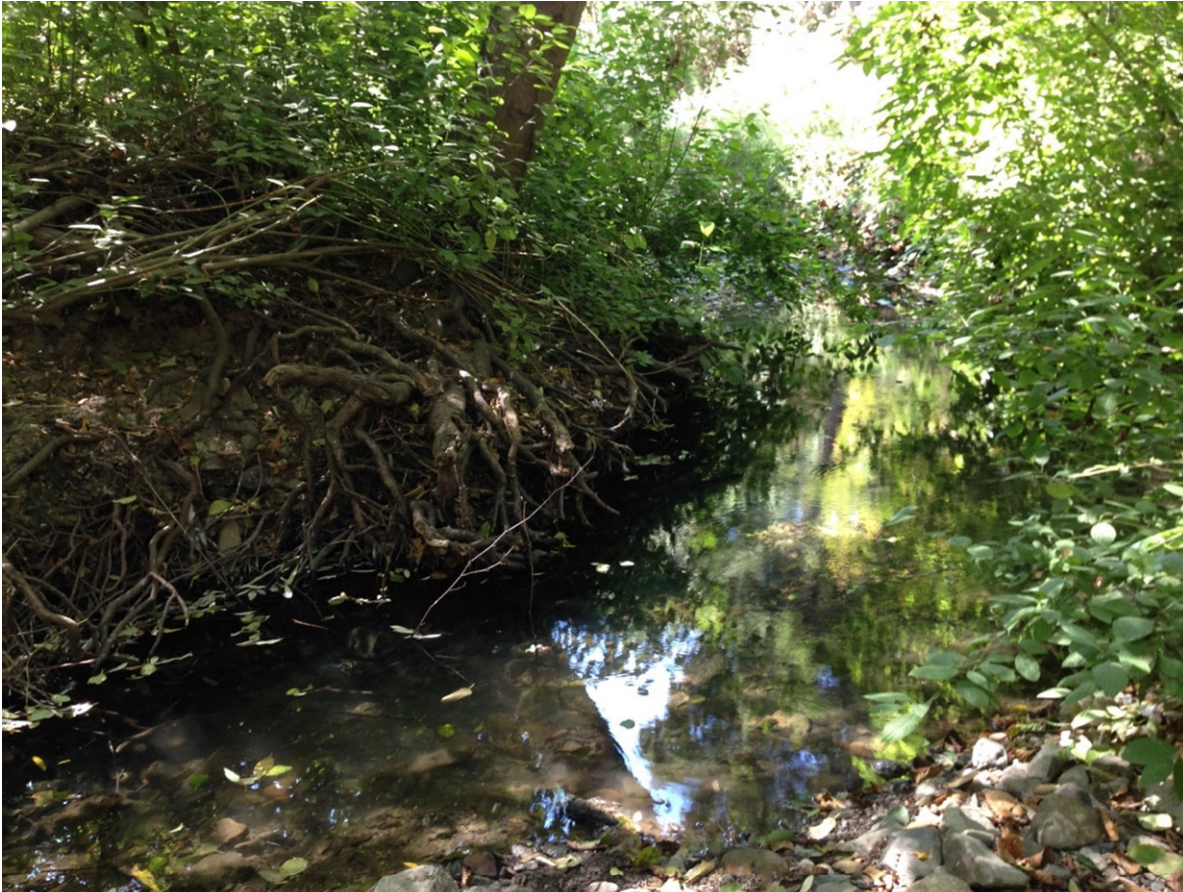
Figure 15. This summer refuge pool for rainbow trout in Dimond Canyon is well-shaded by native dogwood and alder. Undercut banks tangled with alder root wads provide high-quality shelter for trout. Photo by R. Leidy.

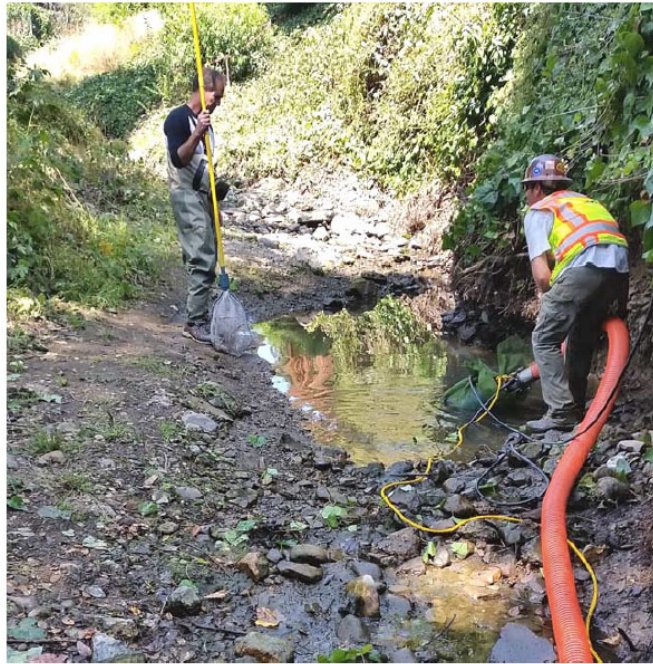
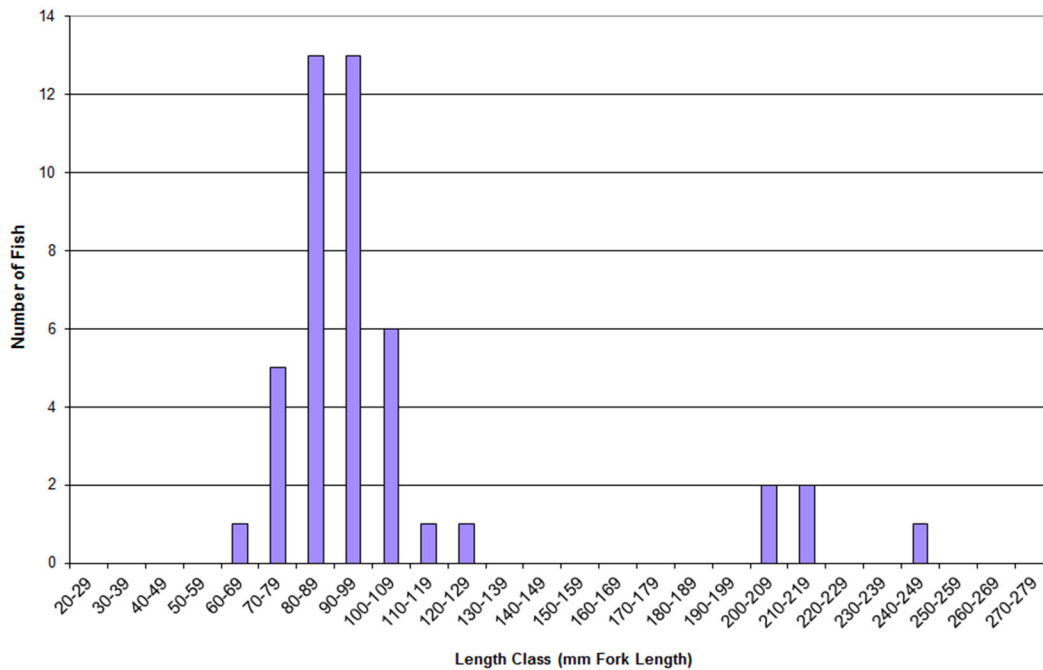
Figure 16. (Top photo). August 2015 stream dewatering and rainbow trout fish rescue/relocation effort in Sausal Creek’s Dimond Park, as part of the City of Oakland’s Sausal Creek Restoration Project in Dimond Park. (Bottom photo). Size distribution of captured and released rainbow trout. Photos and graph by Jeff Hager, Hager Environmental Science, 2015.

In August of 2015, FOsc helped to collect 45 rainbow trout of various age classes in Sausal Creek in Dimond Park (Hager Environmental Science 2015). This trout rescue was part of an effort to relocate fish before dewatering of the stream as part of the Sausal Creek Restoration Project in Dimond Park (Figure 16). The rescued fish were safely moved and released into the El Centro Avenue pool (Robert Leidy, pers. comm.).
