Conservation and Management Plan for Sausal Creek Wild Rainbow Trout

July 7, 2020

Friends of Sausal Creek
PROMOTING WATERSHED AWARENESS

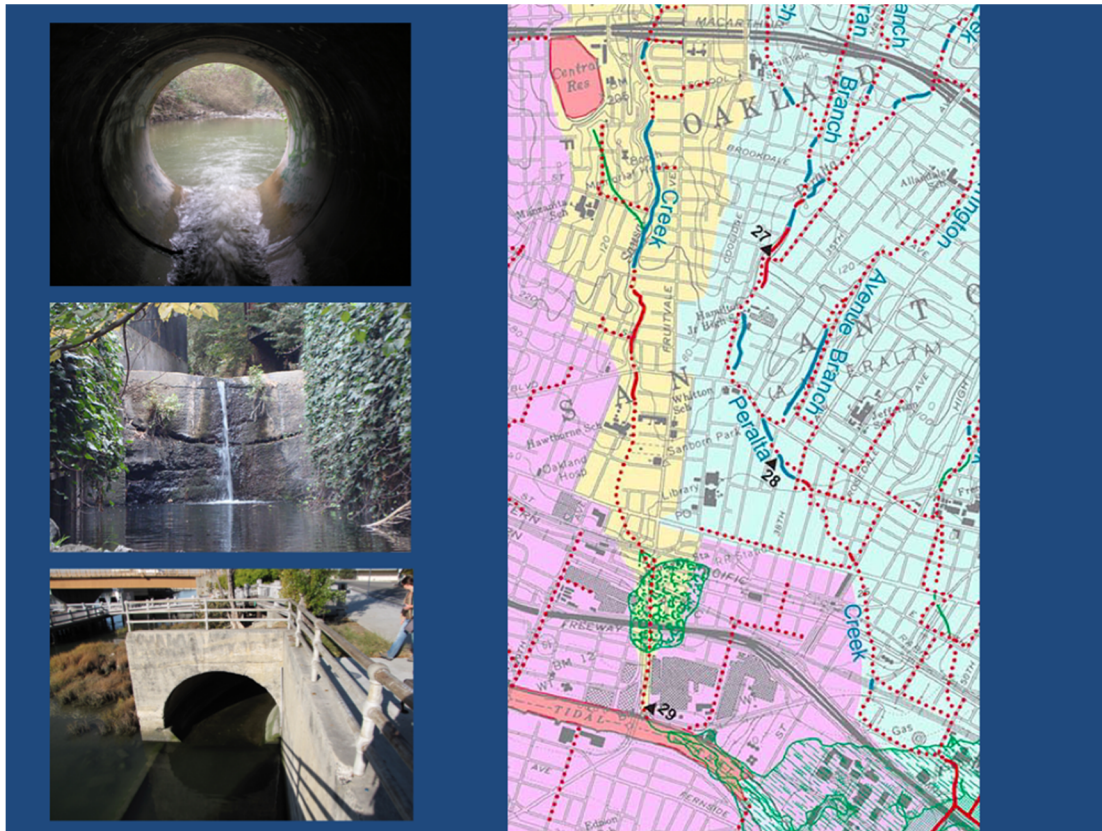
Figure 17. Rainbow trout are prevented from venturing too far upstream or downstream by human-made structures including (counterclockwise from top left): a road culvert under El Centro Avenue; a drop structure at Barry Place; and a large culvert at the Oakland Estuary. The map depicts the lower fragmented reaches of Sausal Creek (left side of figure) where the creek was “channelized” (solid red line), “undergrounded” (dotted red line), not channelized but modified with stormwater infrastructure (blue line), and historical wetland features (green line).

Fragmentation of once continuous, high-quality aquatic habitat in Sausal Creek has left splintered and discontinuous reaches of suitable living space for rainbow trout (Figure 17). In contrast to connectivity, fragmentation is the process of a larger whole being broken apart into smaller pieces that form isolated or incomplete parts. Stream networks are naturally fragmented (e.g., waterfalls that create fish migration barriers), but in urban settings, humans have accelerated the process of stream fragmentation. Examples of human activities that have fragmented Sausal Creek include the construction of roads, culverts, bridges, flood control channels, and dams.

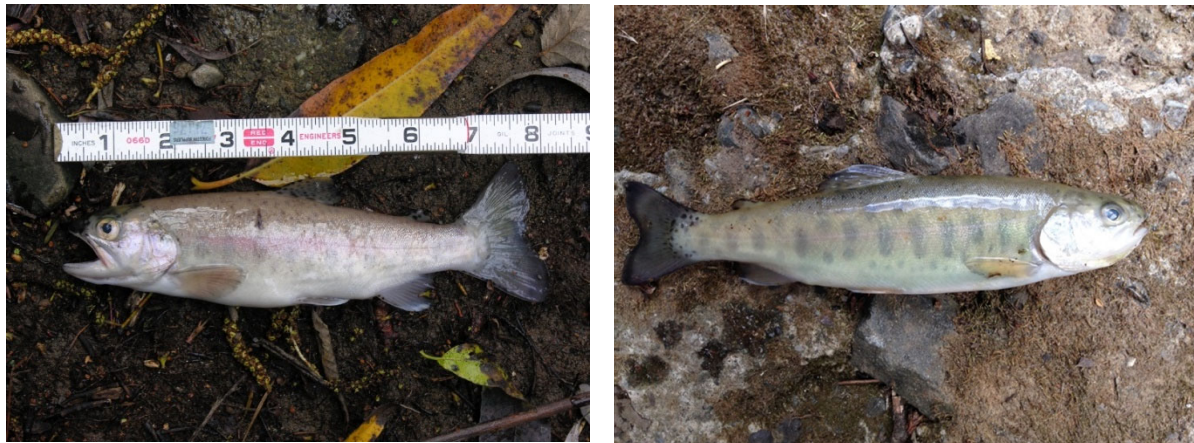
Figure 18. Examples of adult (left) and juvenile (right) rainbow trout killed by the illegal dumping of toxic substances into Sausal Creek. In 2009, at least thirteen adult trout were killed in El Centro Pool by paint solvents dumped into a residential storm drain that empties into the creek. Photos by R. Leidy.

Water quality degradation in Sausal Creek from “point and non-point” pollution sources can pose threats to the resident rainbow trout population. Perhaps the greatest threat to the survival of trout in Sausal Creek comes from illegal dumping of toxic substances such as paints, solvents, and oil. Harmful pollutants may originate in commercial and residential areas where they enter the storm drain system and eventually discharge into Sausal Creek or its tributaries. Several ‘fish kills’ in Sausal Creek have been traced to the dumping of toxic substances into Sausal Creek (Figure 18).

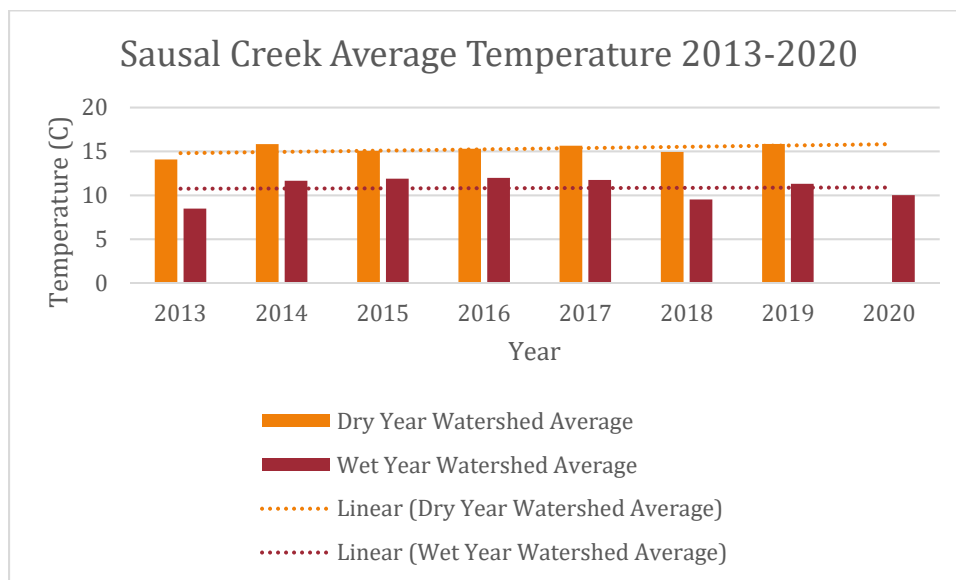
Figure 19. Average water temperatures in Sausal Creek through wet and dry seasons from 2013-2020.

Loss of riparian forest cover contributes to warm water temperatures, while an increase in riparian forest cover shades the waterway and maintains cooler temperatures during the summer and fall. Creek temperatures have generally remained cool in the summer and fall, likely due to the presence of base flows in the creek from seeps and springs. Water temperatures in Sausal Creek from 2013 to 2020 have not surpassed 16°C in the warmest months (Figure 19).

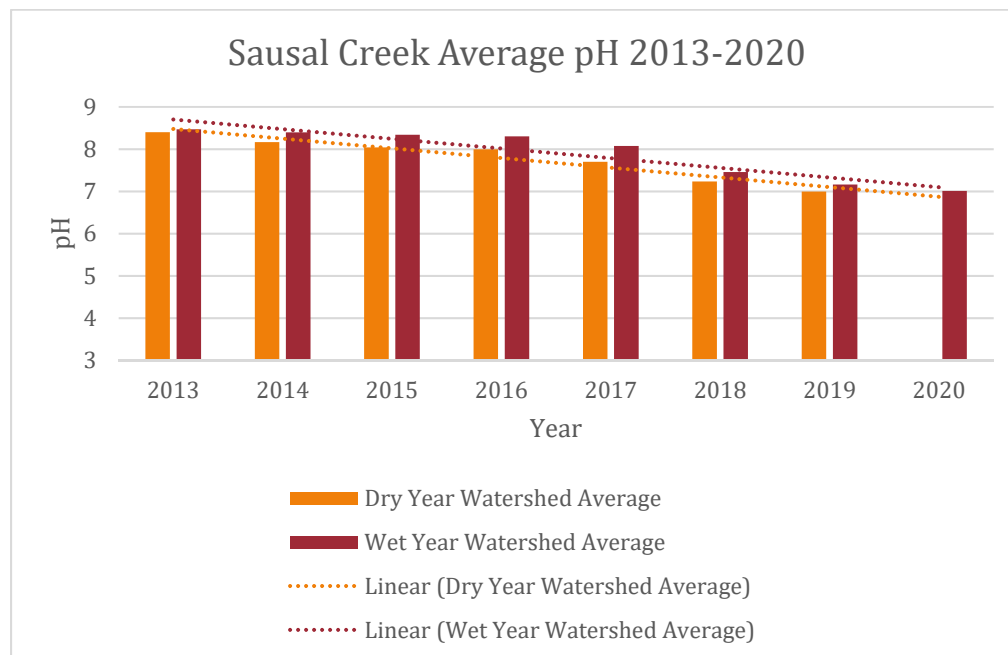
Figure 20. Sausal Creek Average pH 2013-2020. Wet and dry year watershed averages of pH values from a watershed-wide survey compared over 8 years.

All sampling locations displayed a downward trend in pH (increasing acidity), some more sharply than others. The most substantial decrease and variation in pH was observed at Barry Place, the most downstream of all monitoring sites ($y = -0.37x + 9.03$, $R^2 = 0.87$ dry year, $y = -0.30x + 9.1$, $R^2 = 0.79$ wet year).

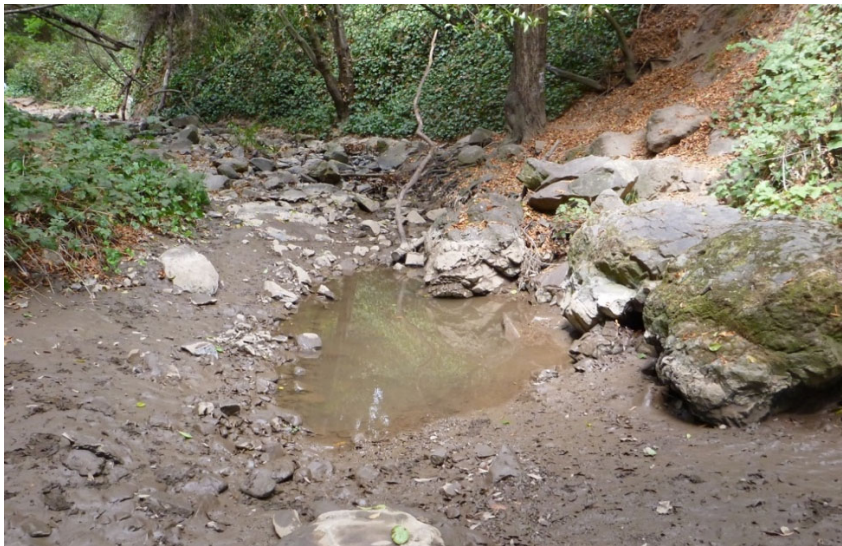
Figure 22. Excessive sedimentation in the Dimond Canyon reach of Sausal Creek exacerbated by a drinking water pipeline break and in the upper watershed. Too much of such fine sediment can smother rainbow trout eggs and reduce the diversity and abundance of aquatic invertebrates that are important prey for trout. Compare this photo with the clean substrate visible in Figure 12, above. Photo by R. Leidy.

Excessive delivery of fine sediment from human-caused erosion is known to occur throughout the Sausal Creek watershed. Sources of high sediment input to Sausal Creek include improperly designed or failing stormwater drain outfalls along major open channels, outlets on extremely steep slopes, and storm drains receiving runoff from large land areas. The 2010 Sausal Creek Watershed Enhancement Plan lists high priority erosion sites (Section VII, Recommended Actions).

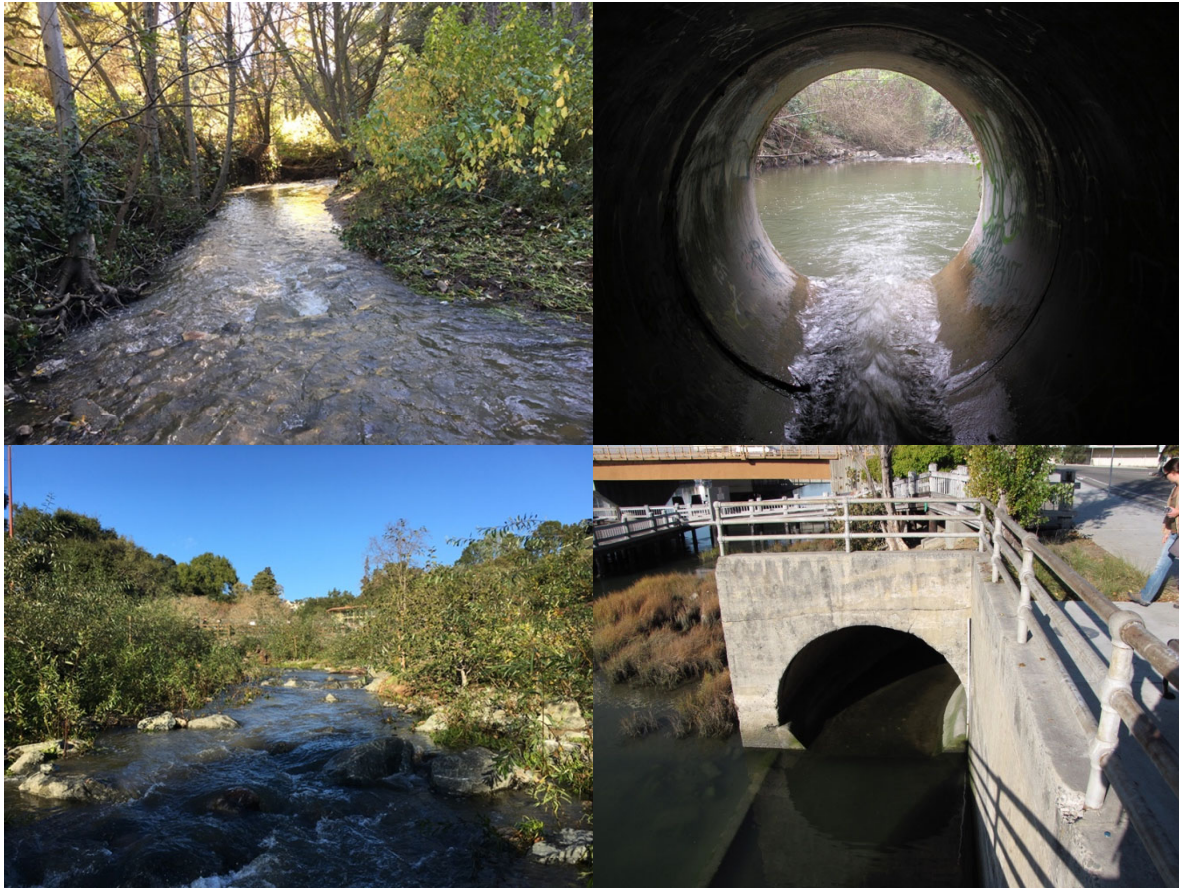
Figure 27. Clockwise from Upper Left. Dimond Canyon. El Centro Avenue culvert. Restored stream channel Dimond Park. Culverted outlet of Sausal Creek into Oakland Estuary. Photos by R. Leidy.
