EVALUATION OF WATERSHED EROSION SITES

Sausal Creek Watershed Plan

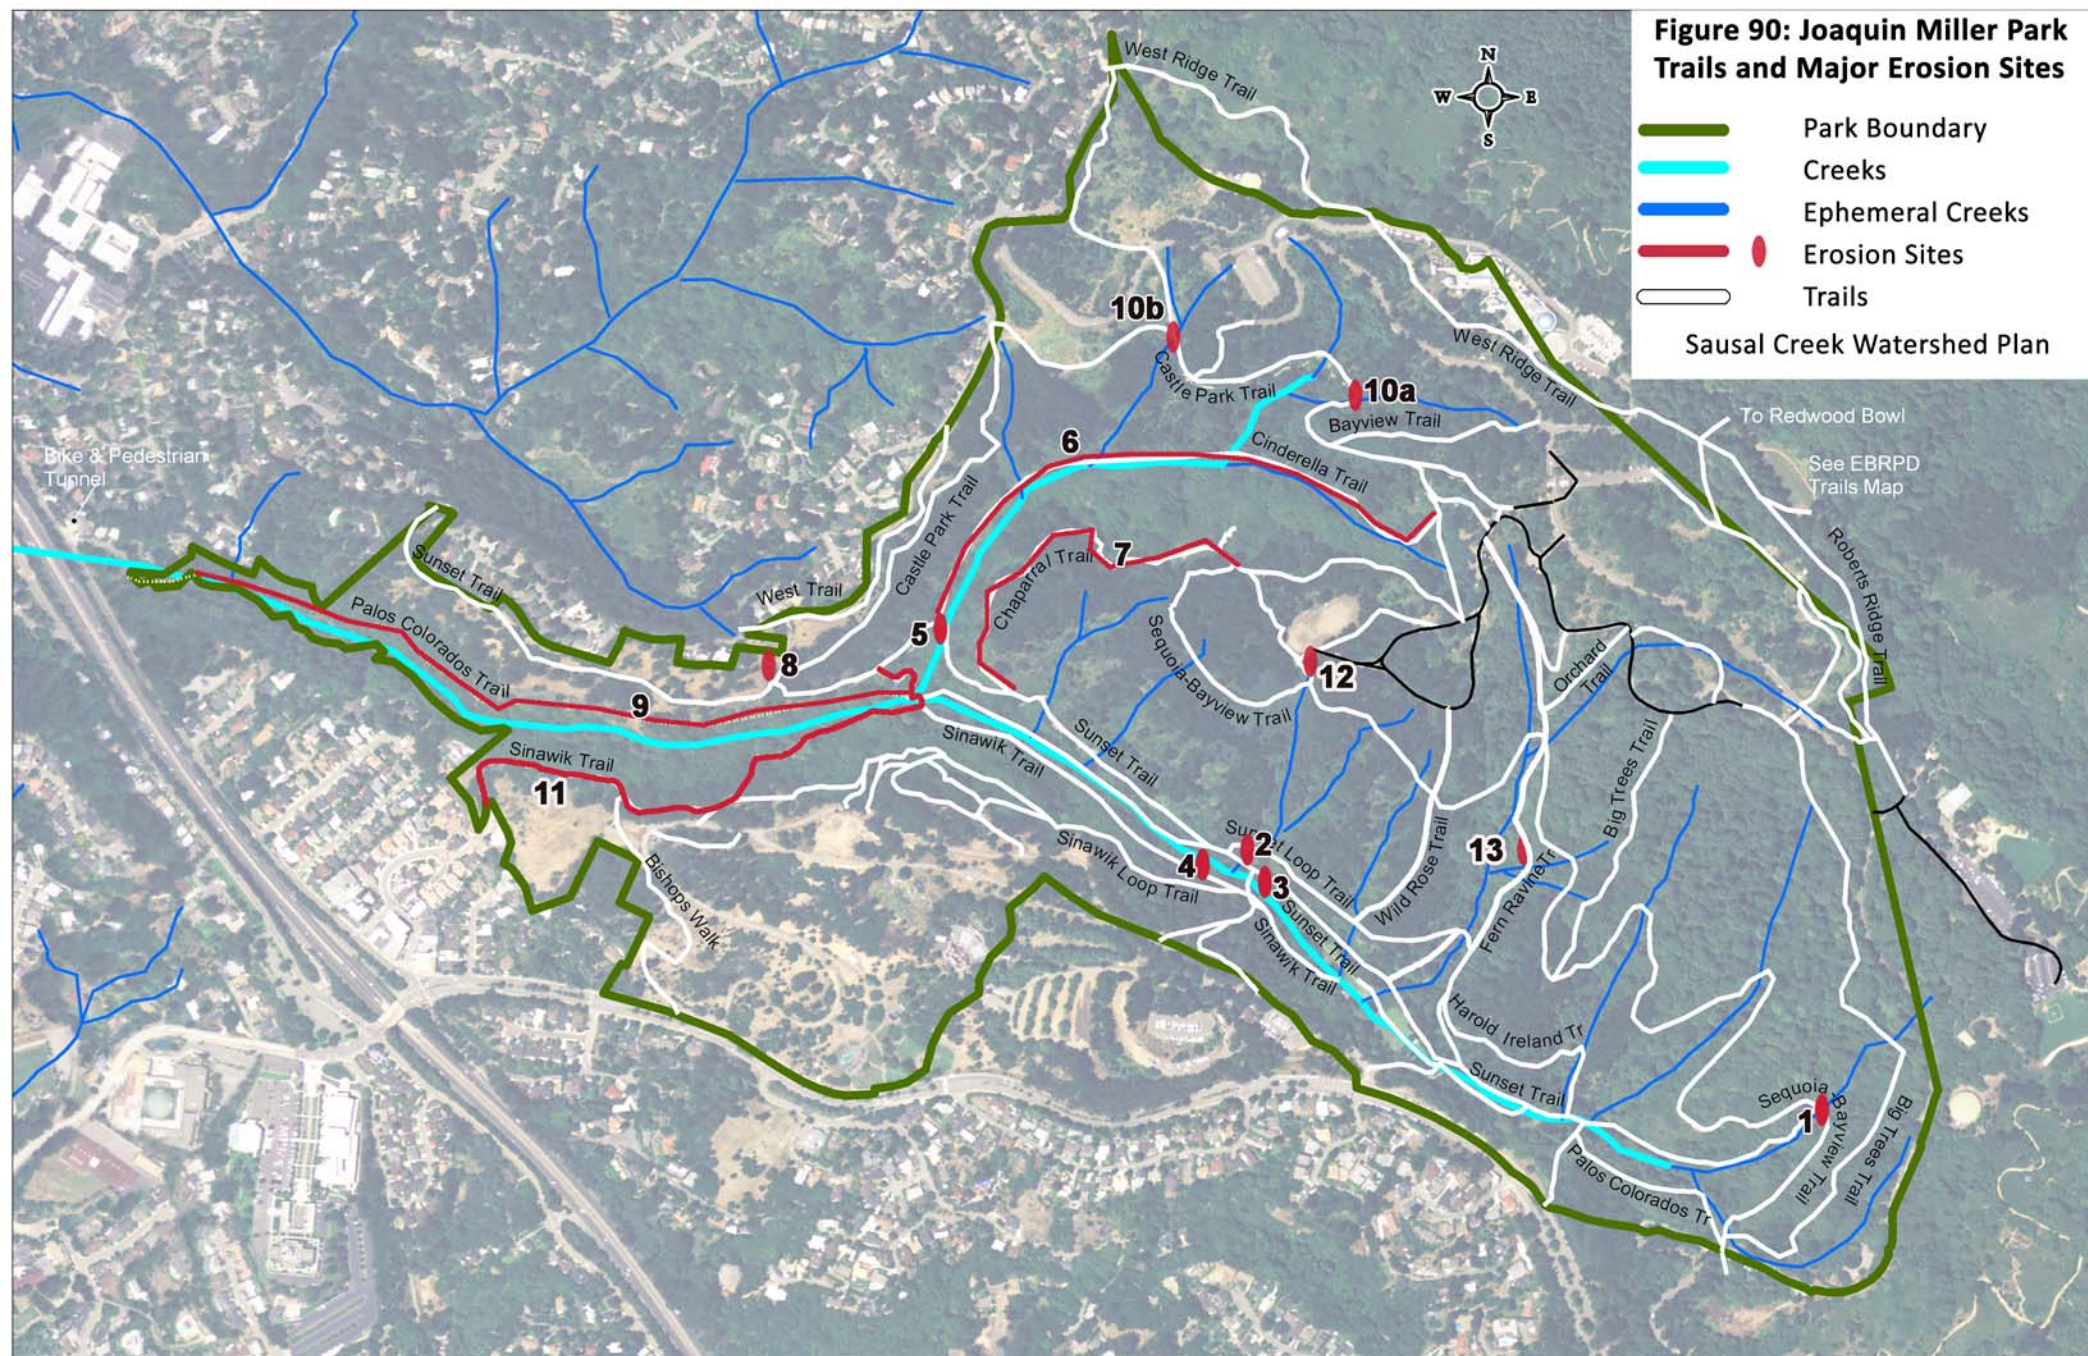
Figure 90: Joaquin Miller Park Trails and Major Erosion Sites

Many of the trails in Joaquin Miller Park date from prior logging activities and were not built for long-term use (Figure 90). There is a general lack of stream crossing culverts, waterbars, and proper drainage on trails. Table 51 lists the most significant erosion sites. These problems have been causing erosion and polluting Palo Seco Creek with fine sediment for a long time (Figure 91-99). City maintenance of these facilities is not funded most years, leading to continued degradation.
