YEAR 5 (2020) ANNUAL MONITORING REPORT

PALLID MANZANITA HABITAT ENHANCEMENT AND CONSERVATION PLAN FOR THE CHABOT SPACE AND SCIENCE CENTER

> **Prepared by** Friends of Sausal Creek P.O. Box 2737 Oakland, CA 94602

JANUARY 31, 2021

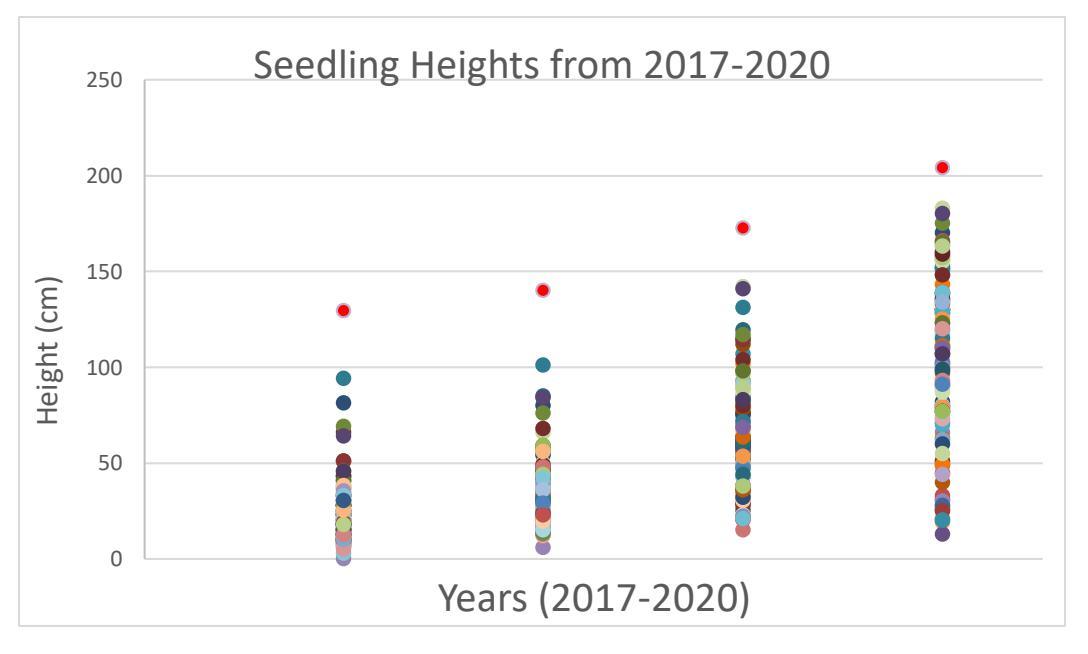
FIGURE 1. All SEEDLING HEIGHTS FROM 2017-2020

Individual #2 (tag number 601) is easily identifiable in this graph as the red dot. It was significantly taller than the rest of the seedlings in 2017, but many seedlings are closing in as of 2020. Individual #3 (the only remaining plant from the original population of 21) was omitted from this graph as it is substantially taller than the rest
